ECU Mount Lawley Redevelopment

Precinct Structure Plan Water Management Report

DevelopmentWA

By Urbaqua

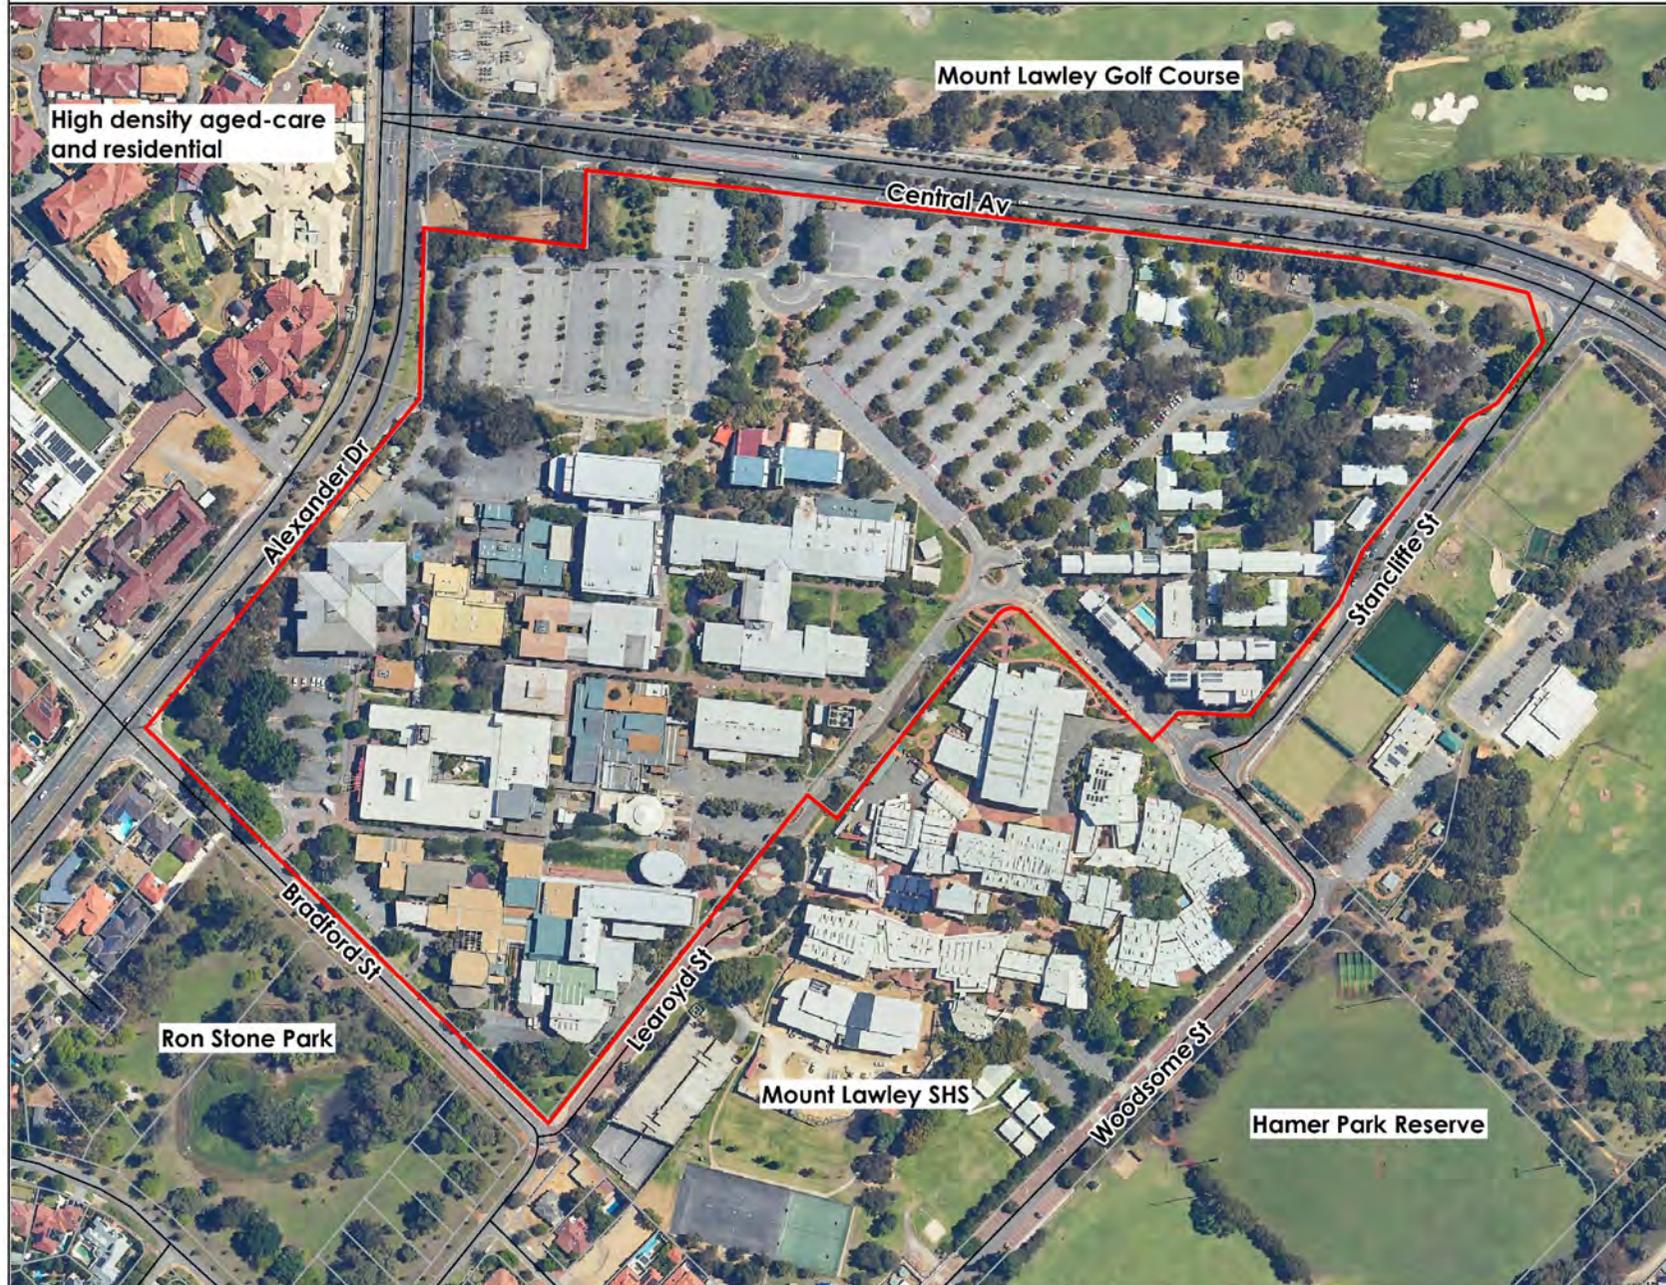
Figure 1 - Location Plan

This strategy addresses the study area presented in Figure 1.

Figure 1 displays the current land uses within and surrounding the study area. The study area has been previously used as a landfill (1896-1932), a pine plantation until 1961 and tertiary education since 1970.

Figure 1 displays the location and current surrounding land uses, which include mostly residential and recreational areas:

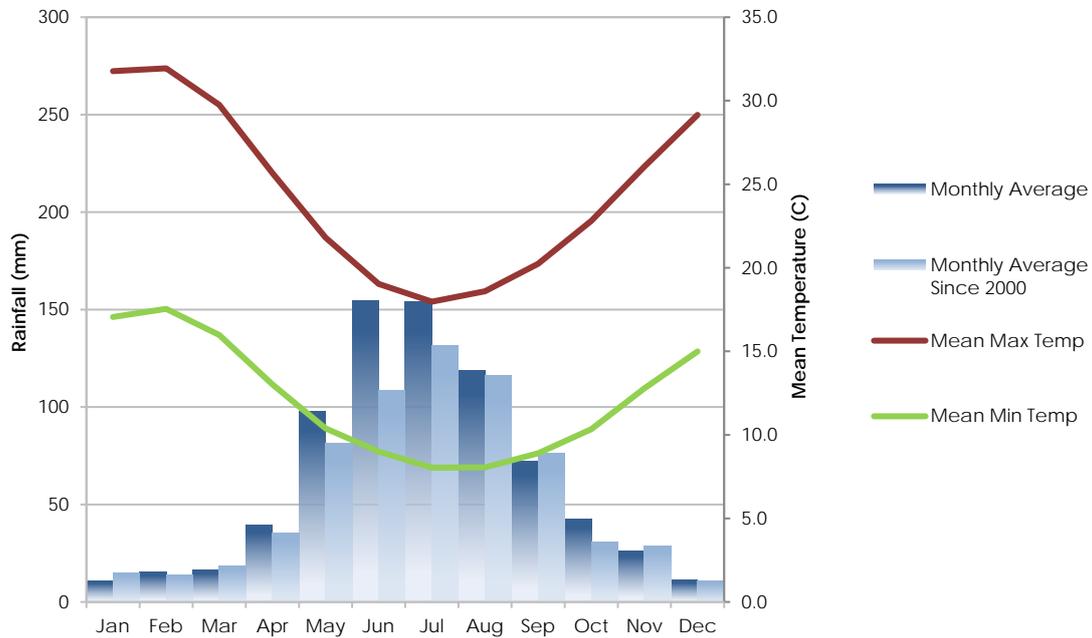
Chart 2: Climate summary data (BoM station no. 9021, BoM, 2024)

Increasing urban heat due to climate change has also been recognised as a significant issue for the Perth region linked to loss of urban canopy and increasing populations. Chart 4 shows the increases that have been observed in mean maximum temperatures recorded at the nearest Bureau of Meteorology weather station (Perth Airport station no. 9021).

Decreasing rainfall is noted in the *Selection of future climate projects for Western Australia* (DoW, 2015). Mean annual rainfall decreases projected by DWER, based on the 1961-1990 baseline, varies between -4% (wet scenario) and -25% (dry scenario) by 2050. This extends to -7% (wet) and -47% (dry) by 2090.

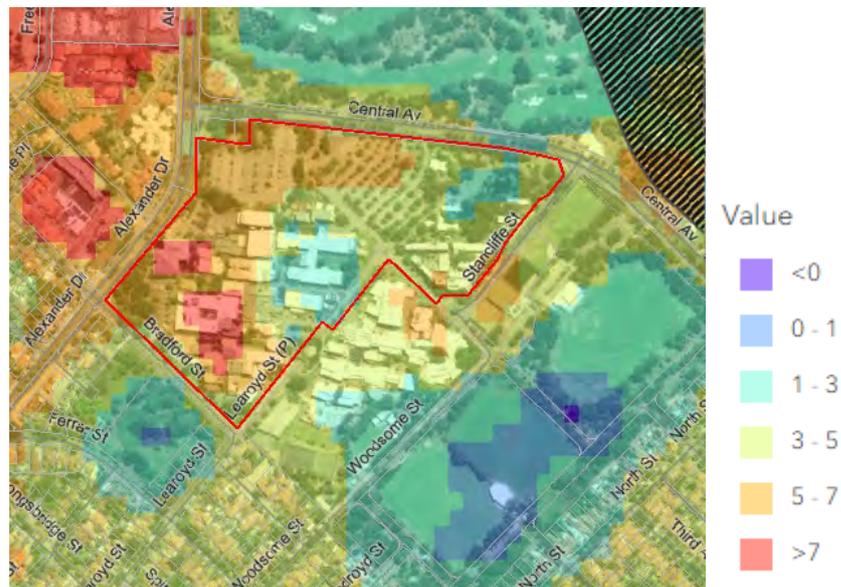
Plate 1: Urban Heat Mapping (WALGA, 2018/19)

Urban heat mapping of the ECU Mount Lawley Campus is shown in Plate 1, showing heat hotspots associated with low vegetation cover to the northwest (high density residential and aged care area), along Alexander Drive, and in the southern portion of the study area. Cooler areas are associated with the parks to the southeast, basin to the south and the golf course to the north of study area.

Low vegetation coverage is a significant contributor to urban heat. As shown on Figure 3, the study area currently has relatively high vegetation cover of 15-25% within boundaries, and for landuse to the south, east and north. This contributes to the areas of lower urban heat (Plate 1) associated with the north-east basins.

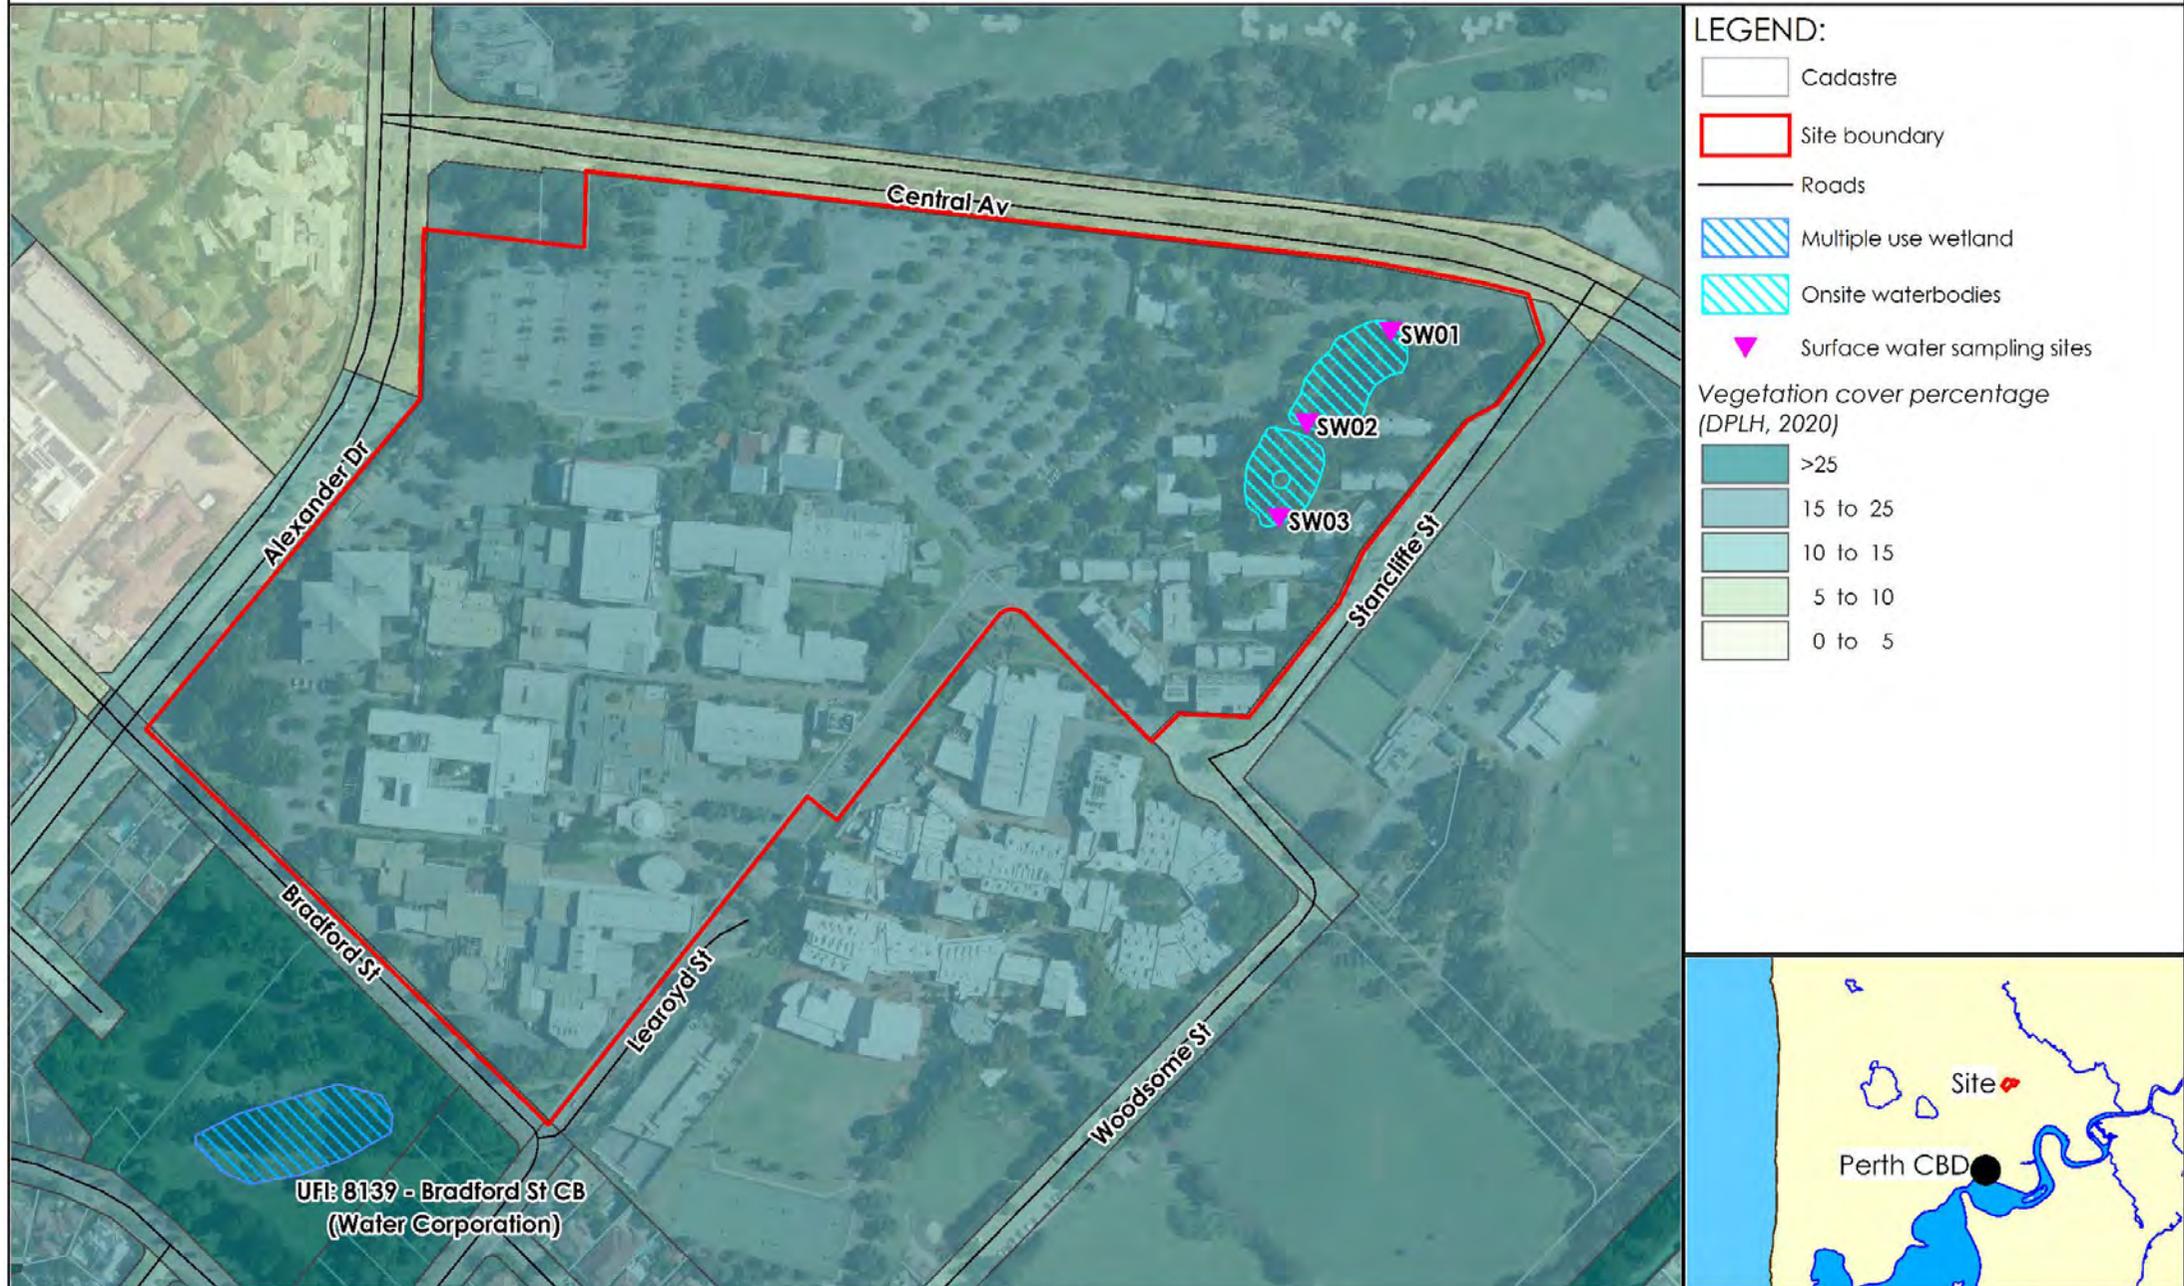
Development WA - ECU Mount Lawley Campus WMS
 Figure 3 - Vegetation and Wetlands

Water quality sampling has been undertaken at three sites in the existing waterbodies within the site, shown on Figure 3. Sampling during contaminated sites investigations found no analyte concentrations that exceeded applied assessment criteria and concluded that *“The water quality data is inferred to indicate that the landfill body is not impacting the water quality in the drainage ponds and that stormwater inflows have a primary influence on water quality”* (Aurora Environmental, 2023).

There are two connected man-made waterbodies present in the northeast corner of the study area, which appear to take runoff from surrounding roads and roof runoff from nearby buildings. The larger lake to the north has water present year-round (as observed with historical aerial imagery) which could indicate a possible connection to groundwater. However, groundwater levels at nearby ECU02 bore recorded an MGL of 20.11 m AHD, which is approximately 0.7m below the lake water level recorded by survey indicating that the lake is regularly topped up with groundwater. The southern ephemeral basin is observed to be dry throughout the summer months.

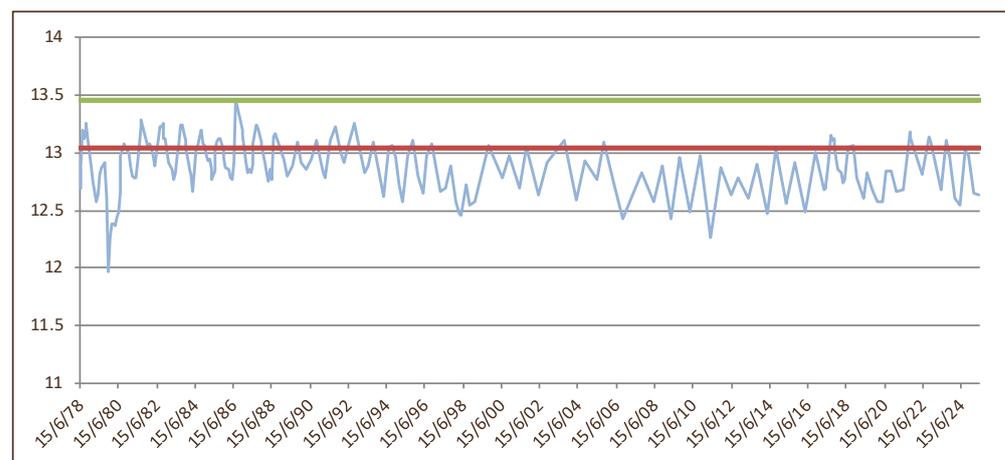
All three of these bores have available long-term groundwater level data recorded in the Superficial Aquifer commencing before 1978 and ongoing to date. Chart 6 to Chart 8 presents groundwater data available for each of these sites since 1978, highlighting the maximum recorded groundwater level (MGL) in that period and the calculated average annual maximum groundwater level (AAMGL). It is observed that groundwater levels have been relatively stable at all three bores throughout the record and therefore it is considered reasonable to base calculations on the full dataset at each site.

DoW Bore	GD6	Maximum GWL (mAD)	13.46
Win Site	61610161	AAMGL (mAD)	13.04

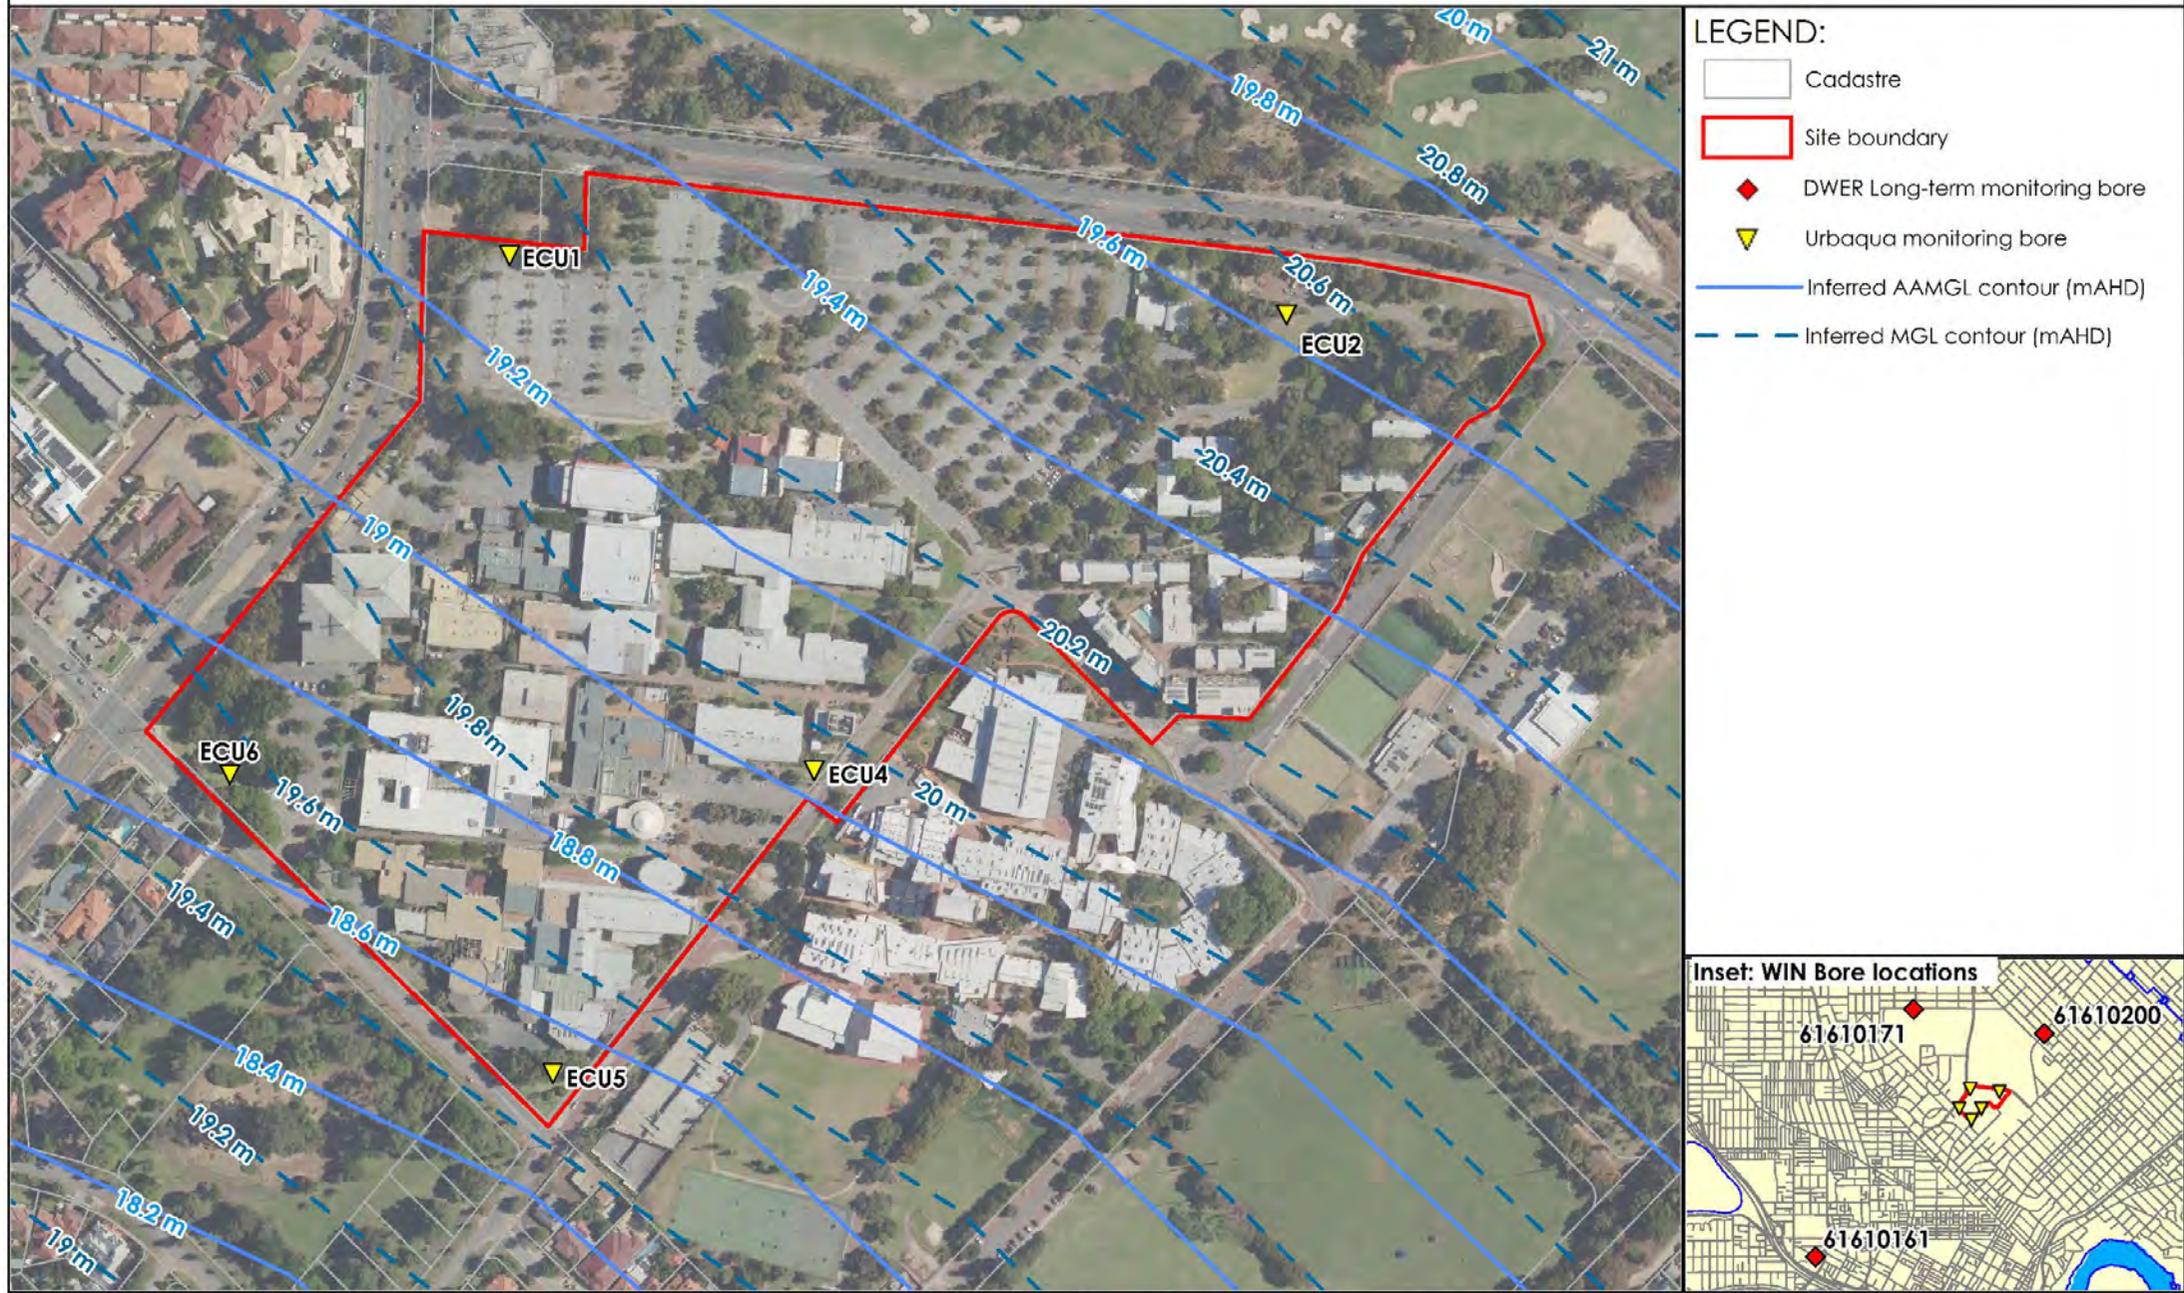
Development WA - ECU Mount Lawley Campus WMS
 Figure 5 - Groundwater

Groundwater quality sampling has occurred at the site as a part of acid sulfate soils and contaminated sites investigations, as discussed in Section 2.3. These investigations were focussed on specific groundwater quality considerations and found that:

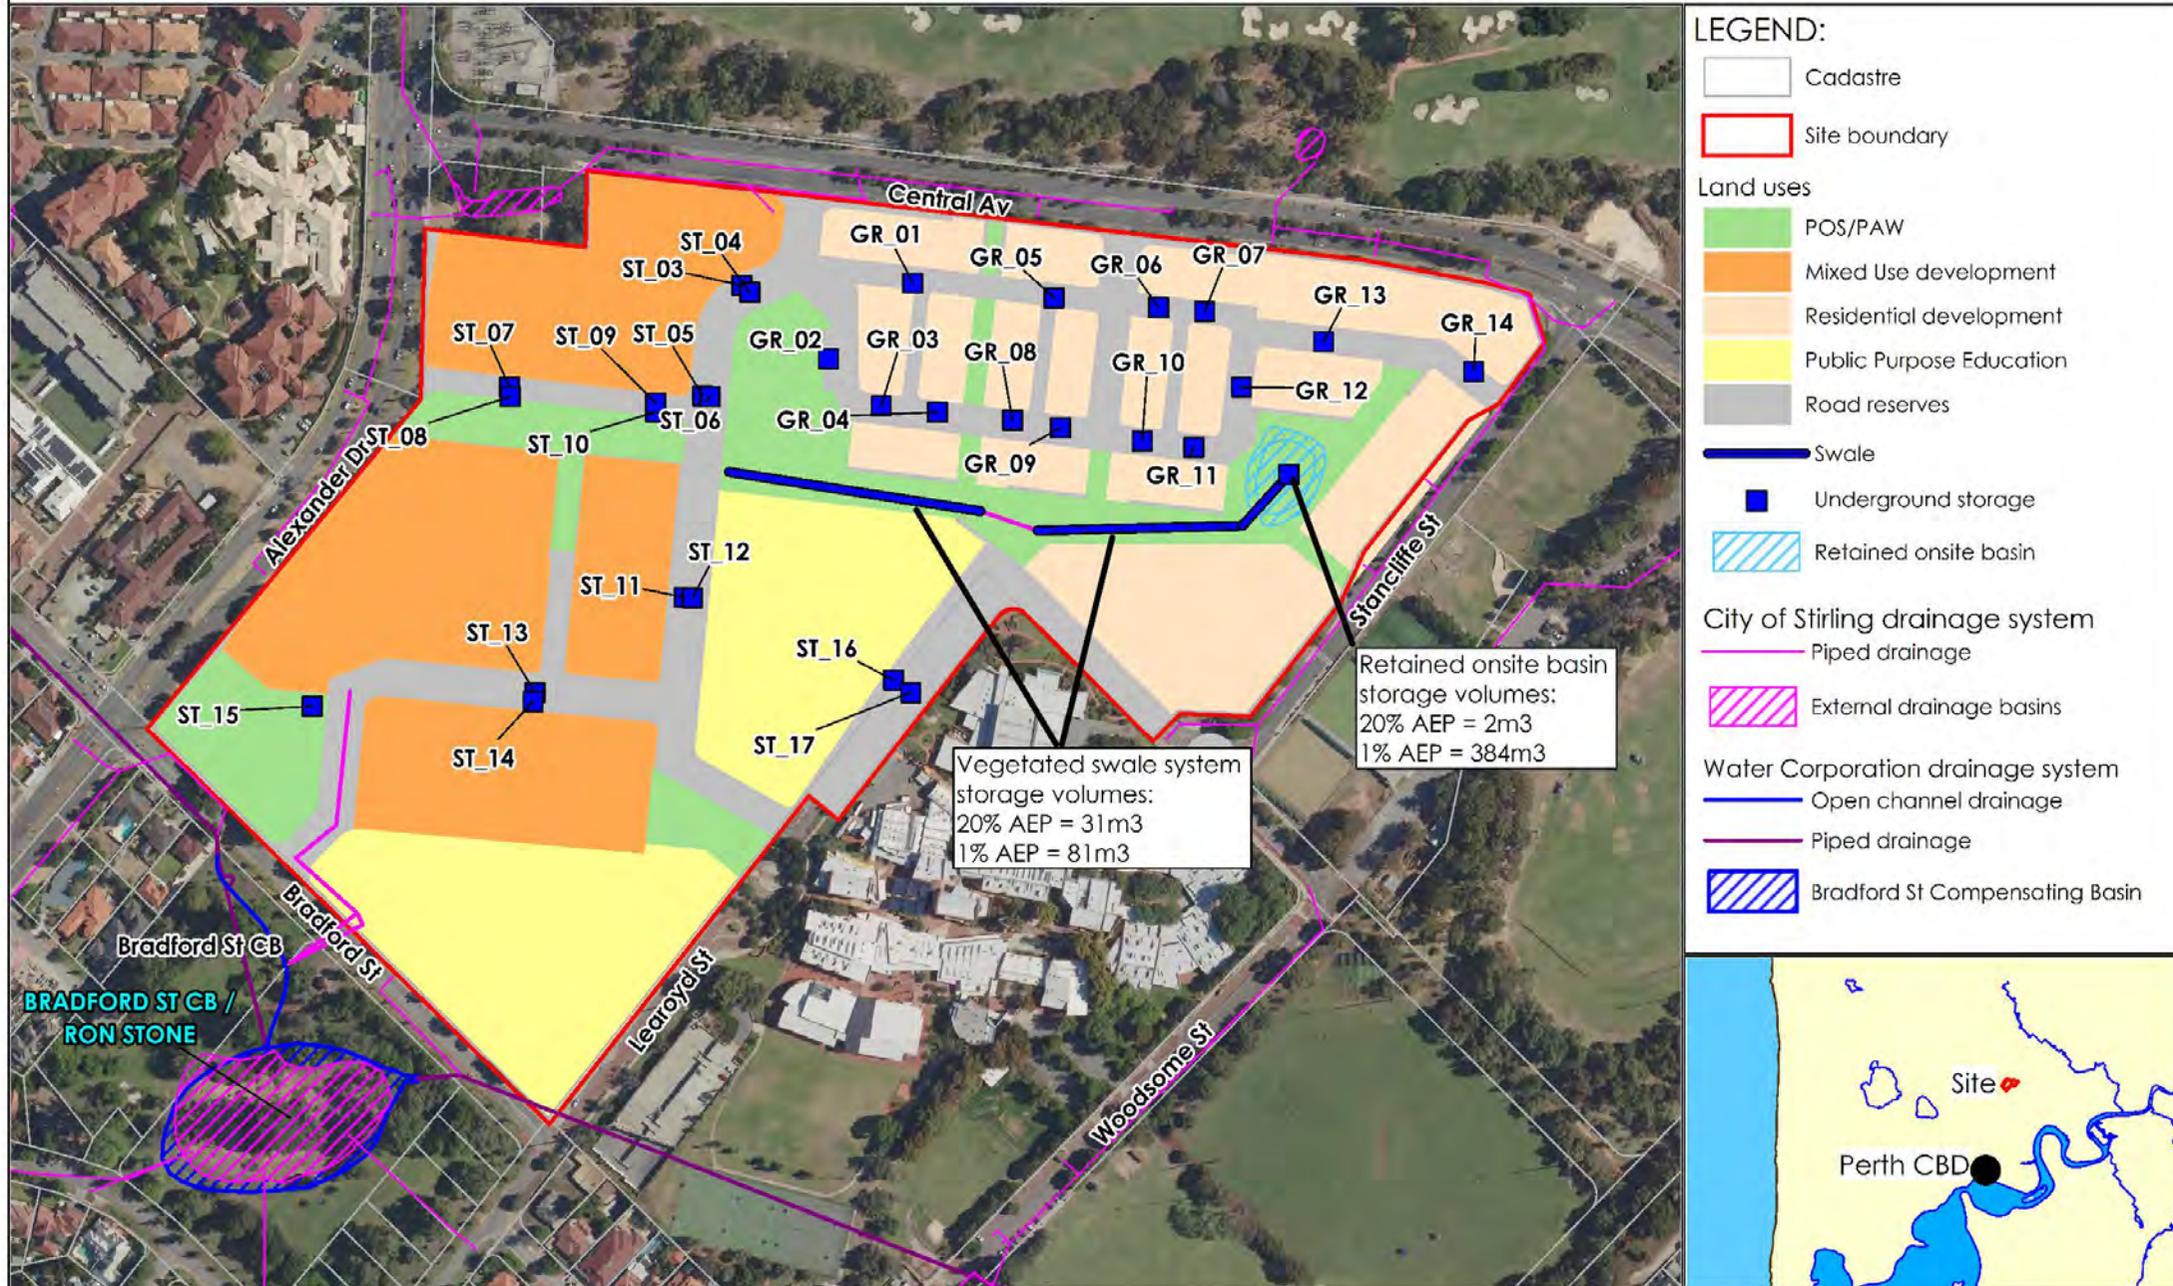
Figure 6 - Stormwater management plan

Stormwater management for the study area will incorporate the use of on-site retention as close to source as possible using underground infiltration systems that will capture runoff from impervious surfaces.

Soakwells are required to be installed to townhouse lots for storage and infiltration of the first 15 mm of rainfall within all private lots in accordance with the *Decision Process for Stormwater Management in WA* (DWER, 2017) and the City of Stirling’s on-site stormwater drainage criteria.

Each lot will be required to retain and infiltrate on site up to and including the 10% AEP event using:

- Underground infiltration systems
- roof gardens
- raingardens
- rainwater tanks
- or other in combination

Table 2 provides an assessment of the required volume and footprint areas of retention storages, assuming that 0.6m deep underground infiltration systems are used.

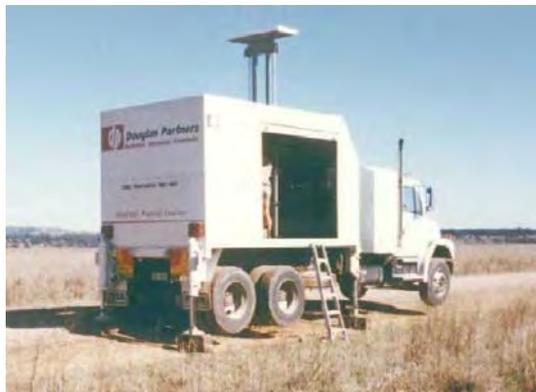
Figure 2: Purpose built CPT rig

The cone is thrust into the ground at a steady rate of about 20 mm/sec, usually using the hydraulic rams of a purpose built CPT rig, or a drilling rig. The testing is carried out in accordance with the Australian Standard AS1289 Test 6.5.1.

The CPT can penetrate most soil types and is particularly suited to alluvial soils, being able to detect fine layering and strength variations. With sufficient thrust the cone can often penetrate a short distance into weathered rock. The cone will usually reach refusal in coarse filling, medium to coarse gravel and on very low strength or better rock. Tests have been successfully completed to more than 60 m.

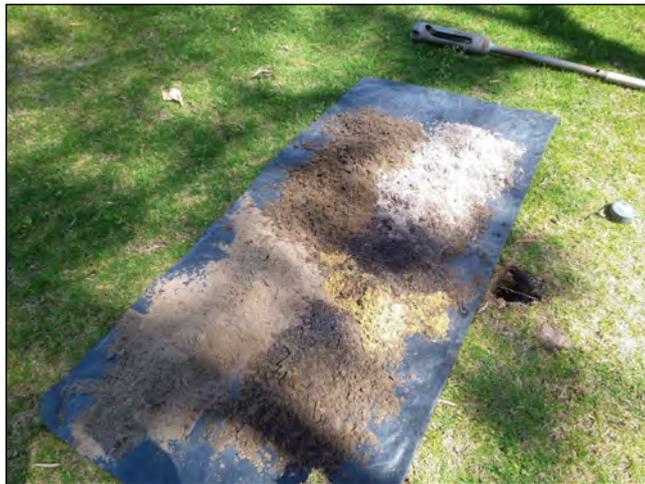
BORE No: 22
PROJECT No: 216618.00
DATE: 28/9/2022
SHEET 1 OF 1

RL	Depth (m)	Description of Strata	Graphic Log	Sampling & In Situ Testing				Water	Dynamic Penetrometer Test (blows per 150mm)									
				Type	Depth	Sample	Results & Comments		5	10	15	20						
20		FILL/SAND SP: fine to medium grained, dark grey-brown, trace silt and gravel, moist, medium dense, fill. - becoming grey-brown from 0.1 m depth.	[Cross-hatch pattern]															
21	1	- becoming dark grey-brown and yellow-brown from 1.4 m depth.	[Cross-hatch pattern]															
21	1.8	SAND SP: fine to medium grained, pale grey, trace silt, moist. Bassendean Sand.	[Dotted pattern]															
21	2.3	Bore discontinued at 2.3m (Hard digging, refusal on tree roots)

TYPE OF BORING: 110 mm diameter hand auger borehole

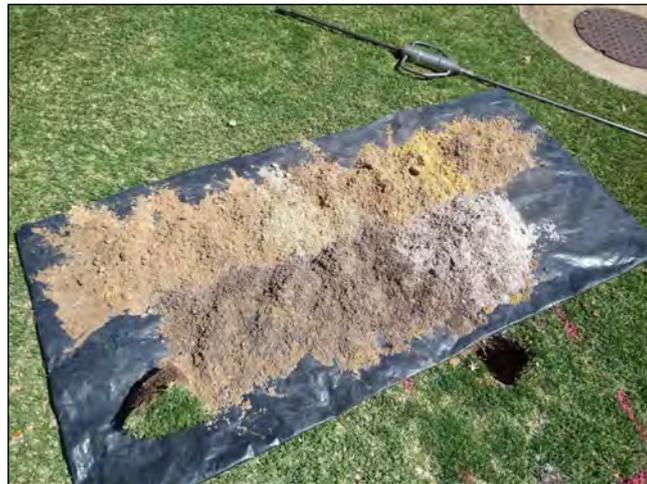
BORE No: 23
PROJECT No: 216618.00
DATE: 28/9/2022
SHEET 1 OF 1

RL	Depth (m)	Description of Strata	Graphic Log	Sampling & In Situ Testing				Water	Dynamic Penetrometer Test (blows per 150mm)
				Type	Depth	Sample	Results & Comments		
23 22 21	0.3	FILL/SAND SP-SM: fine to medium grained, dark grey-brown, with silt, trace gravel, moist, dense, fill.	[Cross-hatched pattern]						
	0.45	FILL/Gravelly SAND SP-SM: fine to medium grained, pale yellow-brown, fine to coarse sized, with silt, moist, very dense, fill. Gravel is crushed limestone.							
	1	FILL/SAND SP-SM: fine to medium grained, grey-brown, yellow-brown, grey and dark grey, with silt, moist, very dense, fill.							
	1.7	SAND SP: fine to medium grained, pale grey, trace silt, moist. Bassendean Sand.	[Dotted pattern]						
2 21	2.3	Bore discontinued at 2.3m (Collapsing conditions)

TYPE OF BORING: 110 mm diameter hand auger borehole

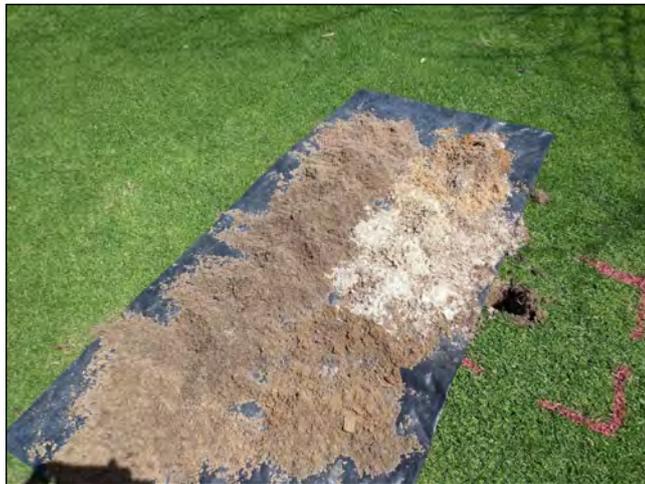
BORE No: 24
PROJECT No: 216618.00
DATE: 28/9/2022
SHEET 1 OF 1

RL	Depth (m)	Description of Strata	Graphic Log	Sampling & In Situ Testing				Water	Dynamic Penetrometer Test (blows per 150mm)
				Type	Depth	Sample	Results & Comments		
23	0	FILL/SAND SP-SM: fine to medium grained, dark grey-brown, with silt, moist, loose, fill. - becoming grey-brown, trace gravel from 0.1 m depth.	[Cross-hatch pattern]						
22	1								
21	1.7	SAND SP: fine to medium grained, pale grey, trace silt, moist. Bassendean Sand. - becoming pale brown and brown from 2.1 m depth.	[Dotted pattern]						
	2								
	2.5	Bore discontinued at 2.5m (Target depth)

TYPE OF BORING: 110 mm diameter hand auger borehole

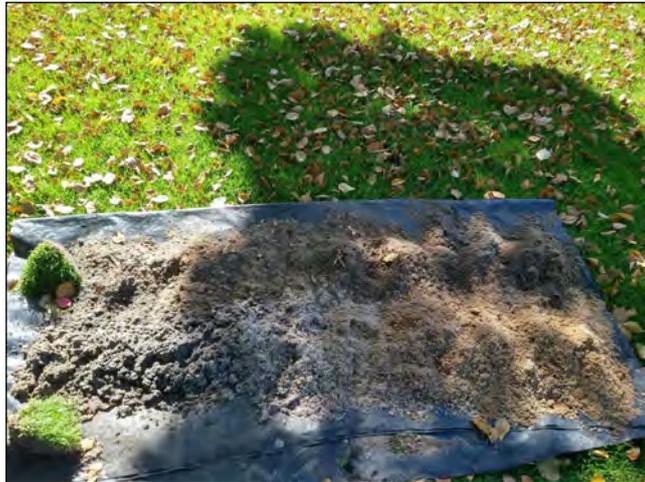
BORE No: 25
PROJECT No: 216618.00
DATE: 28/9/2022
SHEET 1 OF 1

RL	Depth (m)	Description of Strata	Graphic Log	Sampling & In Situ Testing				Water	Dynamic Penetrometer Test (blows per 150mm)					
				Type	Depth	Sample	Results & Comments		5	10	15	20		
22		FILL/SAND SP: fine to medium grained, dark grey-brown, trace silt and gravel, moist, medium dense, fill. - becoming grey-brown from 0.1 m depth.												
	1	- becoming grey from 1.1 m depth.		D	0.9									
21	1.3	SAND SP: fine to medium grained, pale grey, trace silt, moist. Bassendean Sand.												
	2	- becoming pale brown from 2.0 m depth.												
20	2.5	Bore discontinued at 2.5m (Target depth)

TYPE OF BORING: 110 mm diameter hand auger borehole

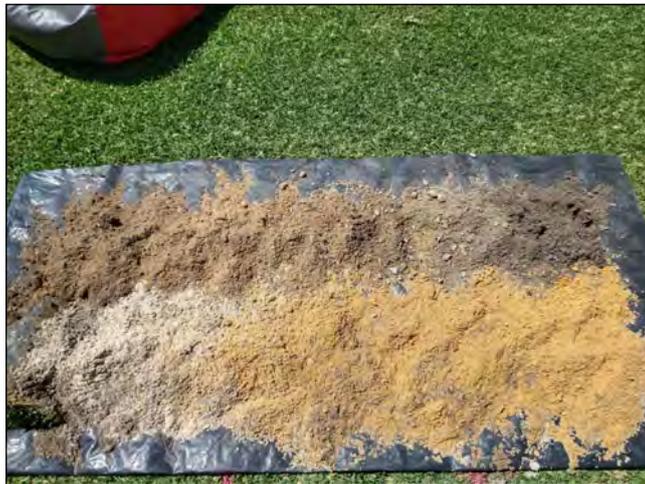
BORE No: 26
PROJECT No: 216618.00
DATE: 28/9/2022
SHEET 1 OF 1

RL	Depth (m)	Description of Strata	Graphic Log	Sampling & In Situ Testing				Water	Dynamic Penetrometer Test (blows per 150mm)
				Type	Depth	Sample	Results & Comments		
23		FILL/SAND SP-SM: fine to medium grained, dark grey-brown, with silt, trace gravel, moist, dense to very dense, fill. Glass pieces observed in fill. - becoming grey-brown from 0.1 m depth.	[Cross-hatch pattern]						
	0.9	- with gravel from 0.65 m depth.							
	1.1	SAND SP-SM: fine to medium grained, dark grey-brown, with silt, moist.	[Dotted pattern]						
	1.4	SAND SP: fine to medium grained, pale grey, trace silt, moist. Bassendean Sand.	[Dotted pattern]						
21	2.5	Bore discontinued at 2.5m (Target depth)

TYPE OF BORING: 110 mm diameter hand auger borehole

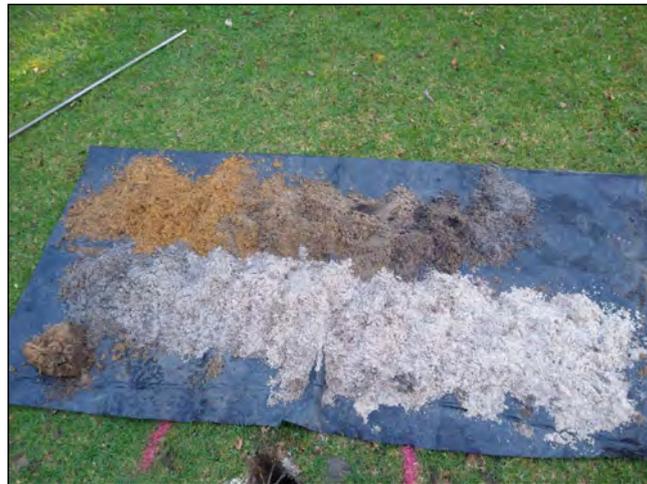
BORE No: 27
PROJECT No: 216618.00
DATE: 28/9/2022
SHEET 1 OF 1

RL	Depth (m)	Description of Strata	Graphic Log	Sampling & In Situ Testing				Water	Dynamic Penetrometer Test (blows per 150mm)			
				Type	Depth	Sample	Results & Comments		5	10	15	20
23	0.0	FILL/SAND SP: fine to medium grained, dark grey-brown, trace silt, moist, medium dense, fill. - becoming orange-brown, trace gravel from 0.1 m depth.	[Cross-hatched pattern]	B	0.0				5	10	15	20
	0.8	SAND SP: fine to medium grained, dark grey, trace silt, moist, medium dense. Bassendean Sand. - becoming grey from 0.9 m depth. - becoming pale grey from 1.1 m depth.										
22	1		[Dotted pattern]									
21	2.5	Bore discontinued at 2.5m (Target depth)

TYPE OF BORING: 110 mm diameter hand auger borehole

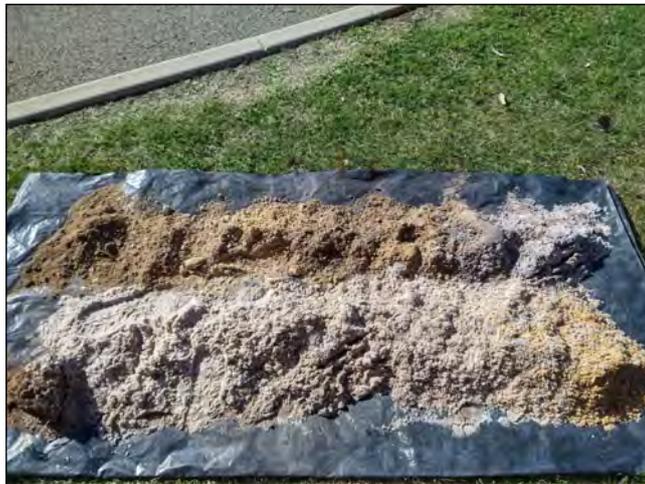
BORE No: 28
PROJECT No: 216618.00
DATE: 27/9/2022
SHEET 1 OF 1

RL	Depth (m)	Description of Strata	Graphic Log	Sampling & In Situ Testing				Water	Dynamic Penetrometer Test (blows per 150mm)					
				Type	Depth	Sample	Results & Comments		5	10	15	20		
24.3	0.55	FILL/Sandy GRAVEL GP-GM: fine to coarse sized, grey-brown and pale yellow-brown, fine to medium grained, with silt, moist, very dense, fill.												
	0.8	FILL/SAND SP-SM: fine to medium grained, grey-brown, with silt, trace gravel, moist, dense, fill.												
	1.0	SAND SP: fine to medium grained, grey, trace silt, moist, medium dense. Bassendean Sand. - becoming pale grey from 0.9 m depth.		D	1.0									
	2.3	- becoming pale yellow-brown from 2.3 m depth.												
	2.5	Bore discontinued at 2.5m (Target depth)

TYPE OF BORING: 110 mm diameter hand auger borehole

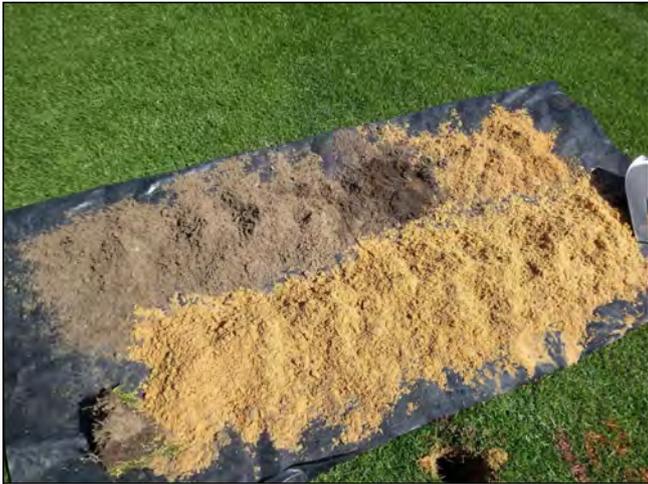
BORE No: 29
PROJECT No: 216618.00
DATE: 28/9/2022
SHEET 1 OF 1

RL	Depth (m)	Description of Strata	Graphic Log	Sampling & In Situ Testing				Water	Dynamic Penetrometer Test (blows per 150mm)
				Type	Depth	Sample	Results & Comments		
24		FILL/SAND SP-SM: fine to medium grained, dark grey-brown, with silt, trace gravel, moist, medium dense, fill. - becoming grey-brown from 0.1 m depth.							
0.7		SAND SP: fine to medium grained, dark grey-brown, trace silt and gravel, moist, medium dense. Sand derived from Tamala Limestone. - becoming yellow-brown, no gravel and dense from 0.85 m depth.		D	0.8				
1									
2.5		Bore discontinued at 2.5m (Target depth)

TYPE OF BORING: 110 mm diameter hand auger borehole

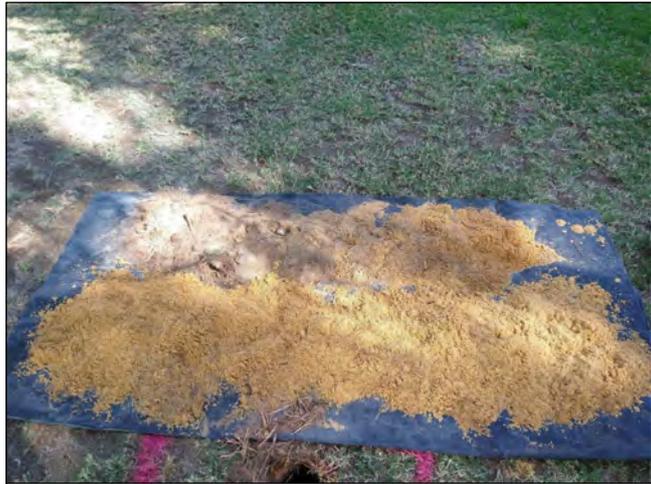
BORE No: 30
PROJECT No: 216618.00
DATE: 27/9/2022
SHEET 1 OF 1

RL	Depth (m)	Description of Strata	Graphic Log	Sampling & In Situ Testing				Water	Dynamic Penetrometer Test (blows per 150mm)				
				Type	Depth	Sample	Results & Comments		5	10	15	20	
	0.45	FILL/SAND SP-SM: fine to medium grained, grey-brown, with silt, trace gravel, moist, dense, fill.	X										
	1	SAND SP: fine to medium grained, yellow-brown, trace silt, moist, dense. Sand derived from Tamala Limestone.	.										
	2.5	Bore discontinued at 2.5m (Target depth)

TYPE OF BORING: 110 mm diameter hand auger borehole

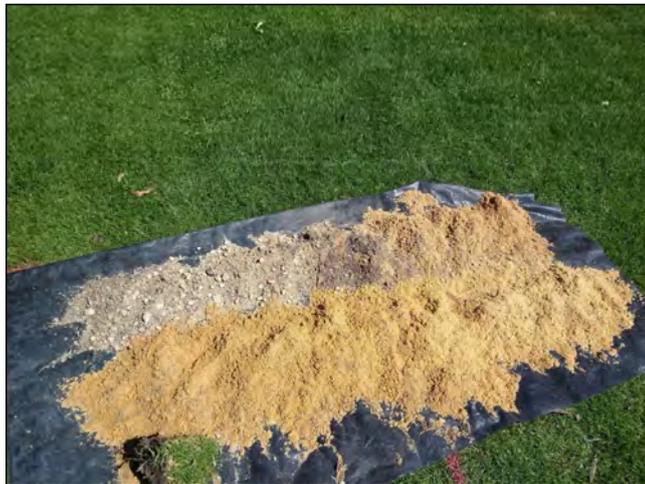
BORE No: 31
PROJECT No: 216618.00
DATE: 27/9/2022
SHEET 1 OF 1

RL	Depth (m)	Description of Strata	Graphic Log	Sampling & In Situ Testing				Water	Dynamic Penetrometer Test (blows per 150mm)				
				Type	Depth	Sample	Results & Comments		5	10	15	20	
	0.45	FILL/Sandy GRAVEL GP-GM: fine to coarse sized, grey-brown and grey, fine to medium grained, with silt, moist, very dense, fill.	[Cross-hatch pattern]										
	0.55	SAND SP-SM: fine to medium grained, dark grey-brown, with silt, moist.	[Dotted pattern]										
	1	SAND SP: fine to medium grained, yellow-brown, trace silt, moist, medium dense to dense. Sand derived from Tamala Limestone.	[Dotted pattern]										
	2.5	Bore discontinued at 2.5m (Target depth)

TYPE OF BORING: 110 mm diameter hand auger borehole

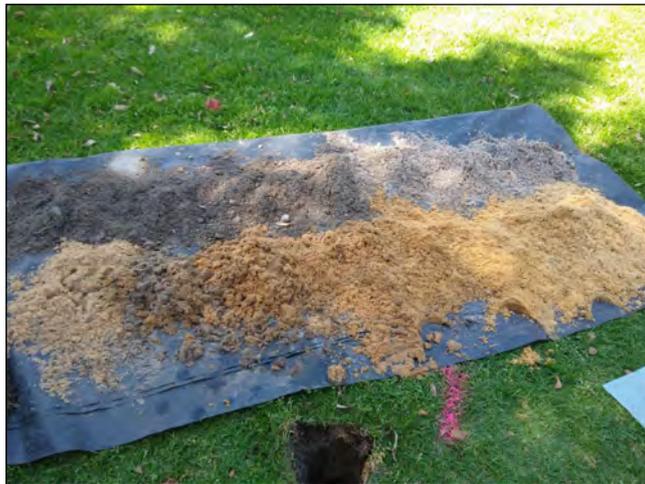
BORE No: 32
PROJECT No: 216618.00
DATE: 27/9/2022
SHEET 1 OF 1

RL	Depth (m)	Description of Strata	Graphic Log	Sampling & In Situ Testing				Water	Dynamic Penetrometer Test (blows per 150mm)
				Type	Depth	Sample	Results & Comments		
23.1	0.8	FILL/SAND SP-SM: fine to medium grained, grey-brown, with silt, trace gravel, moist, dense, fill. Glass pieces observed in fill.							
23.1	1.1	SAND SP: fine to medium grained, grey, trace silt, moist, dense. Bassendean Sand.							
23.1	1.1	SAND SP: fine to medium grained, yellow-brown, trace silt, moist. Sand derived from Tamala Limestone.		D	1.2				
23.1	2.5	Bore discontinued at 2.5m (Target depth)

TYPE OF BORING: 110 mm diameter hand auger borehole

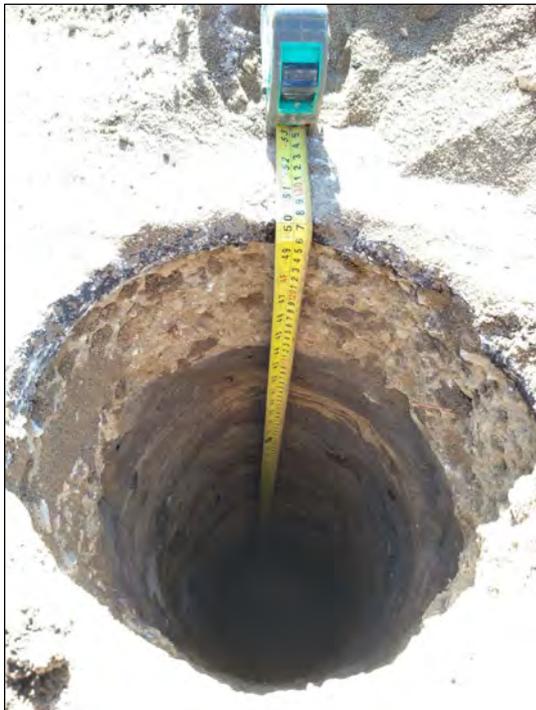
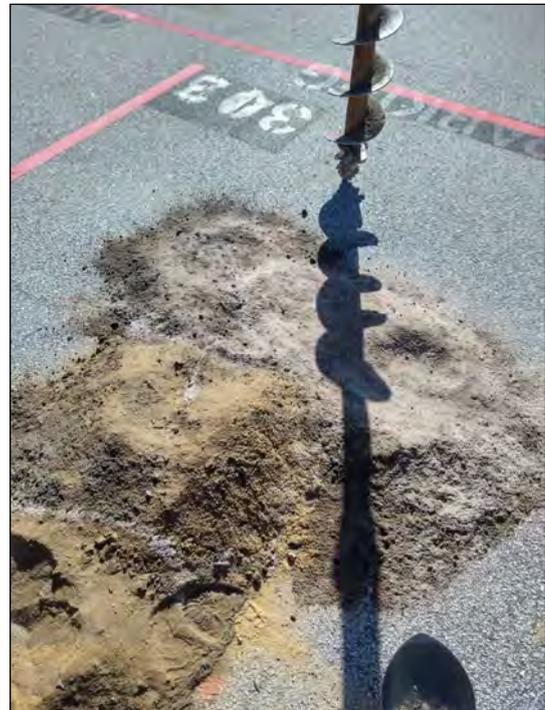
RL	Depth (m)	Description of Strata	Graphic Log	Sampling & In Situ Testing				Water	Dynamic Penetrometer Test (blows per 150mm)					
				Type	Depth	Sample	Results & Comments		5	10	15	20		
20	0.03	ASPHALT: black, 7 mm nominal aggregate.												
	0.18	FILL/Sandy GRAVEL GP-GM: fine to coarse sized, grey-brown, fine to medium grained, with silt, moist, fill. FILL/SAND SP: fine to medium grained, bands of grey-brown, yellow-brown and dark brown, trace silt and gravel, moist, dense to very dense, fill.		B	0.5									
21	1.3	SAND SP: fine to medium grained, dark grey-brown, trace silt, moist. Bassendean Sand. - becoming pale grey from 1.5 m depth.												
22	2.5	Bore discontinued at 2.5m (Target depth)

RIG: 8 tonne backhoe **DRILLER:** ANH Contracting **LOGGED:** GG **CASING:** None

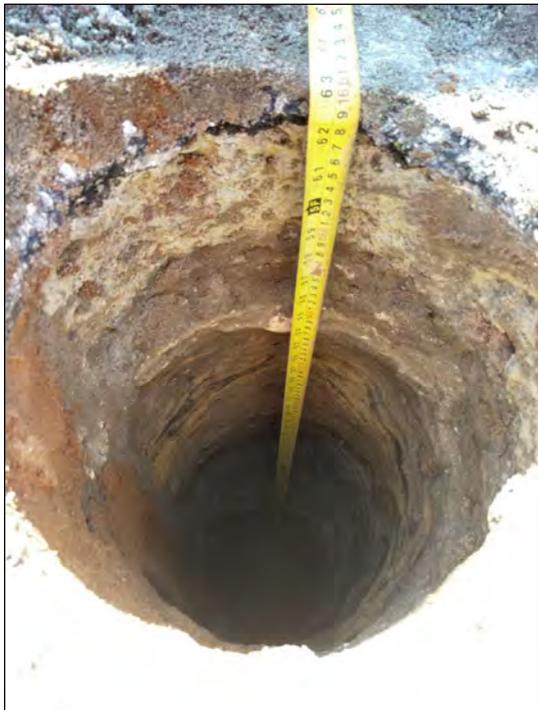
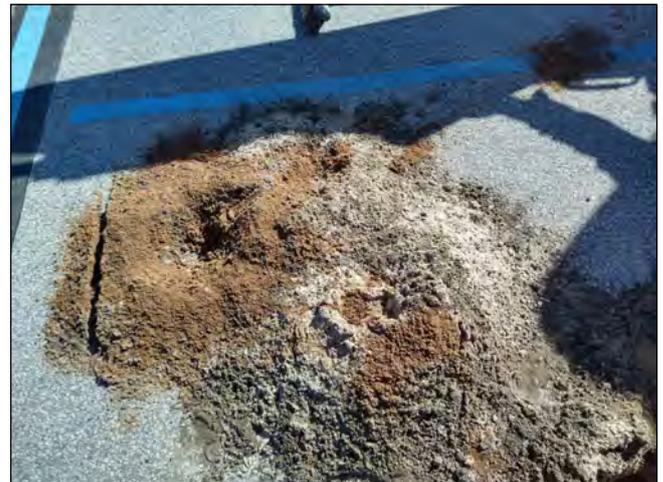
- becoming pale grey from 1.5 m depth.												
	2	- becoming pale brown from 2.0 m depth.												
		- becoming brown, weakly cemented from 2.2 m depth.

TYPE OF BORING: 250 mm diameter power auger borehole

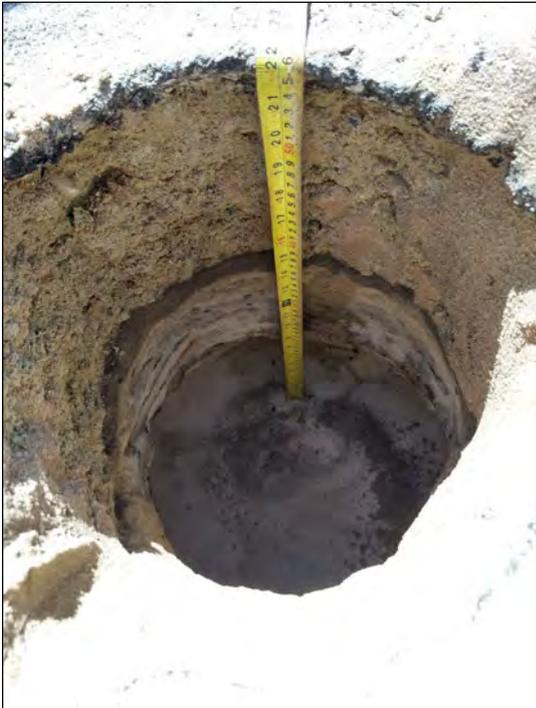
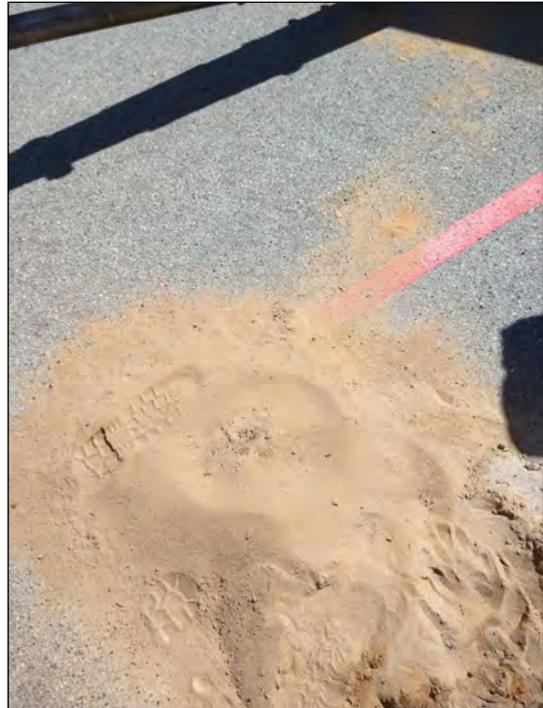
RL	Depth (m)	Description of Strata	Graphic Log	Sampling & In Situ Testing				Water	Dynamic Penetrometer Test (blows per 150mm)					
				Type	Depth	Sample	Results & Comments		5	10	15	20		
	0.02	ASPHALT: black, 7 mm nominal aggregate.	[Cross-hatch pattern]											
	0.2	FILL/Sandy GRAVEL GP-GM: fine to coarse sized, grey-brown and grey, fine to medium grained, with silt, moist, fill.	[Cross-hatch pattern]											
	0.4	FILL/SAND SP: fine to medium grained, bands of dark grey-brown, pale grey, yellow-brown and orange-brown, trace silt, moist, dense, fill.	[Dotted pattern]											
	1	SAND SP: fine to medium grained, pale grey, trace silt, moist, medium dense. Bassendean Sand. - becoming pale brown from 1.0 m depth. - becoming brown from 1.5 m depth.	[Dotted pattern]	B	0.5									
	2.5	Bore discontinued at 2.5m (Target depth)

RIG: 8 tonne backhoe **DRILLER:** ANH Contracting **LOGGED:** GG **CASING:** None
