ECU Mount Lawley Redevelopment

Precinct Structure Plan Water Management Report

DevelopmentWA

By Urbaqua

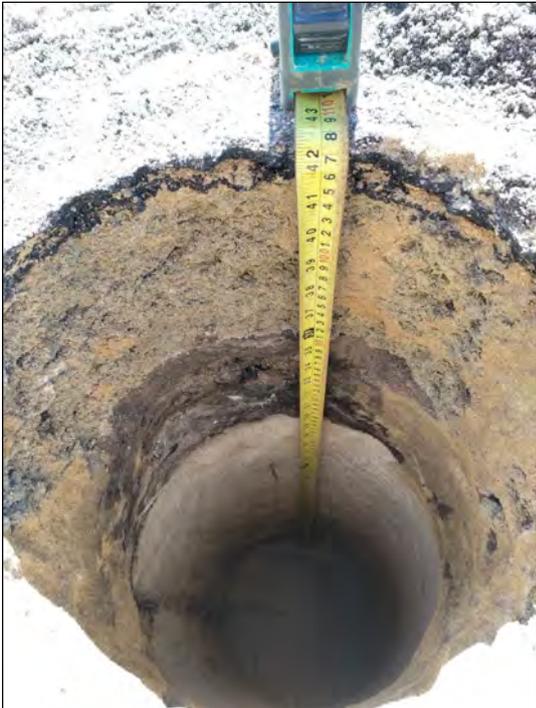
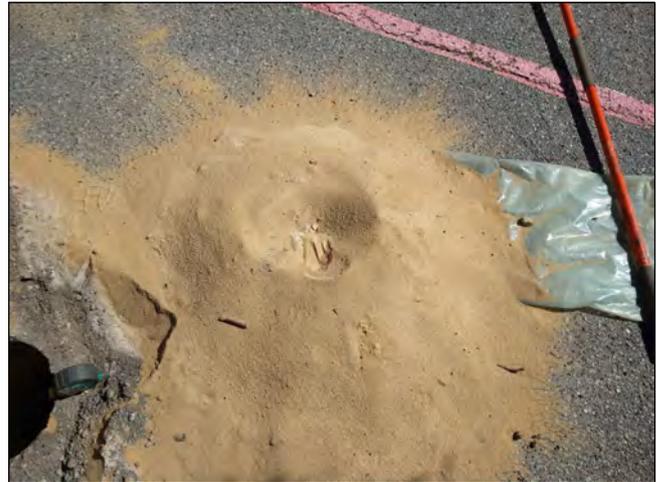
BORE No: 37
PROJECT No: 216618.00
DATE: 27/9/2022
SHEET 1 OF 1

RL	Depth (m)	Description of Strata	Graphic Log	Sampling & In Situ Testing				Water	Dynamic Penetrometer Test (blows per 150mm)					
				Type	Depth	Sample	Results & Comments		5	10	15	20		
	0.03	ASPHALT: black, 7 mm nominal aggregate.	▨											
	0.2	FILL/Sandy GRAVEL GP-GM: fine to coarse sized, grey-brown and pale grey, fine to medium grained, with silt, moist, fill.	▩											
	0.34													
		FILL/SAND SP: fine to medium grained, dark grey-brown and grey-brown, trace silt and gravel, moist, dense, fill.	▩											
	0.8	SAND SP: fine to medium grained, pale grey, trace silt, moist, dense. Possibly fill.	▩											
	0.9	SAND SP: fine to medium grained, pale yellow-brown, trace silt, moist, medium dense. Sand derived from Tamala Limestone.	▩	B	0.9									
	2.5	Bore discontinued at 2.5m (Target depth)

RIG: 8 tonne backhoe **DRILLER:** ANH Contracting **LOGGED:** GG **CASING:** None
TYPE OF BORING: 250 mm diameter power auger borehole
WATER OBSERVATIONS: No free groundwater observed.

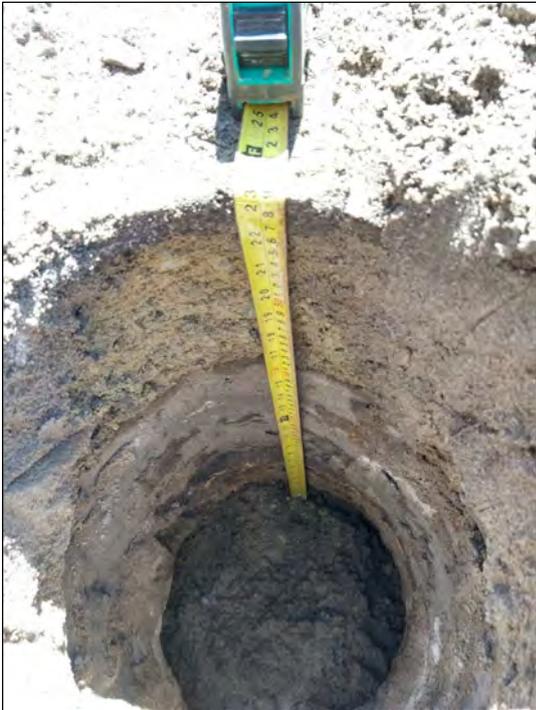
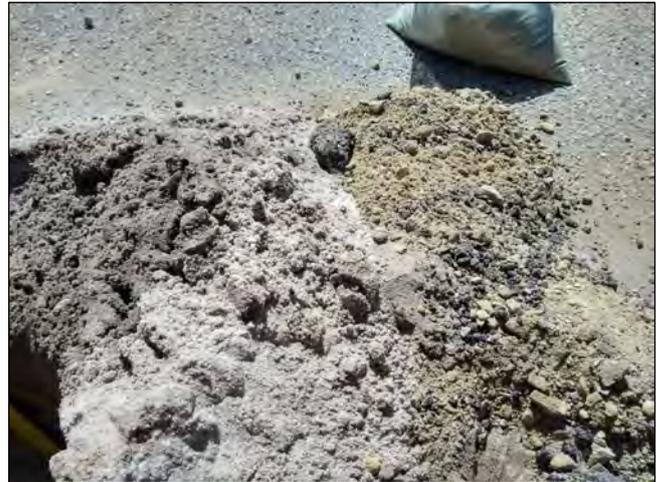
BORE No: 38
PROJECT No: 216618.00
DATE: 27/9/2022
SHEET 1 OF 1

RL	Depth (m)	Description of Strata	Graphic Log	Sampling & In Situ Testing				Water	Dynamic Penetrometer Test (blows per 150mm)					
				Type	Depth	Sample	Results & Comments		5	10	15	20		
	0.03	ASPHALT: black, 7 mm nominal aggregate.	▨											
	0.2	FILL/Sandy GRAVEL GP-GM: fine to coarse sized, grey-brown and grey, fine to medium grained, with silt, moist, fill.	▩											
		FILL/SAND SP-SM: fine to medium grained, bands of grey-brown, dark grey-brown and yellow-brown, with silt, dry to moist, dense, fill.	▩											
	0.9	SAND SP: fine to medium grained, pale grey, trace silt, dry to moist, dense. Bassendean Sand.	▩											
	2.5	Bore discontinued at 2.5m (Target depth)

TYPE OF BORING: 250 mm diameter power auger borehole

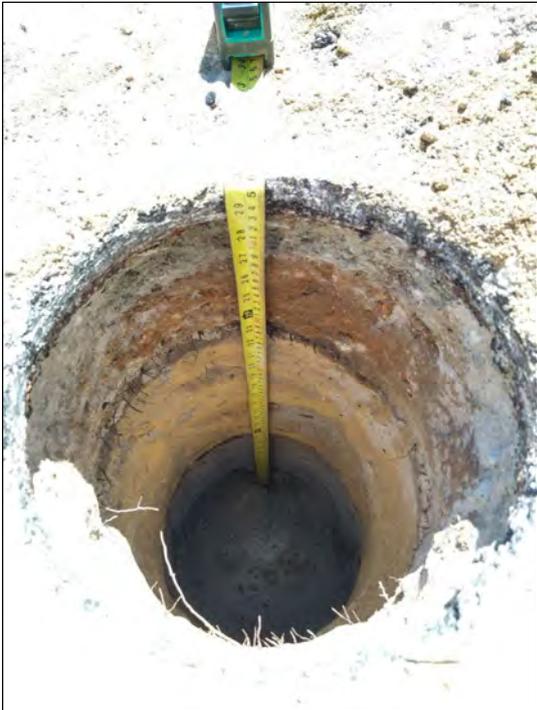
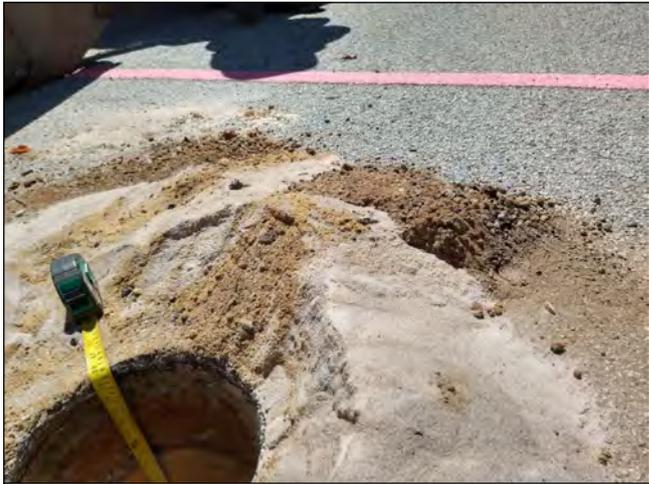
0.23																	
	0.53	FILL/SAND SP-SM: fine to medium grained, dark grey-brown, with silt, moist, fill.	[Dotted pattern]															
	1	FILL/SAND SP: fine to medium grained, yellow-brown, trace silt and gravel, dry to moist, dense, fill. SAND SP: fine to medium grained, pale grey, trace silt, dry to moist, dense. Bassendean Sand.

RIG: 8 tonne backhoe **DRILLER:** ANH Contracting **LOGGED:** GG **CASING:** None
TYPE OF BORING: 250 mm diameter power auger borehole
WATER OBSERVATIONS: No free groundwater observed.
REMARKS: Location coordinates are in MGA94 Zone 50 J. *Surface level measured using a differential GPS with Sand Penetrometer AS1289.6.3.3
 Cone Penetrometer AS1289.6.3.2

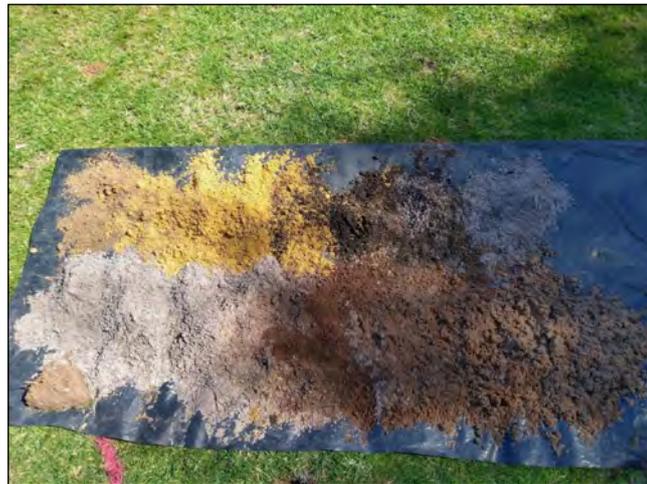
0.6	- becoming dark brown, with gravel from 0.5 m depth.											
	0.75	SAND SP-SM: fine to medium grained, dark grey-brown, with silt, moist, medium dense.	[Dotted pattern]										
	1	SAND SP: fine to medium grained, grey, trace silt, moist, medium dense. Bassendean Sand. - becoming pale grey from 1.0 m depth.

1.7	SAND SP-SM: fine to medium grained, brown, with silt, moist. Bassendean Sand.												
2.5	Bore discontinued at 2.5m (Target depth)

WATER OBSERVATIONS: Groundwater observed at 2.1 m depth.

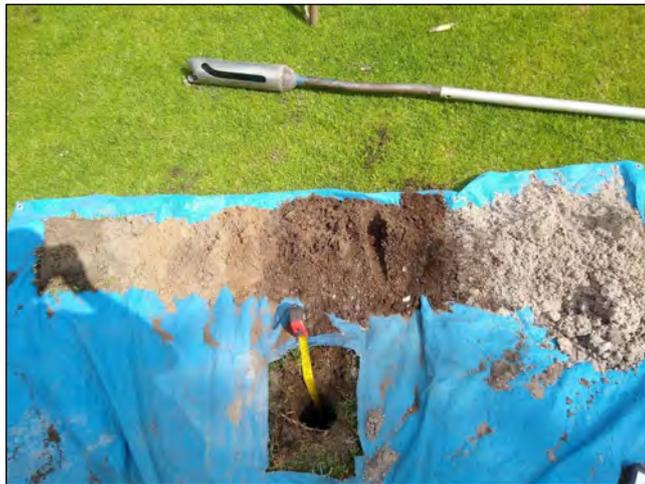
BORE No: 41
PROJECT No: 216618.00
DATE: 28/9/2022
SHEET 1 OF 1

RL	Depth (m)	Description of Strata	Graphic Log	Sampling & In Situ Testing				Water	Dynamic Penetrometer Test (blows per 150mm)				
				Type	Depth	Sample	Results & Comments		5	10	15	20	
22.1	0.15	FILL/SAND SP-SM: fine to medium grained, dark grey-brown, with silt, trace gravel, trace rootlets, moist, fill. FILL/ORGANIC SAND SP: fine to medium grained, brown, trace silt and gravel, moist, medium dense, fill. Pieces of brick, tile and glass observed in fill. - becoming dark grey-brown, with gravel and dense from 0.35 m depth.											
				B	0.6								
					0.9								
21	1.2	SAND SP: fine to medium grained, grey, trace silt, moist. Bassendean Sand.											
20	2							▼ 28-09-22					
	2.5	Bore discontinued at 2.5m (Target depth)

WATER OBSERVATIONS: Groundwater observed at 2.1 m depth.

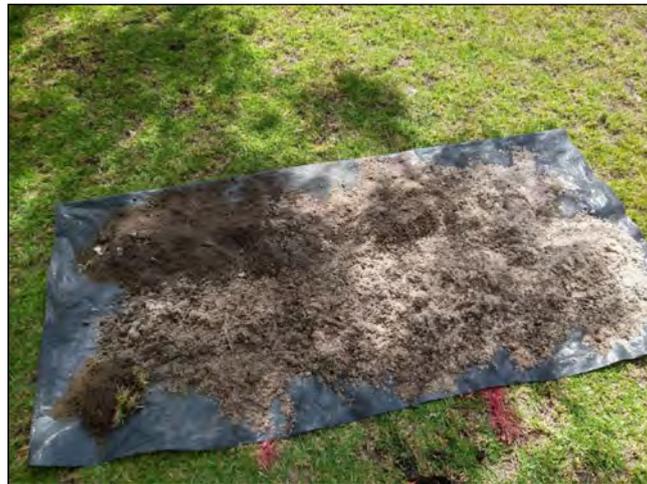
BORE No: 42
PROJECT No: 216618.00
DATE: 28/9/2022
SHEET 1 OF 1

RL	Depth (m)	Description of Strata	Graphic Log	Sampling & In Situ Testing				Water	Dynamic Penetrometer Test (blows per 150mm)					
				Type	Depth	Sample	Results & Comments		5	10	15	20		
23	0.8	FILL/SAND SP-SM: fine to medium grained, dark grey-brown, with silt, trace gravel, moist, medium dense, fill. Glass pieces, plastic waste observed in fill. - becoming grey-brown from 0.4 m depth.												
21	1.0	SAND SP: fine to medium grained, pale grey, trace silt, moist, medium dense. Bassendean Sand.		D	1.0									
	2.5	Bore discontinued at 2.5m (Target depth)

WATER OBSERVATIONS: No free groundwater observed.

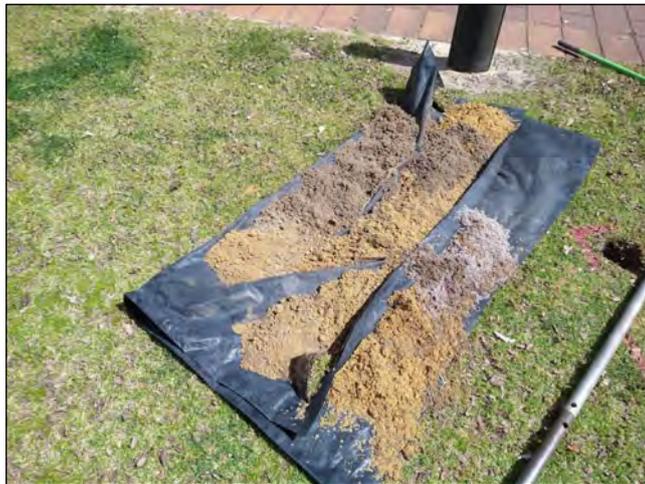
BORE No: 43
PROJECT No: 216618.00
DATE: 28/9/2022
SHEET 1 OF 1

RL	Depth (m)	Description of Strata	Graphic Log	Sampling & In Situ Testing				Water	Dynamic Penetrometer Test (blows per 150mm)				
				Type	Depth	Sample	Results & Comments		5	10	15	20	
	22.1	FILL/SAND SP-SM: fine to medium grained, yellow-brown, with silt, trace gravel, moist, very dense. Brick pieces observed in fill. - with gravel from 0.2 m depth. - becoming grey-brown from 0.35 m depth.											
	21.1	- becoming yellow-brown from 1.0 m depth.											
	20.5	- becoming dark grey-brown and brown from 1.5 m depth.											
	20.2	- becoming yellow-brown from 1.8 m depth.											
	20.3	SAND SP: fine to medium grained, pale grey, trace silt, moist. Bassendean Sand.											
	20.5	Bore discontinued at 2.5m (Target depth)

WATER OBSERVATIONS: No free groundwater observed.

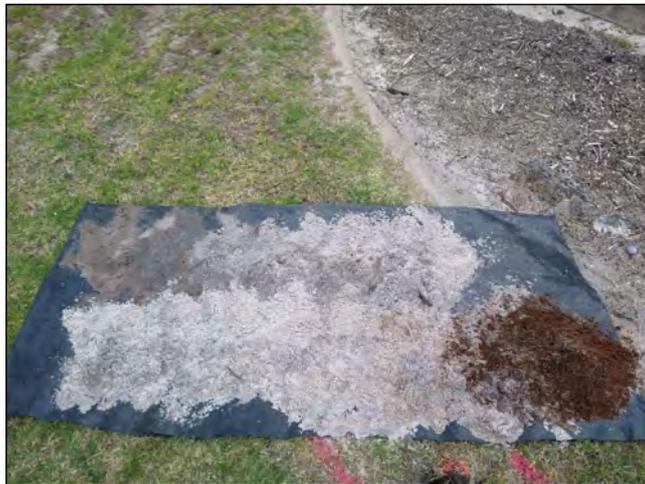
BORE No: 44
PROJECT No: 216618.00
DATE: 28/9/2022
SHEET 1 OF 1

RL	Depth (m)	Description of Strata	Graphic Log	Sampling & In Situ Testing				Water	Dynamic Penetrometer Test (blows per 150mm)				
				Type	Depth	Sample	Results & Comments		5	10	15	20	
	0.3	FILL/SAND SP-SM: fine to medium grained, grey and grey-brown, with silt, trace gravel, moist, dense, fill.	[Cross-hatch pattern]										
		SAND SP: fine to medium grained, pale grey, trace silt, moist, medium dense. Bassendean Sand.	[Dotted pattern]										
	2.2	- becoming pale brown from 2.1 m depth.											
	2.5	SAND SP-SM: fine to medium grained, brown, with silt, moist, weakly cemented. Bassendean Sand.	[Dotted pattern]										
	2.5	Bore discontinued at 2.5m (Target depth)

WATER OBSERVATIONS: No free groundwater observed.

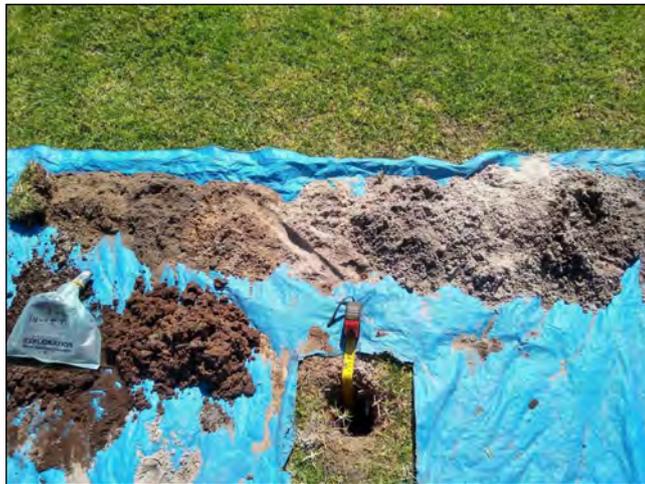
BORE No: 45
PROJECT No: 216618.00
DATE: 28/9/2022
SHEET 1 OF 1

RL	Depth (m)	Description of Strata	Graphic Log	Sampling & In Situ Testing				Water	Dynamic Penetrometer Test (blows per 150mm)				
				Type	Depth	Sample	Results & Comments		5	10	15	20	
	0.1	FILL/SAND SP-SM: fine to medium grained, grey-brown and dark grey-brown, with silt, trace gravel, trace rootlets, moist, fill.	[Cross-hatch pattern]										
	0.7	FILL/SAND SP: fine to medium grained, dark grey-brown, trace silt and gravel, moist, medium dense, fill. - becoming grey, no gravel and trace pockets of Silty SAND SM from 0.4 m depth.	[Cross-hatch pattern]										
	1.0	SAND SP: fine to medium grained, grey, trace silt, moist. Bassendean Sand.	[Dotted pattern]										
	1.4	- with pockets of dark grey-brown sand from 1.4 m depth.		D	1.4								
	1.5				1.5								
	1.7	Bore discontinued at 1.7m (Collapsing conditions)						28-09-22

WATER OBSERVATIONS: Groundwater observed at 1.5 m depth.

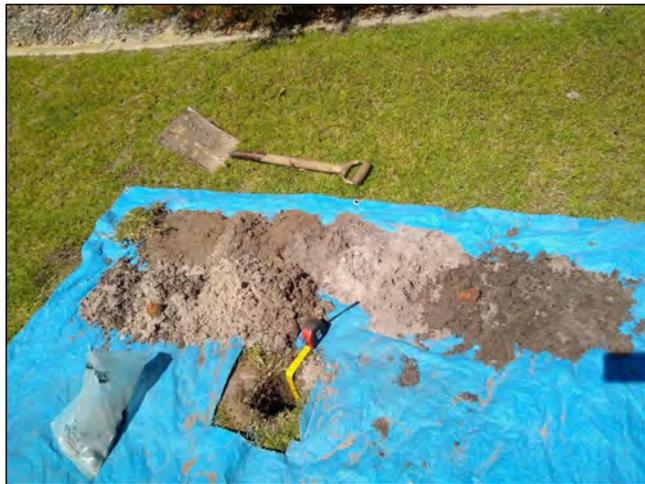
BORE No: 46
PROJECT No: 216618.00
DATE: 28/9/2022
SHEET 1 OF 1

RL	Depth (m)	Description of Strata	Graphic Log	Sampling & In Situ Testing				Water	Dynamic Penetrometer Test (blows per 150mm)				
				Type	Depth	Sample	Results & Comments		5	10	15	20	
22		FILL/SAND SP: fine to medium grained, grey-brown, trace silt and gravel, trace rootlets, moist, medium dense, fill. Pieces of glass, basalt, tile and brick observed in fill.		D	0.85				1				
21	1								1				
21	1.4	SAND SP: fine to medium grained, grey, trace silt, moist. Bassendean Sand.						▼ 28-09-22					
20	2												
20	2.3	Bore discontinued at 2.3m (Collapsing conditions)

WATER OBSERVATIONS: Groundwater observed at 1.6 m depth.

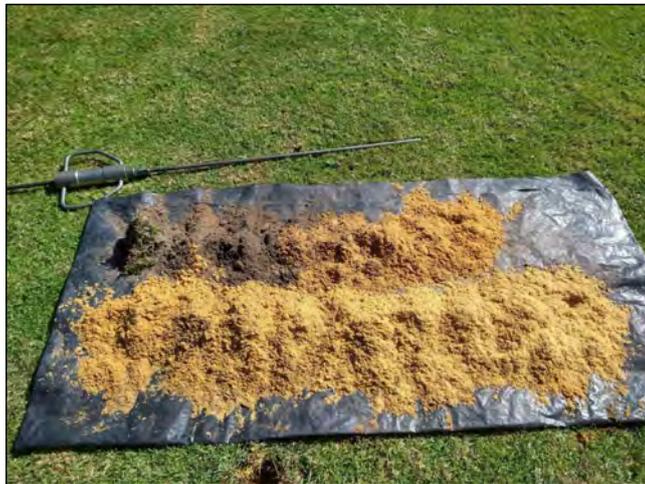
BORE No: 47
PROJECT No: 216618.00
DATE: 28/9/2022
SHEET 1 OF 1

RL	Depth (m)	Description of Strata	Graphic Log	Sampling & In Situ Testing				Water	Dynamic Penetrometer Test (blows per 150mm)
				Type	Depth	Sample	Results & Comments		
	0.5	FILL/SAND SP-SM: fine to medium grained, brown, grey and dark grey-brown, with silt, trace gravel, moist, dense, fill.	[Cross-hatched pattern]						5 10 15 20
	2.0	SAND SP: fine to medium grained, yellow-brown, trace silt, moist, medium dense to dense. Sand derived from Tamala Limestone.	[Dotted pattern]						5 10 15 20
	2.5	Bore discontinued at 2.5m (Target depth)							5 10 15 20

WATER OBSERVATIONS: No free groundwater observed.

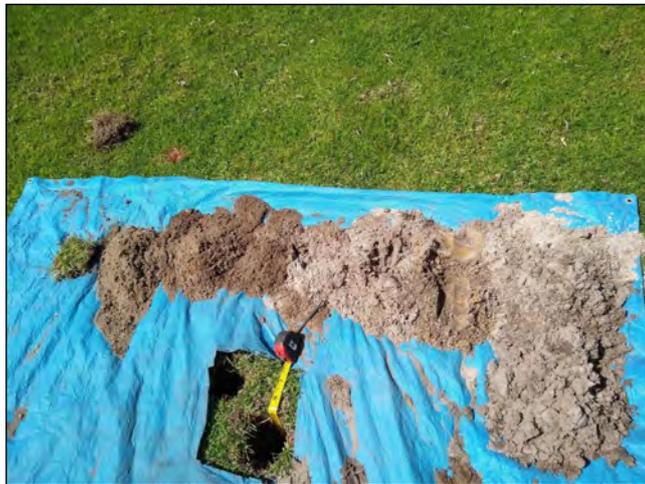
BORE No: 48
PROJECT No: 216618.00
DATE: 28/9/2022
SHEET 1 OF 1

RL	Depth (m)	Description of Strata	Graphic Log	Sampling & In Situ Testing				Water	Dynamic Penetrometer Test (blows per 150mm)				
				Type	Depth	Sample	Results & Comments		5	10	15	20	
	0.1	FILL/SAND SP-SM: fine to medium grained, grey-brown, with silt, trace gravel, moist, fill. FILL/SAND SP: fine to medium grained, dark grey-brown, trace silt and gravel, moist, medium dense, fill. - becoming grey-brown from 0.3 m depth.											
	1.35	SAND SP: fine to medium grained, grey, trace silt and gravel, moist. Possibly fill. - becoming wet from 1.45 m depth.						▼ 28-09-22					
	2.2	Bore discontinued at 2.2m (Collapsing conditions)

WATER OBSERVATIONS: Groundwater observed at 1.45 m depth.

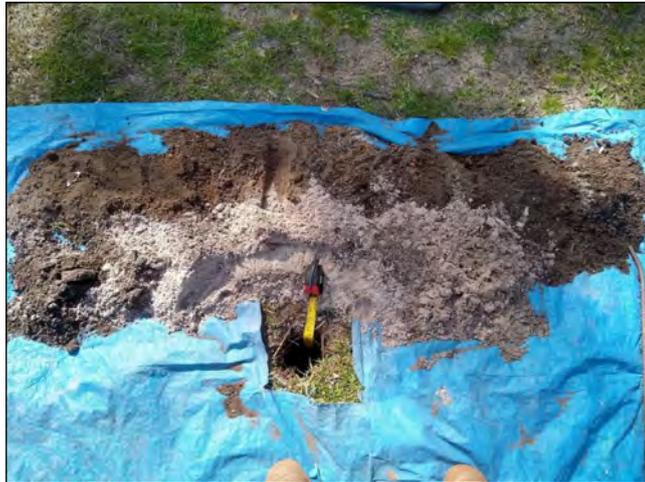
BORE No: 49
PROJECT No: 216618.00
DATE: 28/9/2022
SHEET 1 OF 1

RL	Depth (m)	Description of Strata	Graphic Log	Sampling & In Situ Testing				Water	Dynamic Penetrometer Test (blows per 150mm)			
				Type	Depth	Sample	Results & Comments		5	10	15	20
	0.1	FILL/SAND SP-SM: fine to medium grained, grey-brown, with silt, trace gravel, moist, fill. Tile pieces observed in fill. FILL/SAND SP: fine to medium grained, dark grey-brown and brown, trace silt and gravel, moist, medium dense, fill.							5	10	15	20
	1.35	SAND SP: fine to medium grained, grey, trace silt, moist. Bassendean Sand.										
	2.5	Bore discontinued at 2.5m (Target depth)						▼ 28-09-22

WATER OBSERVATIONS: Groundwater observed at 2.4 m depth.

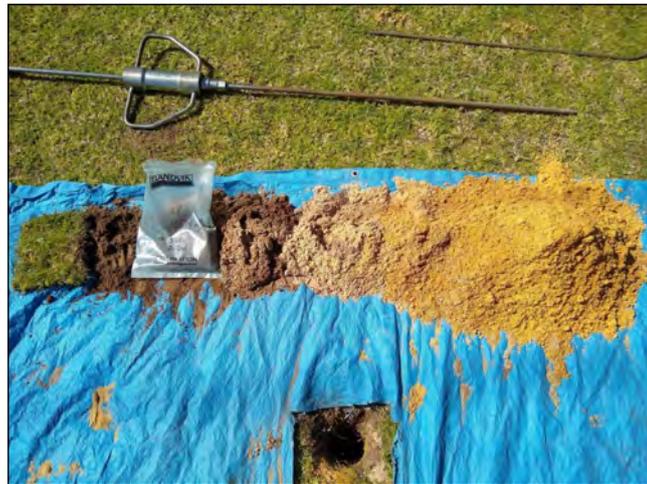
BORE No: 50A
PROJECT No: 216618.00
DATE: 28/9/2022
SHEET 1 OF 1

RL	Depth (m)	Description of Strata	Graphic Log	Sampling & In Situ Testing				Water	Dynamic Penetrometer Test (blows per 150mm)				
				Type	Depth	Sample	Results & Comments		5	10	15	20	
	0.1	FILL/SAND SP-SM: fine to medium grained, grey-brown, with silt, trace gravel, trace rootlets, moist, fill.	[Cross-hatched pattern]	D	0.3								
	0.5	FILL/SAND SP: fine to medium grained, grey-brown and brown, trace silt and gravel, trace pockets of Silty SAND SM, moist, medium dense, fill. Glass pieces observed in fill. SAND SP: fine to medium grained, yellow-brown, trace silt, moist, medium dense. Sand derived from Tamala Limestone.	[Dotted pattern]										
	2.5	Bore discontinued at 2.5m (Target depth)

WATER OBSERVATIONS: No free groundwater observed.

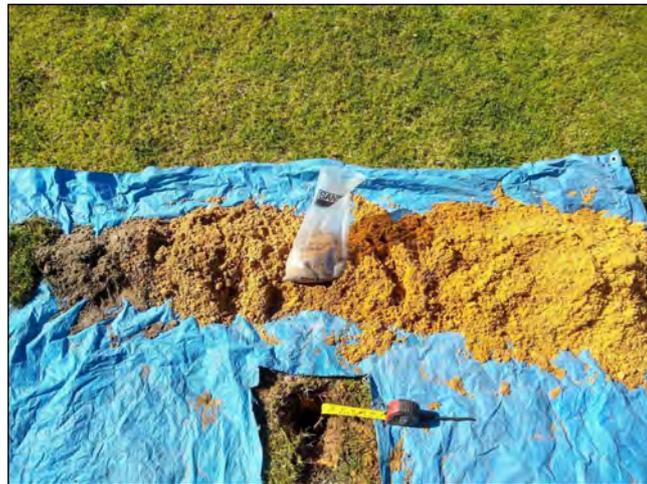
BORE No: 51
PROJECT No: 216618.00
DATE: 28/9/2022
SHEET 1 OF 1

RL	Depth (m)	Description of Strata	Graphic Log	Sampling & In Situ Testing				Water	Dynamic Penetrometer Test (blows per 150mm)					
				Type	Depth	Sample	Results & Comments		5	10	15	20		
24	0.13	FILL/TOPSOIL: SAND SP-SM: fine to medium grained, dark grey-brown, with silt, trace rootlets, moist, fill.												
	0.6	FILL/SAND SP: fine to medium grained, yellow-brown and brown, trace silt and gravel, trace rootlets, moist, medium dense, fill. - becoming yellow-brown from 0.3 m depth.												
	0.8	SAND SP: fine to medium grained, yellow-brown, trace silt, moist, very dense. Sand derived from Tamala Limestone.		D	0.8									
	1													
	2													
	2.5	Bore discontinued at 2.5m (Target depth)

WATER OBSERVATIONS: No free groundwater observed.

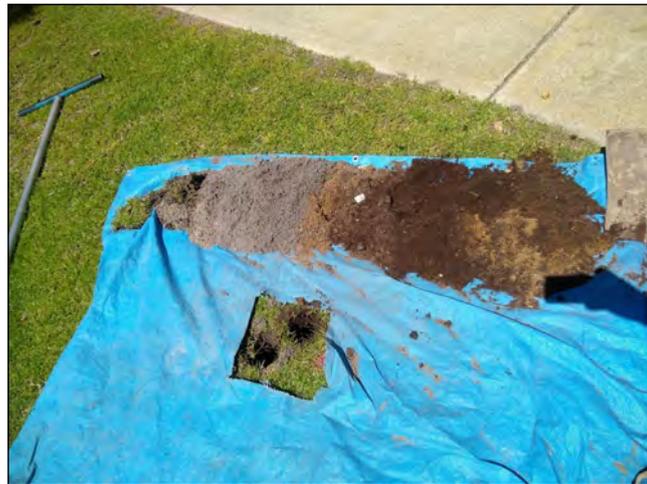
BORE No: 52
PROJECT No: 216618.00
DATE: 28/9/2022
SHEET 1 OF 1

RL	Depth (m)	Description of Strata	Graphic Log	Sampling & In Situ Testing				Water	Dynamic Penetrometer Test (blows per 150mm)					
				Type	Depth	Sample	Results & Comments		5	10	15	20		
	0.15	FILL/SAND SP-SM: fine to medium grained, dark grey-brown, with silt, trace gravel, trace rootlets, moist, fill.												
	0.5	FILL/SAND SP: fine to medium grained, grey-brown, trace silt and gravel, moist, medium dense, fill.												
	0.6	FILL/SAND SP-SM: fine to medium grained, brown, with silt, trace gravel, moist, medium dense to dense, fill. Pieces of tile, brick and ceramic observed in fill.		B	0.6									
	1.0				1.0									
	1.4	Bore discontinued at 1.4m (Hard digging)

WATER OBSERVATIONS: No free groundwater observed.

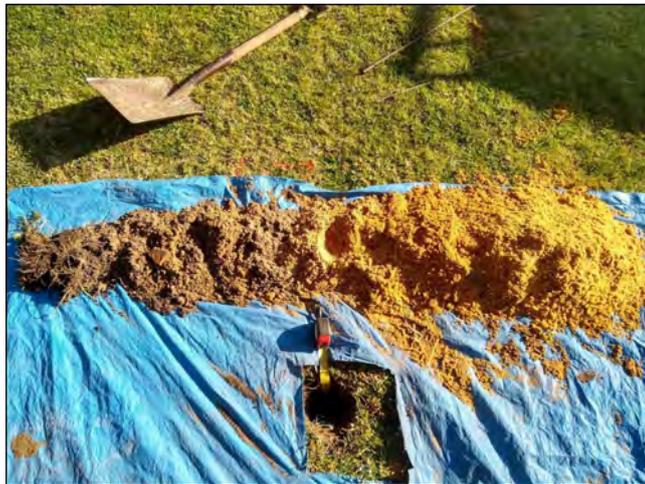
BORE No: 53
PROJECT No: 216618.00
DATE: 28/9/2022
SHEET 1 OF 1

RL	Depth (m)	Description of Strata	Graphic Log	Sampling & In Situ Testing				Water	Dynamic Penetrometer Test (blows per mm)			
				Type	Depth	Sample	Results & Comments		5	10	15	20
24	0.1	FILL/SAND SP-SM: fine to medium grained, dark grey-brown, with silt, trace gravel, trace rootlets, moist, fill.	[Cross-hatch pattern]		0.3		No PSP was undertaken at this location due to risk of intersection with underground services.					
	0.55	FILL/SAND SP: fine to medium grained, brown, trace silt and gravel, trace rootlets to 0.15 m depth, moist, fill. Brick pieces observed at 0.5 m depth.	[Cross-hatch pattern]									
	1	SAND SP: fine to medium grained, yellow-brown, trace silt, moist. Bassendean Sand.	[Dotted pattern]									
-1												
-2												
-2	2.5	Bore discontinued at 2.5m (Target depth)

WATER OBSERVATIONS: No free groundwater observed.

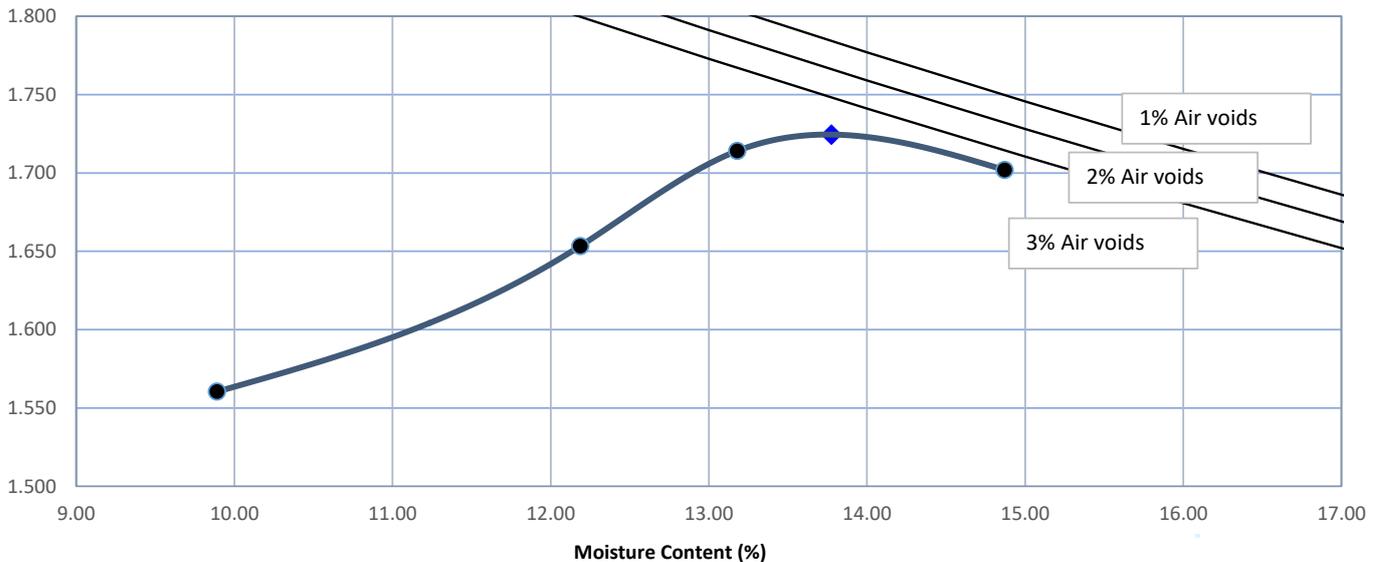
Dry Density (t/m³)

Modified Maximum Dry Density (t/m³)

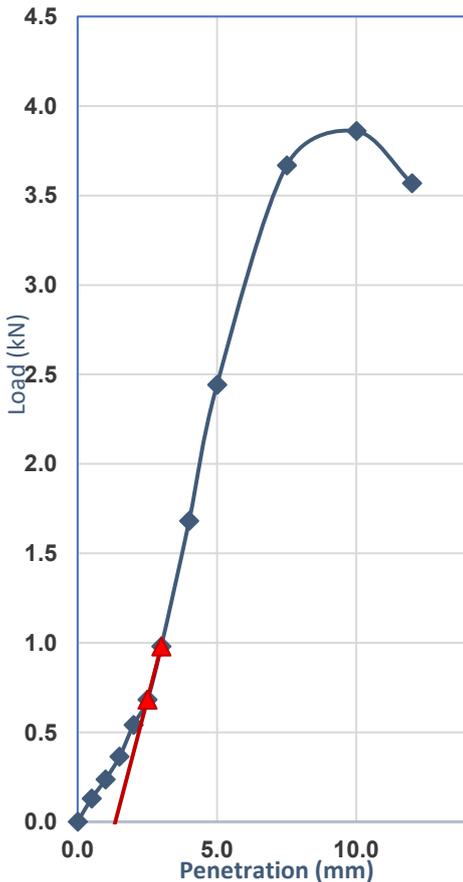
Load Penetration Curve

Compaction Details

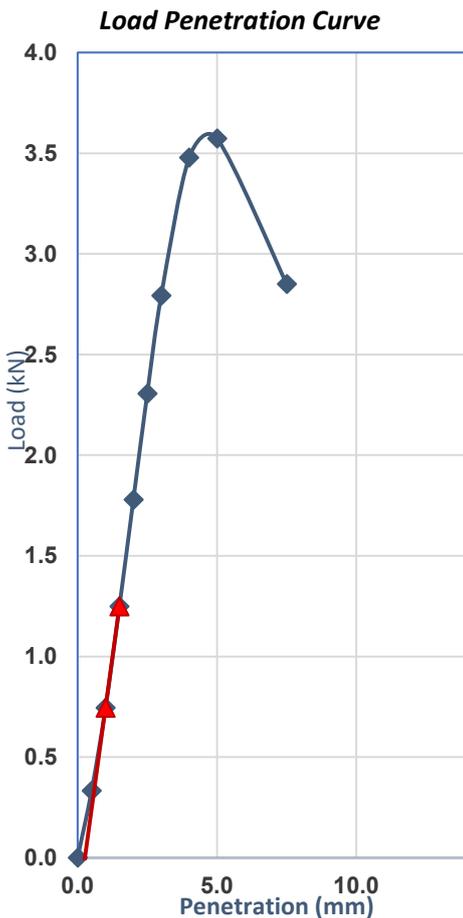
Sample Description: Sand, trace Gravel
 Sampling Method: Sampled by Client, Tested as Received

Compaction Details			
Compaction Method	AS 1289.5.2.1	Hammer Type	Modified
Plasticity Determined by	Estimated	Curing Time (Hours)	2.0
% Retained 19.0mm	0	Excluded/Replaced	Excluded
Maximum Dry Density (t/m ³)	1.81	Optimum Moisture (%)	12.0
Target Dry Density Ratio (%)	95	Target Moisture Ratio (%)	100

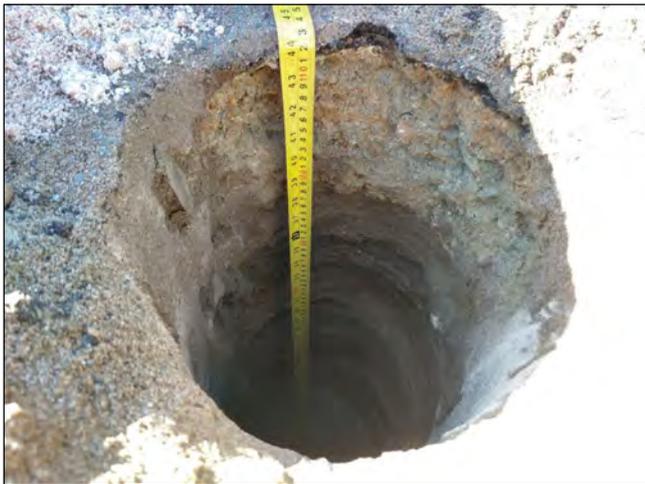
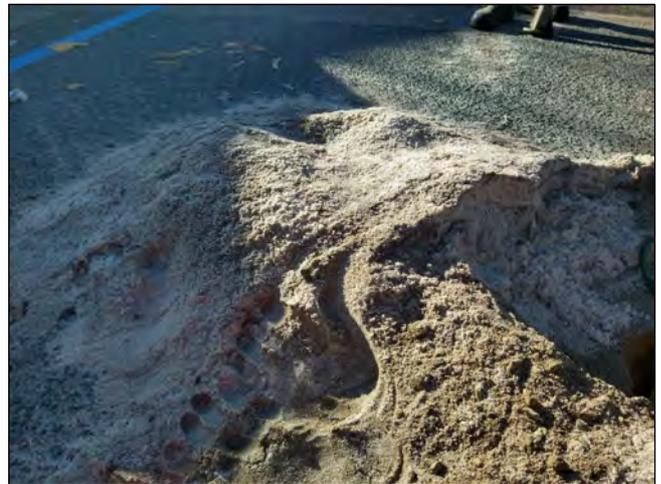
BORE No: 129
PROJECT No: 216618.01
DATE: 27/6/2023
SHEET 1 OF 1

RL	Depth (m)	Description of Strata	Graphic Log	Sampling & In Situ Testing				Water	Dynamic Penetrometer Test (blows per 150mm)					
				Type	Depth	Sample	Results & Comments		5	10	15	20		
	0.02	ASPHALT: black, 7 mm sized nominal aggregate.	[Cross-hatched pattern]											
	0.18	FILL/BASECOURSE: Sandy GRAVEL GP-GM: fine to coarse sized, grey and yellow-brown, fine to medium grained, with silt, moist, fill. Gravel is crushed rock.	[Cross-hatched pattern]											
	0.75	FILL/SAND SP: fine to medium grained, bands of grey, grey-brown and dark grey, trace gravel to 0.38 m depth, trace silt, moist, dense to very dense, fill. SAND SP: fine to medium grained, pale grey, trace silt, moist. Bassendean Sand.	[Dotted pattern]											
	2.5	Bore discontinued at 2.5m (Target depth)

RIG: 8 tonne backhoe **DRILLER:** ANH Contracting **LOGGED:** GG **CASING:**
TYPE OF BORING: 250 mm diameter power auger borehole
WATER OBSERVATIONS: No free groundwater observed.

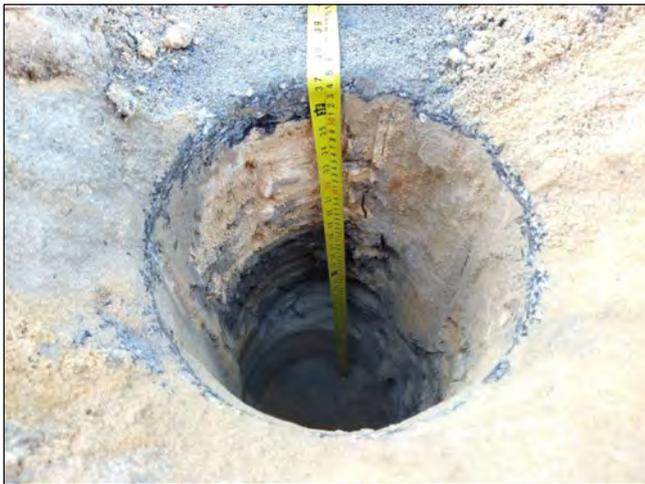
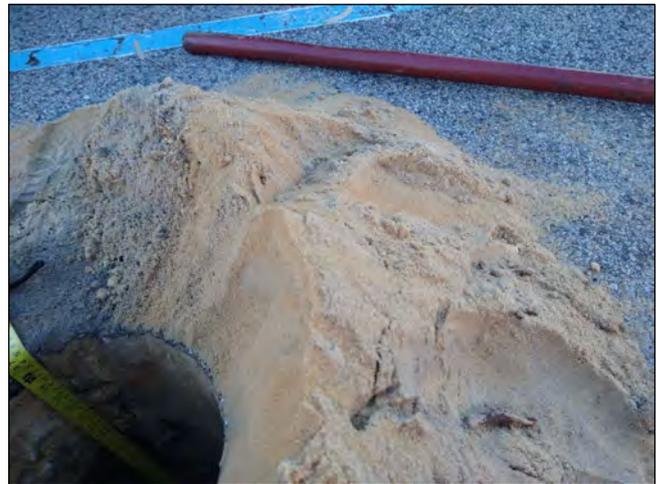
BORE No: 130
PROJECT No: 216618.01
DATE: 29/6/2023
SHEET 1 OF 1

RL	Depth (m)	Description of Strata	Graphic Log	Sampling & In Situ Testing				Water	Dynamic Penetrometer Test (blows per 150mm)					
				Type	Depth	Sample	Results & Comments		5	10	15	20		
	0.05	ASPHALT: black, 7 mm sized nominal aggregate.	[Asphalt symbol]											
	0.25	FILL/BASECOURSE: Sandy GRAVEL GP-GM: fine to medium grained, pale yellow, fine to medium grained, with silt, moist, fill. Gravel is crushed limestone.	[Gravel symbol]	B	0.25									
	0.5	FILL/SAND SP: fine to medium grained, dark grey, trace gravel and silt, moist, fill. - becoming grey and dark grey from 0.35 m depth.	[Sand SP symbol]		0.5									
	1	SAND SP: fine to medium grained, pale yellow, trace silt, dense. Sand derived from Tamala Limestone. - becoming yellow-brown from 0.7 m depth.	[Sand SP symbol]											
	2.5	Bore discontinued at 2.5m (Target depth)

RIG: 8 tonne backhoe **DRILLER:** ANH Contracting **LOGGED:** GG **CASING:**
TYPE OF BORING: 250 mm diameter power auger borehole
WATER OBSERVATIONS: No free groundwater observed.

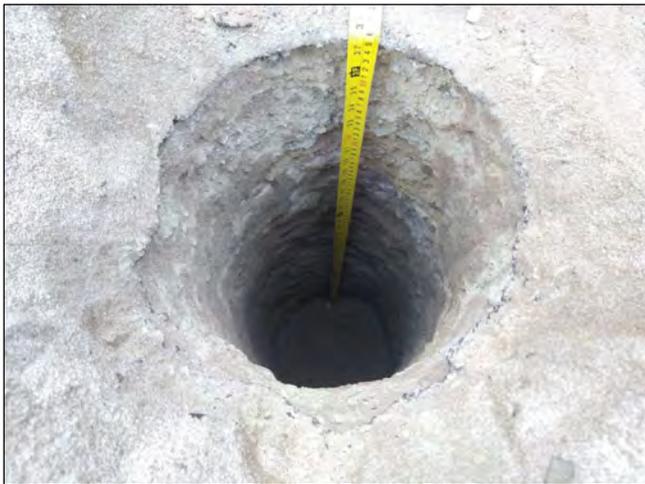
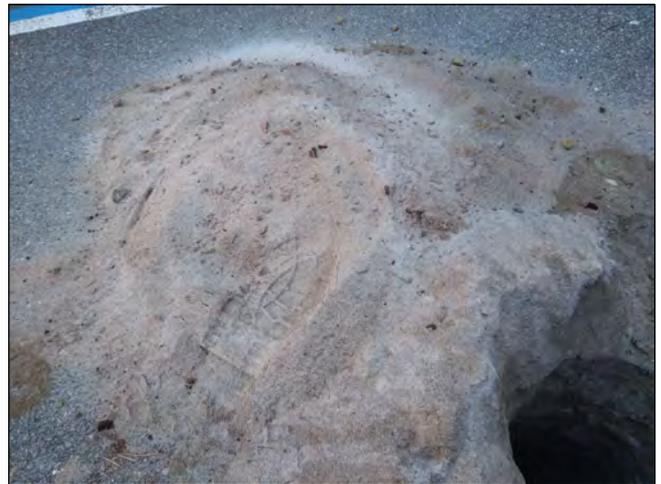
22.1	1.2	SAND SP: fine to medium grained, grey, trace silt, moist. Bassendean Sand. - becoming pale grey from 1.4 m depth.	●						
22.2	2.2	SAND SP-SM: fine to medium grained, dark brown, with silt, trace pockets of weakly cemented Silty SAND SM, moist. Bassendean Sand.	●

22.5	2.5	Bore discontinued at 2.5m (Target depth)

RIG: 8 tonne backhoe **DRILLER:** ANH Contracting **LOGGED:** GG **CASING:**
TYPE OF BORING: 250 mm diameter power auger borehole
WATER OBSERVATIONS: No free groundwater observed.

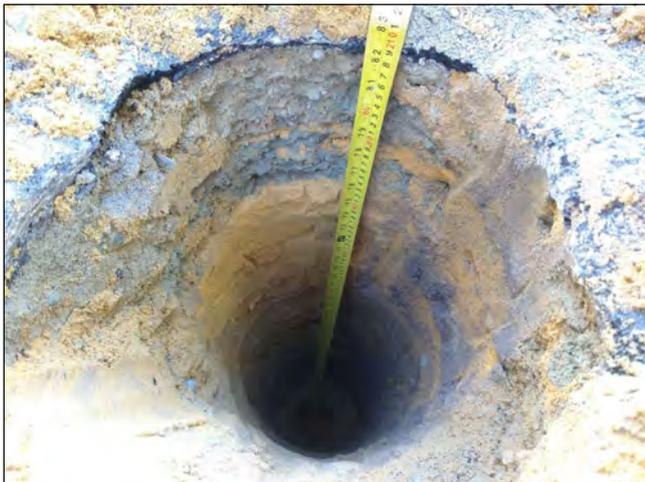
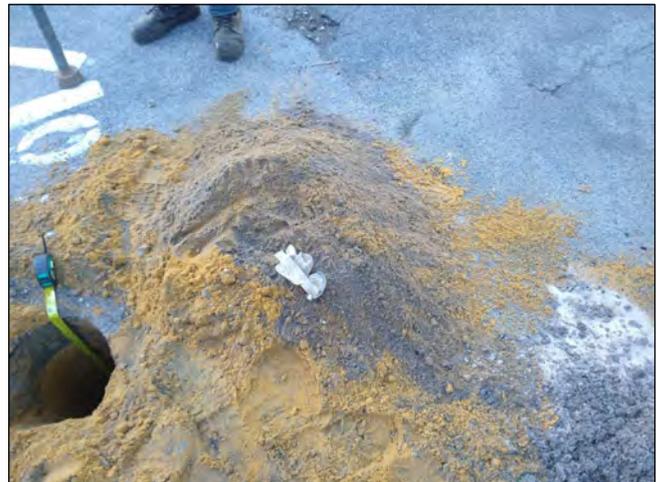
- tile pieces observed at 2.0 m depth.		D	2.0									
2.3		SAND SP: fine to medium grained, pale grey, trace silt, moist. Bassendean Sand.	S

2.5		Bore discontinued at 2.5m (Target depth)

RIG: 8 tonne backhoe **DRILLER:** ANH Contracting **LOGGED:** GG **CASING:**
TYPE OF BORING: 250 mm diameter power auger borehole to 1.8 m and 110 mm diameter hand auger borehole to 2.5 m depth

WATER OBSERVATIONS: No free groundwater observed.

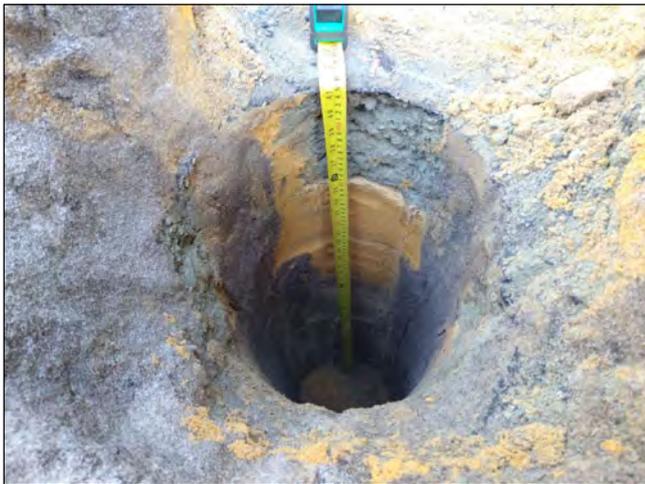
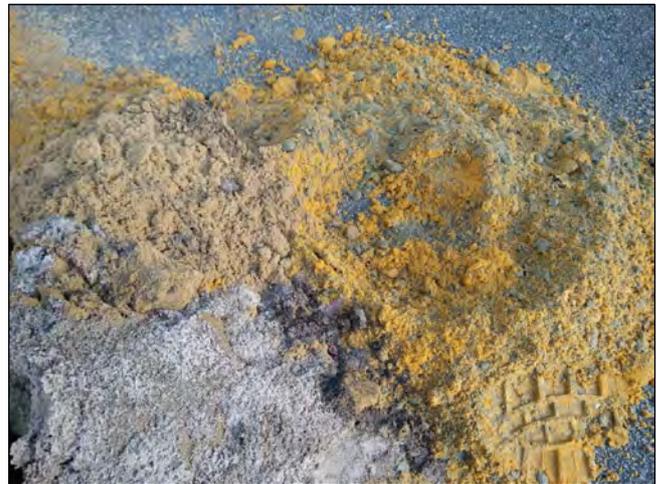
BORE No: 133
PROJECT No: 216618.01
DATE: 27/6/2023
SHEET 1 OF 1

RL	Depth (m)	Description of Strata	Graphic Log	Sampling & In Situ Testing				Water	Dynamic Penetrometer Test (blows per 150mm)					
				Type	Depth	Sample	Results & Comments		5	10	15	20		
	0.02	ASPHALT: black, 7 mm sized nominal aggregate.	▨											
	0.155	FILL/BASECOURSE: Sandy GRAVEL GP-GM: fine to coarse sized, blue-grey, fine to medium grained, with silt, fill. Gravel is crushed rock.	▩											
		FILL/SAND SP: fine to medium grained, yellow-brown and pale yellow-brown, trace silt, moist, dense to very dense, fill. - becoming brown from 0.48 m depth.	▩											
	1.3	SAND SP-SM: fine to medium grained, dark grey-brown, with silt, moist. Bassendean Sand.	▩											
	1.4	SAND SP: fine to medium grained, pale grey, trace silt, moist. Bassendean Sand.	▩											
	2.5	Bore discontinued at 2.5m (Target depth)

RIG: 8 tonne backhoe **DRILLER:** ANH Contracting **LOGGED:** GG **CASING:**
TYPE OF BORING: 250 mm diameter power auger borehole
WATER OBSERVATIONS: No free groundwater observed.

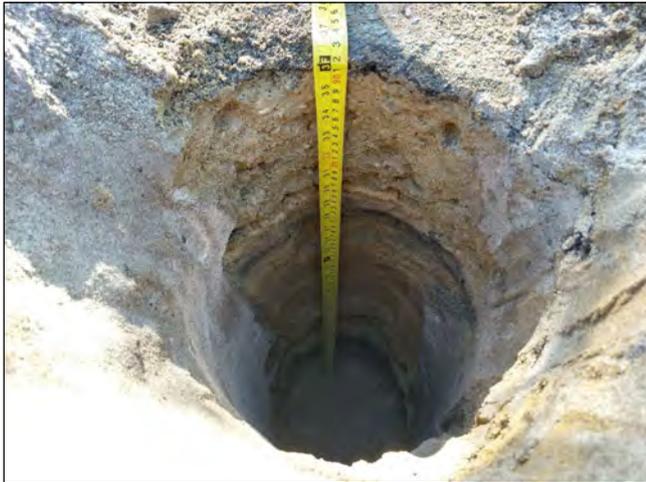
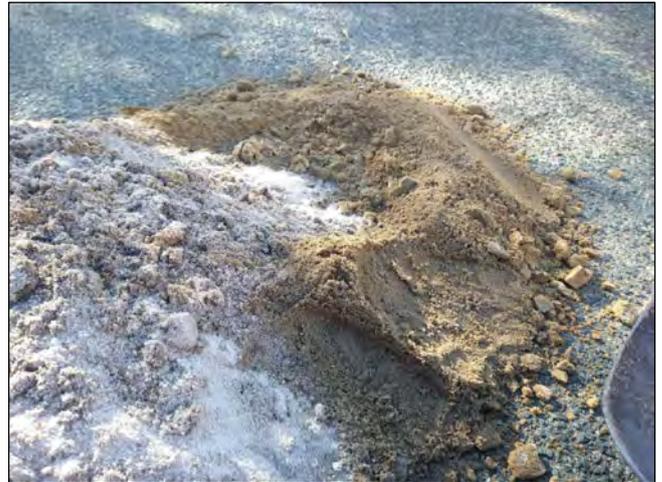
BORE No: 134
PROJECT No: 216618.01
DATE: 27/6/2023
SHEET 1 OF 1

RL	Depth (m)	Description of Strata	Graphic Log	Sampling & In Situ Testing				Water	Dynamic Penetrometer Test (blows per 150mm)					
				Type	Depth	Sample	Results & Comments		5	10	15	20		
	0.02	ASPHALT: black, 7 mm sized nominal aggregate.												
	0.2	FILL/BASECOURSE: Sandy GRAVEL GP-GM: fine to coarse sized, grey-brown, fine to medium grained, with silt, moist, fill.												
		FILL/SAND SP: fine to medium grained, grey-brown, trace silt, moist, medium dense to dense, fill. - becoming yellow-brown from 0.25 m depth. - becoming pale grey from 0.6 m depth. - becoming dark grey and grey from 0.8 m depth.												
	1.1	SAND SP: fine to medium grained, grey, trace silt, moist, medium dense. Bassendean Sand. - becoming pale grey from 1.3 m depth.												
	2.5	Bore discontinued at 2.5m (Target depth)

RIG: 8 tonne backhoe **DRILLER:** ANH Contracting **LOGGED:** GG **CASING:**
TYPE OF BORING: 250 mm diameter power auger borehole
WATER OBSERVATIONS: No free groundwater observed.

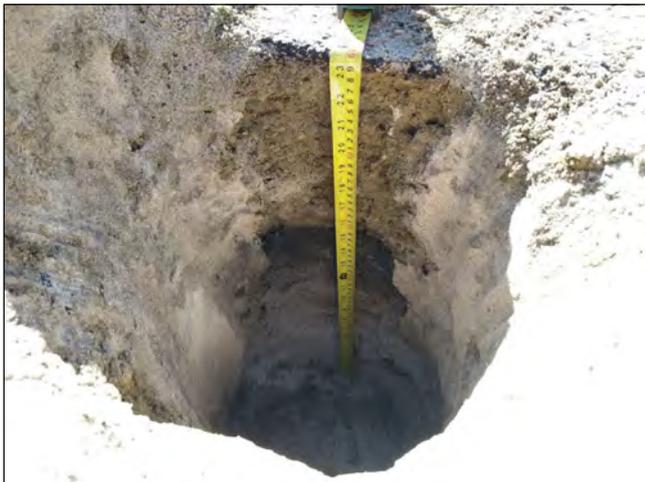
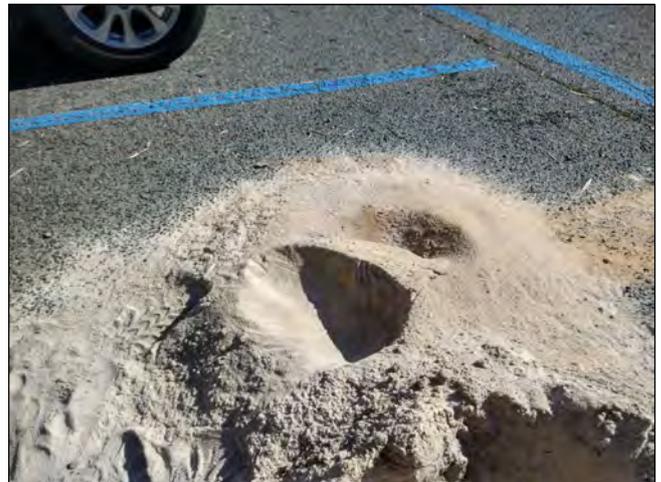
BORE No: 135
PROJECT No: 216618.01
DATE: 27/6/2023
SHEET 1 OF 1

RL	Depth (m)	Description of Strata	Graphic Log	Sampling & In Situ Testing				Water	Dynamic Penetrometer Test (blows per 150mm)					
				Type	Depth	Sample	Results & Comments		5	10	15	20		
	0.015	ASPHALT: black, 7 mm sized nominal aggregate.	AS											
	0.22	FILL/BASECOURSE: Gravelly SAND SP-SM: fine to coarse sized, grey-brown, fine to medium grained, with silt, moist, fill.	FS											
		SAND SP: fine to medium grained, dark grey, trace silt, moist, medium dense to dense. Bassendean Sand. - becoming pale grey from 0.32 m depth.	S	B	0.5									
		- becoming pale brown and brown from 2.3 m depth.												
	2.5	Bore discontinued at 2.5m (Target depth)

RIG: 8 tonne backhoe **DRILLER:** ANH Contracting **LOGGED:** GG **CASING:**
TYPE OF BORING: 250 mm diameter power auger borehole
WATER OBSERVATIONS: No free groundwater observed.

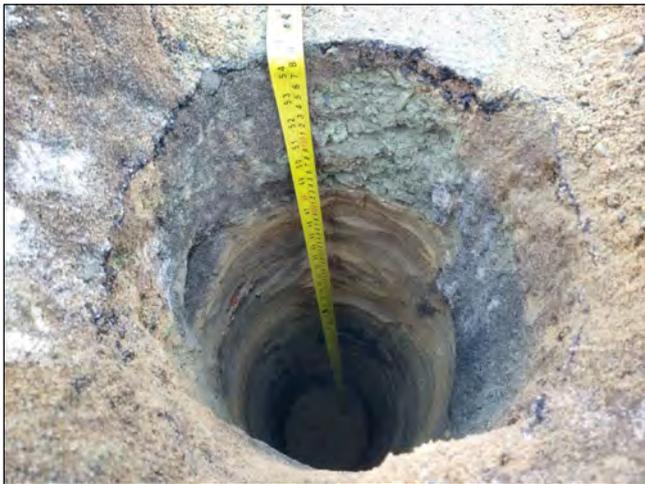
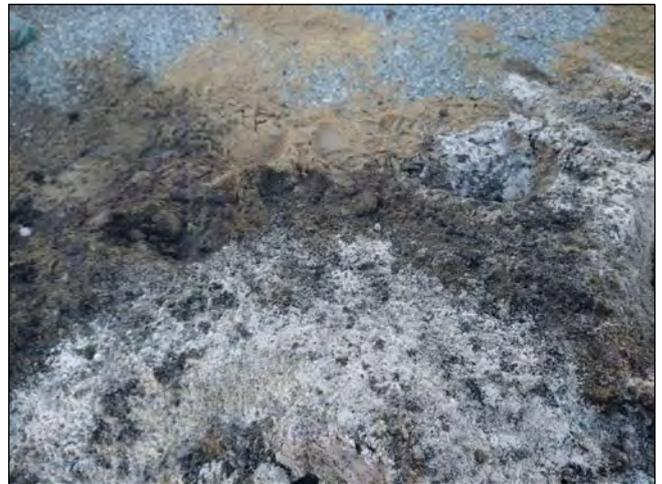
0.015		ASPHALT: black, 7 mm sized nominal aggregate.	AS											
0.18		FILL/BASECOURSE: Sandy GRAVEL GP-GM: fine to coarse sized, grey-brown, fine to medium grained, with silt, moist, fill.	G											
		FILL/SAND SP: fine to medium grained, yellow-brown, trace silt and gravel, moist, medium dense, fill.	B	0.5										
	1	- becoming grey-brown from 1.0 m depth.

1.5	- becoming dark grey from 1.5 m depth.												
	1.8	FILL/ORGANIC SAND SP-SM: fine to medium grained, dark grey-brown, with silt, moist, fill. Pieces of glass and tile observed in fill.	D	2.0

2.1	SAND SP: fine to medium grained, pale grey, trace silt, moist. Bassendean Sand.	S											
	2.5	Bore discontinued at 2.5m (Target depth)

RIG: 8 tonne backhoe **DRILLER:** ANH Contracting **LOGGED:** GG **CASING:**
TYPE OF BORING: 250 mm diameter power auger borehole
WATER OBSERVATIONS: No free groundwater observed.

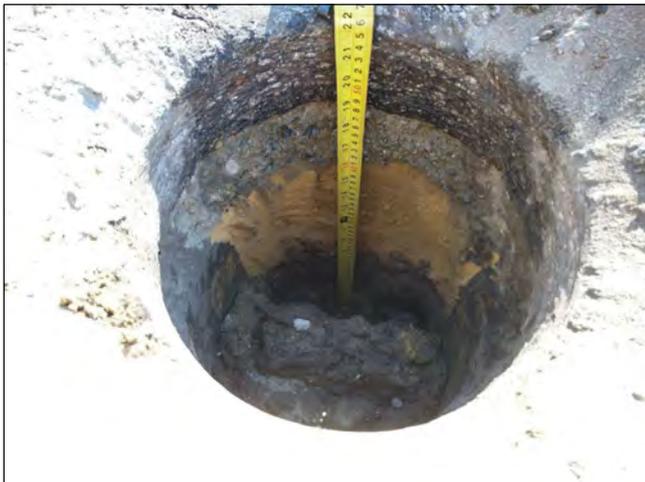
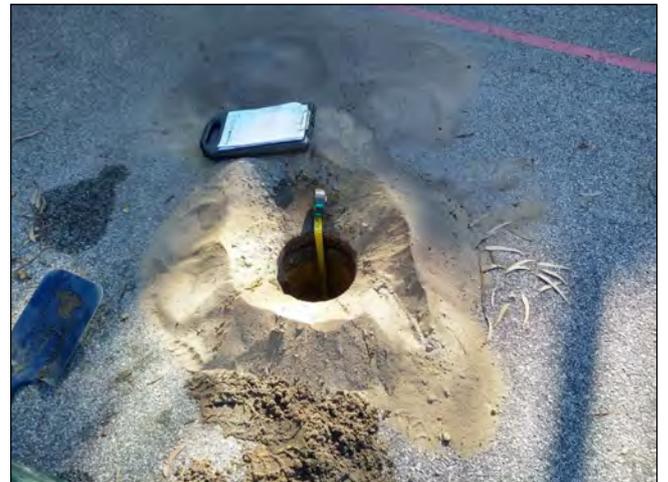
BORE No: 137
PROJECT No: 216618.01
DATE: 27/6/2023
SHEET 1 OF 1

RL	Depth (m)	Description of Strata	Graphic Log	Sampling & In Situ Testing				Water	Dynamic Penetrometer Test (blows per 150mm)					
				Type	Depth	Sample	Results & Comments		5	10	15	20		
	0.08	ASPHALT: black, 7 mm sized nominal aggregate.												
	0.15	FILL/BASECOURSE: Sandy GRAVEL GP-GM: fine to coarse sized, grey-brown, fine to medium grained, with silt, moist, fill. Gravel is crushed rock.												
		FILL/SAND SP: fine to medium grained, yellow-brown, trace silt, moist, very dense, fill. - becoming grey-brown, trace silt from 0.38 m depth.												
	1.5	SAND SP: fine to medium grained, pale grey, trace silt, moist. Bassendean Sand.												
	2.2	Bore discontinued at 2.2m (Collapsing conditions)

RIG: 8 tonne backhoe **DRILLER:** ANH Contracting **LOGGED:** GG **CASING:**
TYPE OF BORING: 250 mm diameter power auger borehole
WATER OBSERVATIONS: No free groundwater observed.

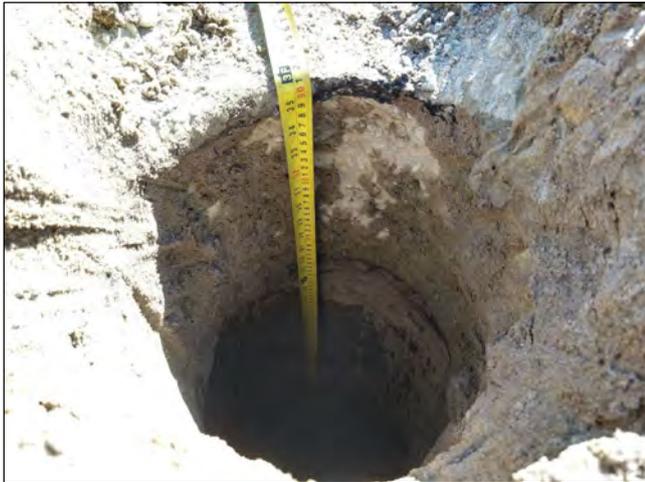
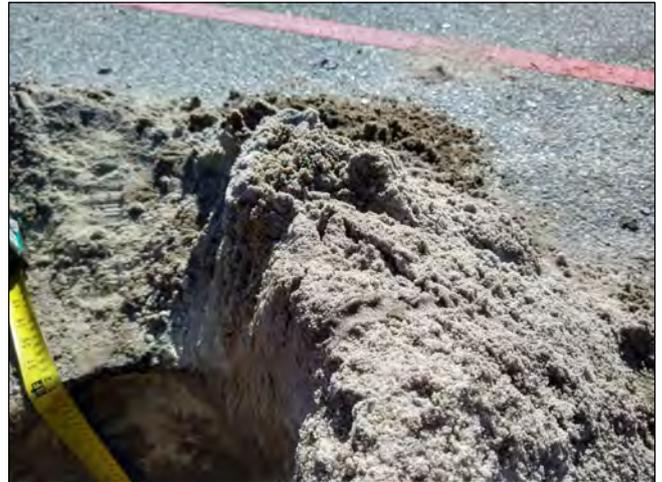
BORE No: 138
PROJECT No: 216618.01
DATE: 27/6/2023
SHEET 1 OF 1

RL	Depth (m)	Description of Strata	Graphic Log	Sampling & In Situ Testing				Water	Dynamic Penetrometer Test (blows per 150mm)					
				Type	Depth	Sample	Results & Comments		5	10	15	20		
22.9	0.02	ASPHALT: black, 7 mm sized nominal aggregate.	[Cross-hatch pattern]											
	0.26	FILL/BASECOURSE: Sandy GRAVEL GP-GM: fine to coarse sized, pale grey, fine to medium grained, with silt, moist, fill. Gravel is crushed rock.	[Cross-hatch pattern]											
		FILL/SAND SP: fine to medium grained, grey, trace gravel and silt, dry to moist, dense to very dense, fill.	[Cross-hatch pattern]	D	0.7									
	1.2	SAND SP: fine to medium grained, pale grey, trace silt, moist. Bassendean Sand.	[Dotted pattern]											
		- becoming brown from 2.3 m depth.	[Dotted pattern]											
	2.5	Bore discontinued at 2.5m (Target depth)

RIG: 8 tonne backhoe **DRILLER:** ANH Contracting **LOGGED:** GG **CASING:**
TYPE OF BORING: 250 mm diameter power auger borehole
WATER OBSERVATIONS: No free groundwater observed.

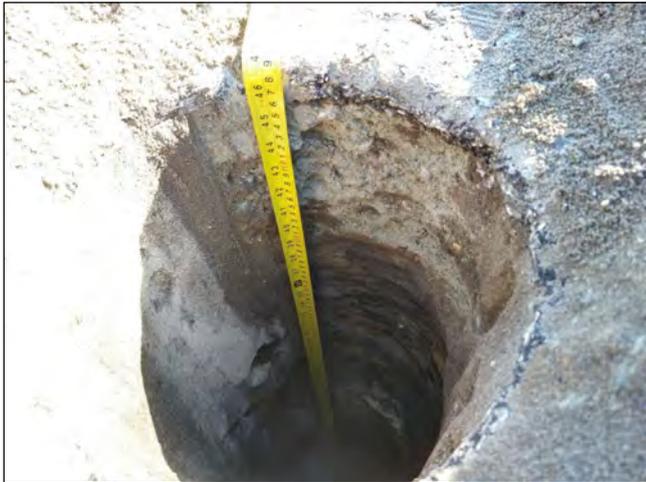
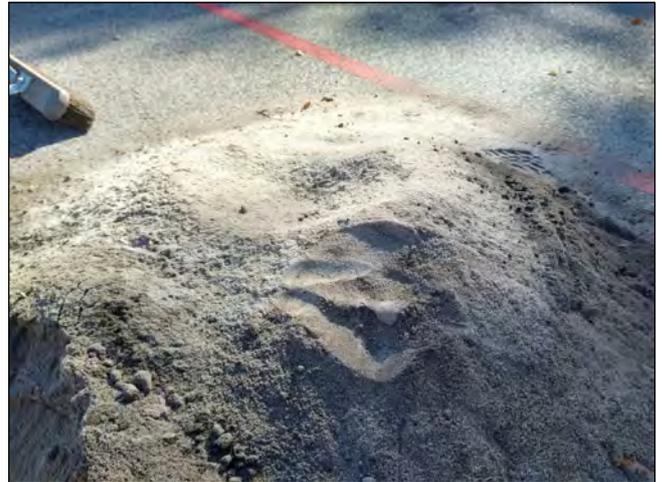
BORE No: 139
PROJECT No: 216618.01
DATE: 27/6/2023
SHEET 1 OF 1

RL	Depth (m)	Description of Strata	Graphic Log	Sampling & In Situ Testing				Water	Dynamic Penetrometer Test (blows per 150mm)					
				Type	Depth	Sample	Results & Comments		5	10	15	20		
	0.02	ASPHALT: black, 7 mm sized nominal aggregate.	ASPH											
	0.2	FILL/BASECOURSE: Sandy GRAVEL GP-GM: fine to coarse sized, pale grey, fine to medium grained, with silt, moist, fill. Gravel is crushed rock.	GRAVEL											
	0.35	FILL/SAND SP: fine to medium grained, dark grey-brown and dark brown, trace silt, moist, fill. - becoming brown and yellow, trace limestone gravel from 0.35 m depth. - a piece of limestone cobble observed at 0.7 m depth.	SAND SP											
	1.0	SAND SP: fine to medium grained, grey, trace silt, moist, dense. Bassendean Sand. - becoming pale grey from 1.1 m depth.	SAND SP											
	2.5	Bore discontinued at 2.5m (Target depth)

RIG: 8 tonne backhoe **DRILLER:** ANH Contracting **LOGGED:** GG **CASING:**
TYPE OF BORING: 250 mm diameter power auger borehole
WATER OBSERVATIONS: No free groundwater observed.
