ECU Mount Lawley Redevelopment

Precinct Structure Plan Water Management Report

DevelopmentWA

By Urbaqua

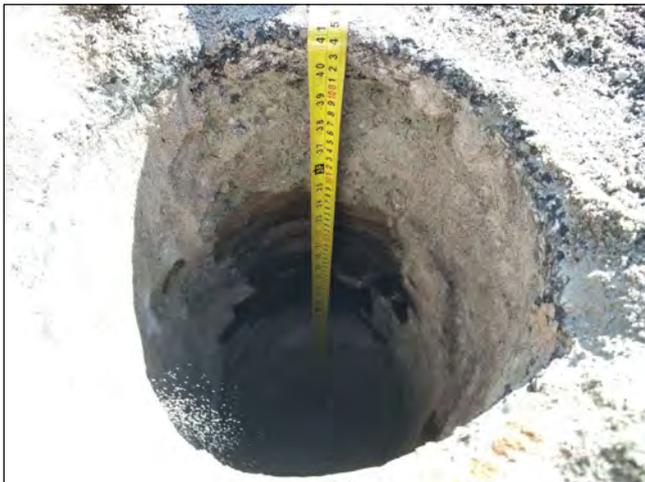
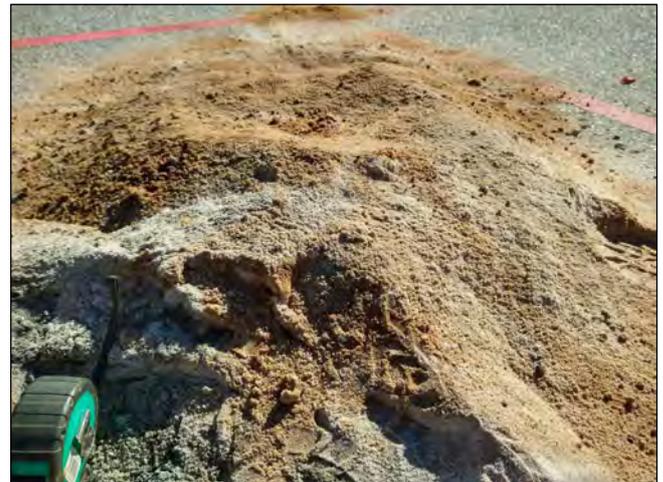
BORE No: 140
PROJECT No: 216618.01
DATE: 27/6/2023
SHEET 1 OF 1

RL	Depth (m)	Description of Strata	Graphic Log	Sampling & In Situ Testing				Water	Dynamic Penetrometer Test (blows per 150mm)					
				Type	Depth	Sample	Results & Comments		5	10	15	20		
	0.04	ASPHALT: black, 7 mm sized nominal aggregate.	[Asphalt Pattern]											
	0.18	FILL/BASECOURSE: Sandy GRAVEL GP-GM: fine to coarse sized, blue-grey, fine to medium grained, with silt, moist, fill.	[Cross-hatch Pattern]	B	0.3									
	0.55	FILL/SAND SP: fine to medium grained, dark grey-brown and dark brown, trace gravel and silt, moist, fill. SAND SP: fine to medium grained, pale grey, trace silt, moist, very dense. Bassendean Sand.	[Dotted Pattern]											
		- becoming pale brown from 1.6 m depth.												
		- becoming brown from 1.9 m depth.												
		- trace pockets of SAND SP-SM from 2.2 m depth.												
	2.5	Bore discontinued at 2.5m (Target depth)

RIG: 8 tonne backhoe **DRILLER:** ANH Contracting **LOGGED:** GG **CASING:**
TYPE OF BORING: 250 mm diameter power auger borehole
WATER OBSERVATIONS: No free groundwater observed.

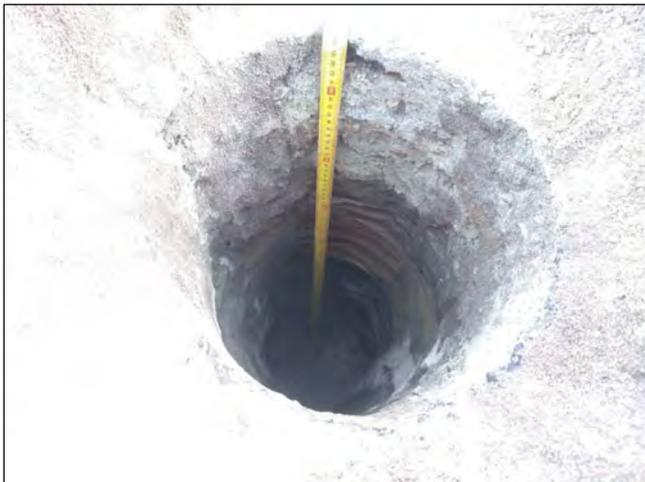
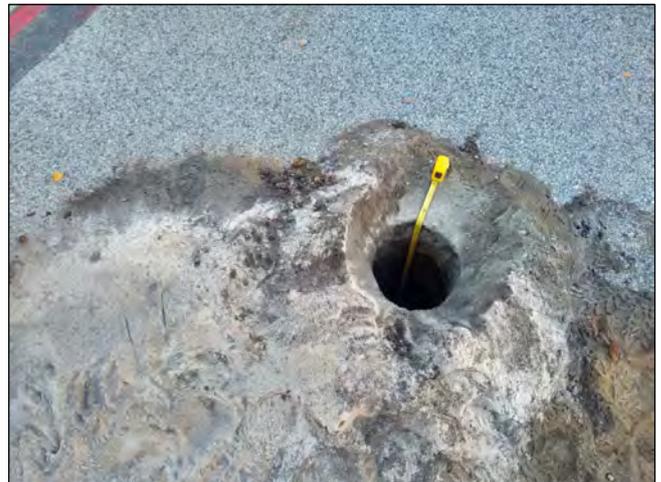
BORE No: 141
PROJECT No: 216618.01
DATE: 28/6/2023
SHEET 1 OF 1

RL	Depth (m)	Description of Strata	Graphic Log	Sampling & In Situ Testing				Water	Dynamic Penetrometer Test (blows per 150mm)					
				Type	Depth	Sample	Results & Comments		5	10	15	20		
	0.03	ASPHALT: black, 7 mm sized nominal aggregate.	[Symbol]											
	0.2	FILL/BASECOURSE: Sandy GRAVEL GP-GM: fine to coarse sized, grey-brown, fine to medium grained, with silt, moist, fill.	[Symbol]											
	0.55	FILL/SAND SP: fine to medium grained, bands of dark grey, dark grey-brown and yellow-brown, trace gravel and silt, moist, dense, fill. - becoming grey from 0.55 m depth.	[Symbol]											
	1.0	SAND SP: fine to medium grained, grey, trace silt, moist. Bassendean Sand. - becoming pale grey from 1.2 m depth.	[Symbol]	D	1.5									
	2.5	- becoming dark brown, trace pockets of SAND SP-SM from 2.4 m depth. Bore discontinued at 2.5m (Target depth)	[Symbol]

RIG: 8 tonne backhoe **DRILLER:** ANH Contracting **LOGGED:** GG **CASING:**
TYPE OF BORING: 250 mm diameter power auger borehole
WATER OBSERVATIONS: No free groundwater observed.

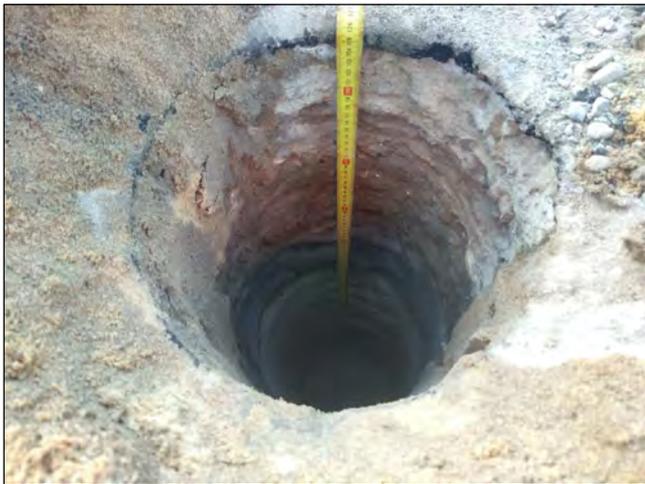
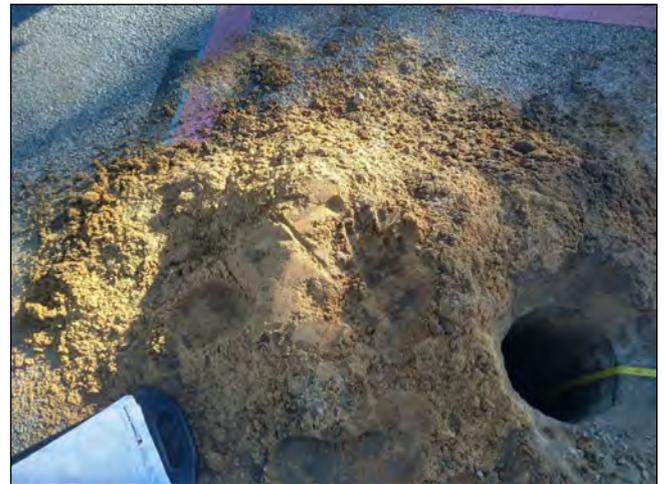
BORE No: 142
PROJECT No: 216618.01
DATE: 28/6/2023
SHEET 1 OF 1

RL	Depth (m)	Description of Strata	Graphic Log	Sampling & In Situ Testing				Water	Dynamic Penetrometer Test (blows per 150mm)					
				Type	Depth	Sample	Results & Comments		5	10	15	20		
	0.02	ASPHALT: black, 7 mm sized nominal aggregate.	AS											
	0.11	FILL/BASECOURSE: Sandy GRAVEL GP-GM: fine to coarse sized, grey, fine to medium grained, with silt, moist, fill.	GB											
	0.6	FILL/SAND SP: fine to medium grained, grey-brown, with gravel, trace silt, moist, fill. - becoming grey, trace gravel from 0.38 m depth. - becoming yellow-brown between 0.55 m to 0.6 m depth.	FS											
	1.1	SAND SP: fine to medium grained, pale grey, trace silt, moist, dense. Possibly fill.	SS	D	1.2									
	2.5	Bore discontinued at 2.5m (Target depth)

RIG: 8 tonne backhoe **DRILLER:** ANH Contracting **LOGGED:** GG **CASING:**
TYPE OF BORING: 250 mm diameter power auger borehole
WATER OBSERVATIONS: No free groundwater observed.

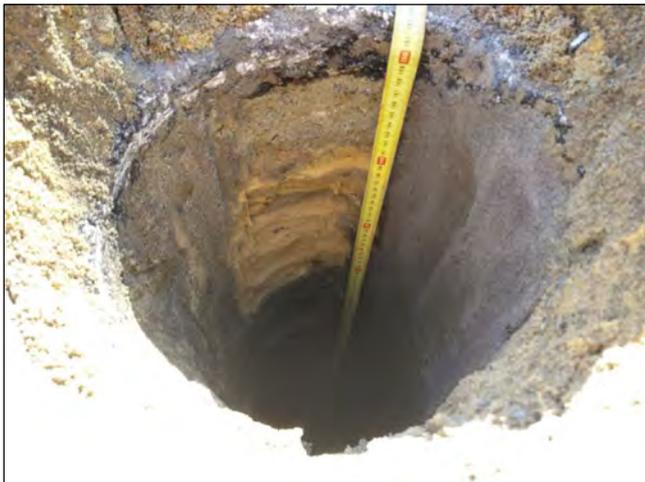
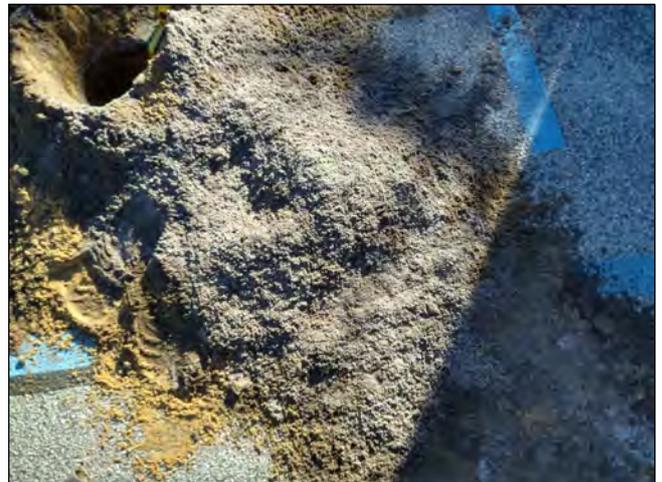
BORE No: 143
PROJECT No: 216618.01
DATE: 28/6/2023
SHEET 1 OF 1

RL	Depth (m)	Description of Strata	Graphic Log	Sampling & In Situ Testing				Water	Dynamic Penetrometer Test (blows per 150mm)				
				Type	Depth	Sample	Results & Comments		5	10	15	20	
20	0.05	ASPHALT: black, 7 mm sized nominal aggregate.	b. s.										
	0.14	FILL/BASECOURSE: Sandy GRAVEL GP-GM: fine to coarse sized, grey-brown, fine to medium grained, with silt, moist, fill.	x										
		FILL/SAND SP: fine to medium grained, bands of yellow-brown, brown and grey-brown, trace silt, moist, dense to very dense, fill. Pieces of broken glass and tile observed in fill. - becoming dark grey-brown and dark grey, trace gravel from 0.45 m depth.	x										
21	1.8	SAND SP: fine to medium grained, pale grey, trace silt, moist. Bassendean Sand.	.										
21	2.5	Bore discontinued at 2.5m (Target depth)

RIG: 8 tonne backhoe **DRILLER:** ANH Contracting **LOGGED:** GG **CASING:**
TYPE OF BORING: 250 mm diameter power auger borehole
WATER OBSERVATIONS: No free groundwater observed.

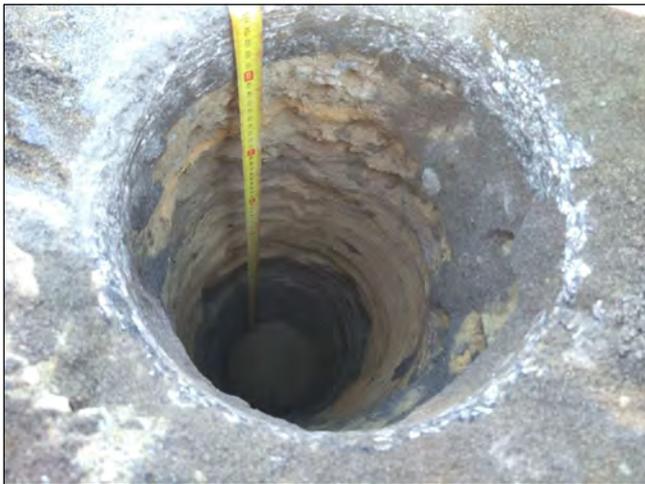
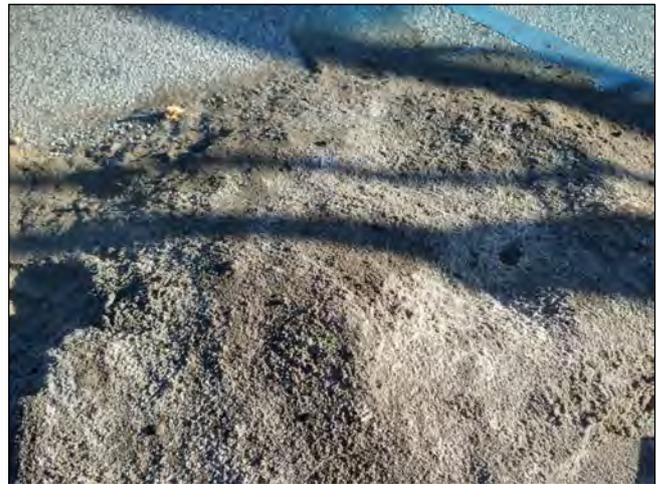
BORE No: 144
PROJECT No: 216618.01
DATE: 28/6/2023
SHEET 1 OF 1

RL	Depth (m)	Description of Strata	Graphic Log	Sampling & In Situ Testing				Water	Dynamic Penetrometer Test (blows per 150mm)					
				Type	Depth	Sample	Results & Comments		5	10	15	20		
	0.06	ASPHALT: black, 7 mm sized nominal aggregate.	[ASPHALT]											
	0.14	FILL/BASECOURSE: Sandy GRAVEL GP-GM: fine to coarse sized, grey, fine to medium grained, with silt, moist, fill.	[GRAVEL]											
	0.5	FILL/SAND SP: fine to medium grained, yellow-brown, trace gravel and silt, moist, fill. Pieces of glass bottle observed in fill. - becoming grey-brown from 0.17 m depth. - becoming dark grey and dark grey-brown from 0.6 m depth.	[SAND SP]	B	0.5									
	1.5	SAND SP: fine to medium grained, grey, trace silt, moist. Bassendean Sand. - becoming pale grey from 1.8 m depth.	[SAND SP]											
	2.5	Bore discontinued at 2.5m (Target depth)

RIG: 8 tonne backhoe **DRILLER:** ANH Contracting **LOGGED:** GG **CASING:**
TYPE OF BORING: 250 mm diameter power auger borehole
WATER OBSERVATIONS: No free groundwater observed.

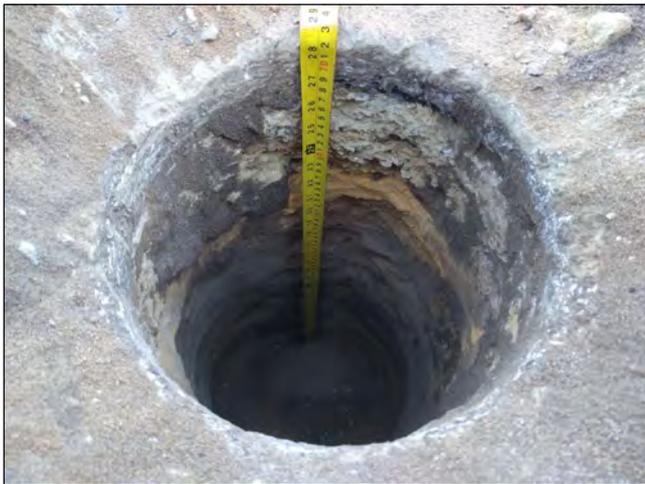
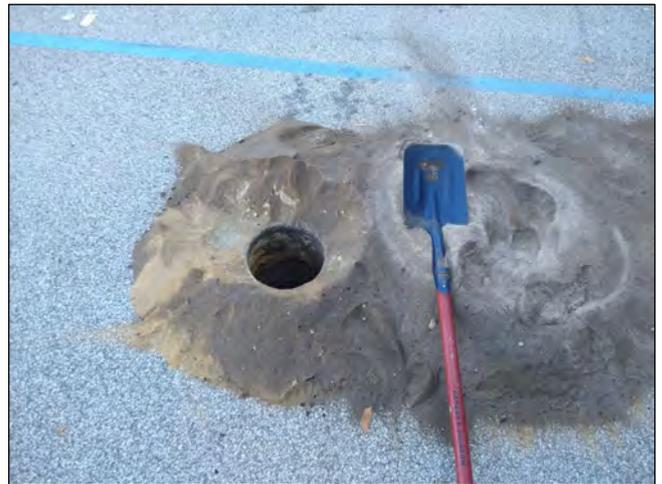
RL	Depth (m)	Description of Strata	Graphic Log	Sampling & In Situ Testing				Water	Dynamic Penetrometer Test (blows per 150mm)				
				Type	Depth	Sample	Results & Comments		5	10	15	20	
0.04	0.13	ASPHALT: black, 7 mm sized nominal aggregate. FILL/BASECOURSE: Sandy GRAVEL GP-GM: fine to coarse sized, grey and grey-brown, fine to medium grained, with silt, moist, fill. FILL/SAND SP: fine to medium grained, yellow-brown, trace gravel and silt, moist, dense to very dense, fill. - becoming grey-brown from 0.22 m depth. - becoming grey-brown and dark grey from 0.45 m depth.

1.9	2.5	SAND SP: fine to medium grained, grey, trace silt, moist. Bassendean Sand. Bore discontinued at 2.5m (Target depth)

RIG: 8 tonne backhoe **DRILLER:** ANH Contracting **LOGGED:** GG **CASING:**
TYPE OF BORING: 250 mm diameter power auger borehole
WATER OBSERVATIONS: No free groundwater observed.

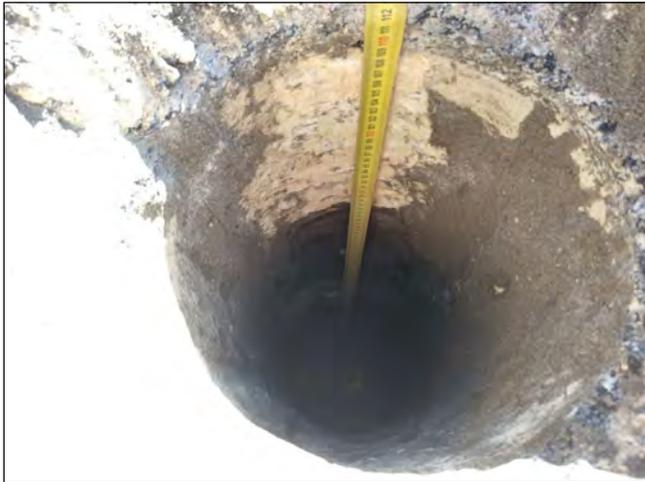
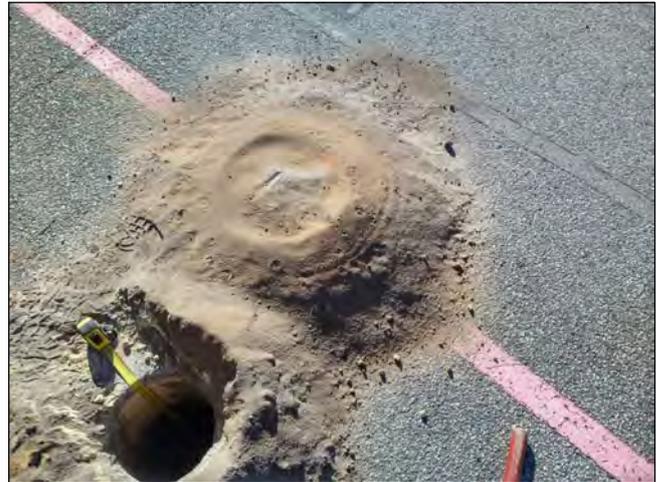
BORE No: 146
PROJECT No: 216618.01
DATE: 28/6/2023
SHEET 1 OF 1

RL	Depth (m)	Description of Strata	Graphic Log	Sampling & In Situ Testing				Water	Dynamic Penetrometer Test (blows per 150mm)					
				Type	Depth	Sample	Results & Comments		5	10	15	20		
	0.04	ASPHALT: black, 7 mm sized nominal aggregate.	[Asphalt Pattern]											
	0.28	FILL/BASECOURSE: Sandy GRAVEL GP-GM: fine to medium grained, pale yellow, fine to medium grained, with silt, moist, fill. Gravel is crushed limestone. FILL/SAND SP: fine to medium grained, dark grey, trace gravel and silt, moist, fill. - piece of limestone cobble observed at 0.65 m depth.	[Gravel Pattern]											
	1.0	SAND SP: fine to medium grained, pale grey, trace silt, moist. Bassendean Sand.	[Sand Pattern]											
	2.0	SAND SP: fine to medium grained, brown, trace silt, moist. Possibly sand derived from Tamala Limestone.	[Sand Pattern]											
	2.5	Bore discontinued at 2.5m (Target depth)

RIG: 8 tonne backhoe **DRILLER:** ANH Contracting **LOGGED:** GG **CASING:**
TYPE OF BORING: 250 mm diameter power auger borehole
WATER OBSERVATIONS: No free groundwater observed.

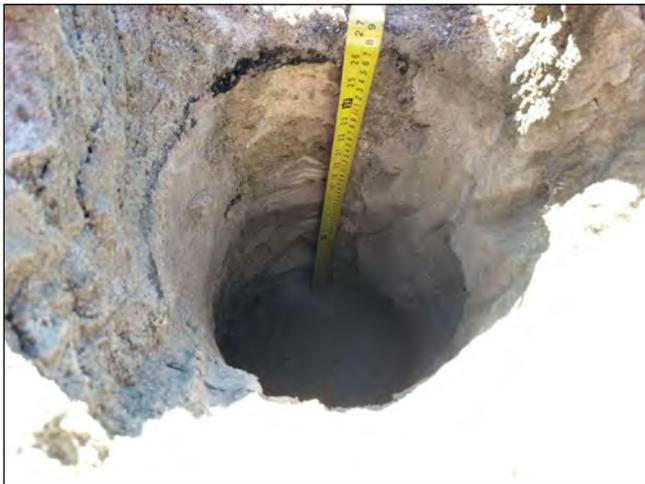
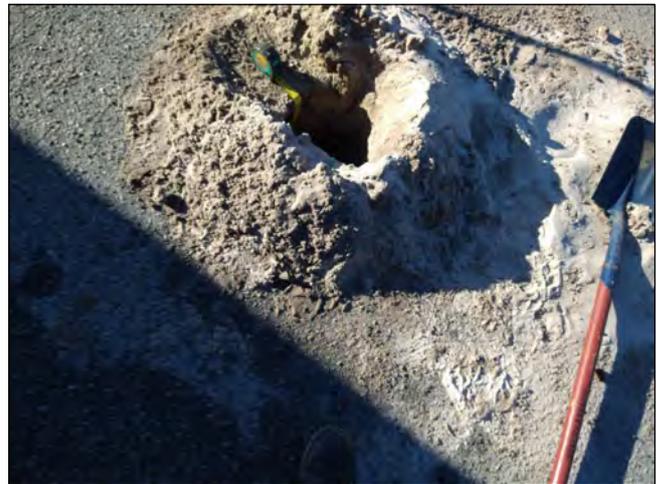
BORE No: 147
PROJECT No: 216618.01
DATE: 29/6/2023
SHEET 1 OF 1

RL	Depth (m)	Description of Strata	Graphic Log	Sampling & In Situ Testing				Water	Dynamic Penetrometer Test (blows per 150mm)					
				Type	Depth	Sample	Results & Comments		5	10	15	20		
	0.04	ASPHALT: black, 7 mm sized nominal aggregate.	[Asphalt symbol]											
	0.2	FILL/BASECOURSE: Sandy GRAVEL GP-GM: fine to coarse sized, pale grey, fine to medium grained, with silt, moist, fill. Gravel is crushed rock. - becoming grey-brown from 0.12 m depth.	[Gravel symbol]											
	0.5	FILL/SAND SP: fine to medium grained, bands of grey, pale grey and grey-brown, trace gravel and silt, moist, fill. SAND SP: fine to medium grained, pale grey, trace silt, moist, very dense. Bassendean Sand.	[Sand SP symbol]											
	1													
	2													
	2.5	- becoming dark brown, trace pockets of SAND SP-SM from 2.1 m depth. Bore discontinued at 2.5m (Target depth)

RIG: 8 tonne backhoe **DRILLER:** ANH Contracting **LOGGED:** GG **CASING:**
TYPE OF BORING: 250 mm diameter power auger borehole
WATER OBSERVATIONS: No free groundwater observed.

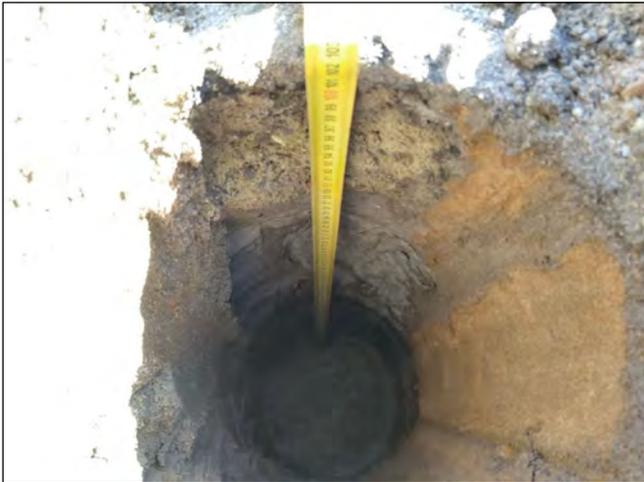
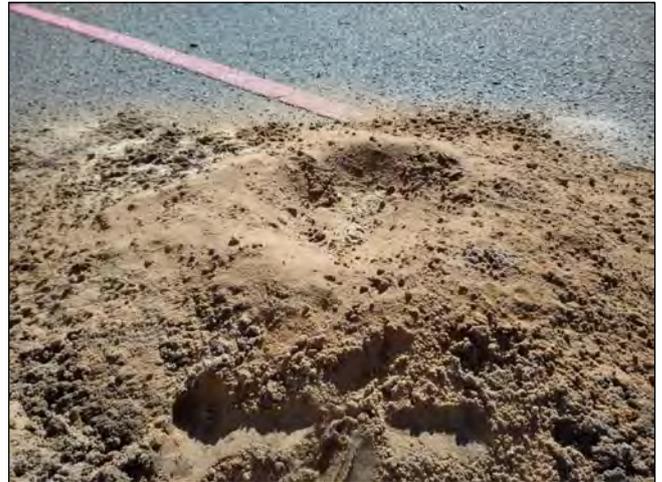
0.02		ASPHALT: black, 7 mm sized nominal aggregate.	S											
0.17		FILL/BASECOURSE: Sandy GRAVEL GP-GM: fine to coarse sized, grey-brown, fine to medium grained, with silt, moist, fill. Gravel is crushed rock.	G

0.55		FILL/SAND SP: fine to medium grained, grey, trace gravel and silt, moist, very dense, fill. SAND SP: fine to medium grained, pale grey, trace silt, moist, very dense. Bassendean Sand.	S

1.0		- becoming pale brown from 1.0 m depth.												
1.3		SAND SP: fine to medium grained, yellow-brown, trace silt, moist. Possibly sand derived from Tamala Limestone.	S

2.0		- becoming pale brown from 2.1 m depth.		D	2.0									
2.5		Bore discontinued at 2.5m (Target depth)

RIG: 8 tonne backhoe **DRILLER:** ANH Contracting **LOGGED:** GG **CASING:**
TYPE OF BORING: 250 mm diameter power auger borehole
WATER OBSERVATIONS: No free groundwater observed.

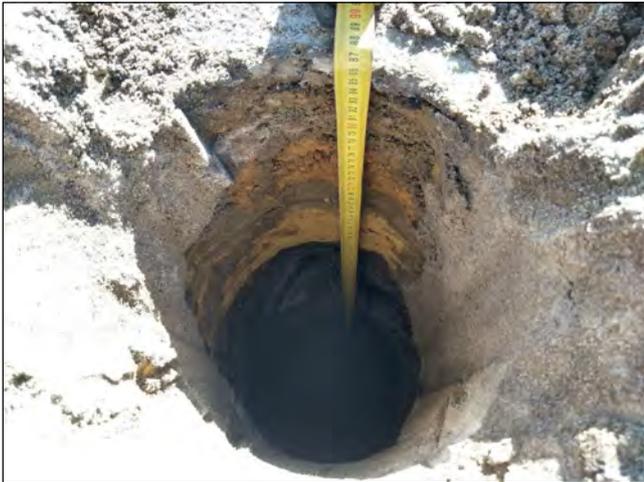
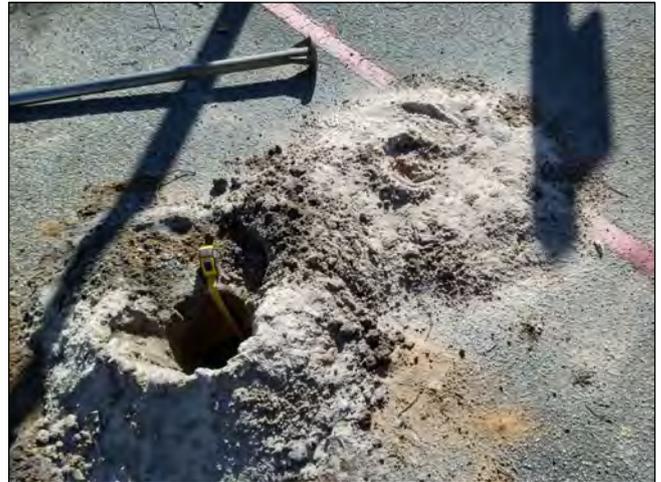
BORE No: 150
PROJECT No: 216618.01
DATE: 28/6/2023
SHEET 1 OF 1

RL	Depth (m)	Description of Strata	Graphic Log	Sampling & In Situ Testing				Water	Dynamic Penetrometer Test (blows per 150mm)					
				Type	Depth	Sample	Results & Comments		5	10	15	20		
	0.03	ASPHALT: black, 7 mm sized nominal aggregate.	[Symbol]											
	0.2	FILL/BASECOURSE: Sandy GRAVEL GP-GM: fine to coarse sized, grey-brown, fine to medium grained, with silt, moist, fill. - becoming yellow-brown from 0.125 m depth.	[Symbol]											
	0.65	FILL/SAND SP: fine to medium grained, grey-brown, trace gravel and silt, moist, medium dense, fill. Scrap metal observed in fill. - becoming pale yellow-brown from 0.26 m depth. - becoming grey-brown and dark grey from 0.37 m depth.	[Symbol]											
	1	SAND SP: fine to medium grained, pale grey, trace silt, moist, medium dense. Bassendean Sand.	[Symbol]											
	2.5	Bore discontinued at 2.5m (Target depth)

RIG: 8 tonne backhoe **DRILLER:** ANH Contracting **LOGGED:** GG **CASING:**
TYPE OF BORING: 250 mm diameter power auger borehole
WATER OBSERVATIONS: No free groundwater observed.

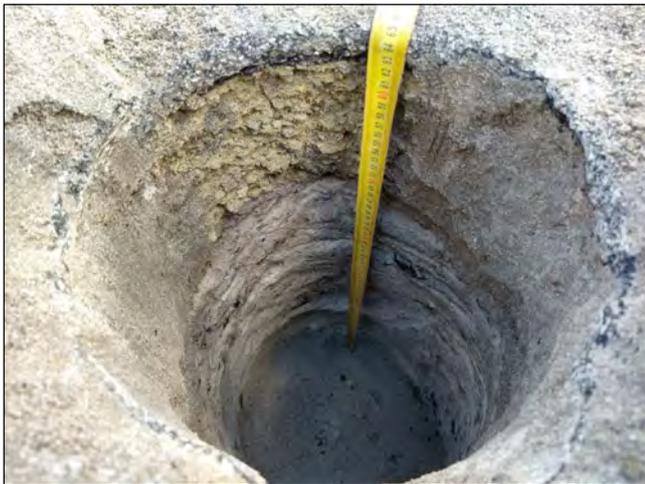
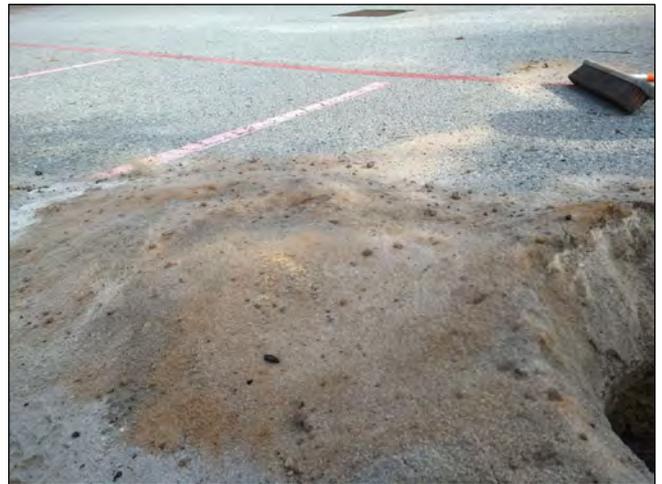
BORE No: 151
PROJECT No: 216618.01
DATE: 28/6/2023
SHEET 1 OF 1

RL	Depth (m)	Description of Strata	Graphic Log	Sampling & In Situ Testing				Water	Dynamic Penetrometer Test (blows per 150mm)					
				Type	Depth	Sample	Results & Comments		5	10	15	20		
	0.03	ASPHALT: black, 7 mm sized nominal aggregate.	[Symbol]											
	0.135	FILL/BASECOURSE: Sandy GRAVEL GP-GM: fine to coarse sized, grey-brown, fine to medium grained, with silt, moist, fill.	[Symbol]	B	0.2									
	0.5	FILL/SAND SP: fine to medium grained, grey and grey-brown, trace gravel and silt, moist, medium dense, fill. SAND SP: fine to medium grained, pale grey, trace silt, moist, medium dense. Bassendean Sand. - becoming dark brown, trace pockets of Silty SAND SM from 1.7 m depth. - becoming pale brown from 2.0 m depth.	[Symbol]		0.5									
	2.5	Bore discontinued at 2.5m (Target depth)

RIG: 8 tonne backhoe **DRILLER:** ANH Contracting **LOGGED:** GG **CASING:**
TYPE OF BORING: 250 mm diameter power auger borehole
WATER OBSERVATIONS: No free groundwater observed.

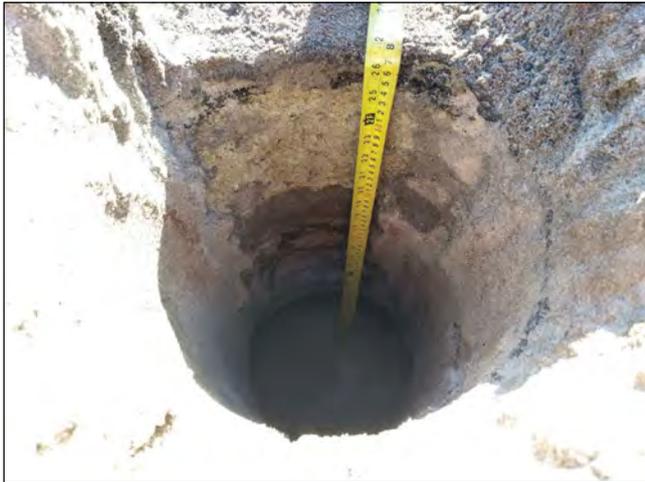
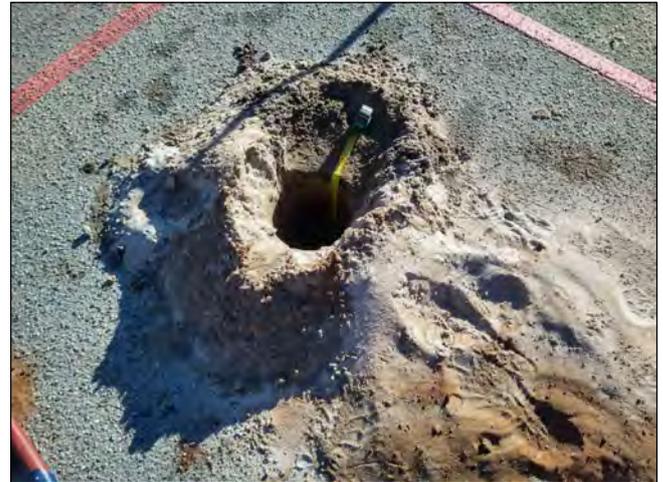
BORE No: 154
PROJECT No: 216618.01
DATE: 29/6/2023
SHEET 1 OF 1

RL	Depth (m)	Description of Strata	Graphic Log	Sampling & In Situ Testing				Water	Dynamic Penetrometer Test (blows per 150mm)					
				Type	Depth	Sample	Results & Comments		5	10	15	20		
	0.04	ASPHALT: black, 7 mm sized nominal aggregate.	[Asphalt symbol]											
	0.19	FILL/BASECOURSE: Sandy GRAVEL GP-GM: fine to coarse sized, grey-brown, fine to medium grained, with silt, moist, fill.	[Gravel symbol]											
	0.45	FILL/SAND SP: fine to medium grained, dark grey, trace gravel and silt, moist, fill. - becoming grey from 0.35 m depth.	[Sand SP symbol]											
		SAND SP: fine to medium grained, pale grey, trace silt, moist, medium dense. Bassendean Sand.	[Sand SP symbol]											
		- becoming dark brown and trace pockets of SAND SP-SM from 2.1 m depth. - becoming pale brown from 2.3 m depth.	[Sand SP symbol]											
	2.5	Bore discontinued at 2.5m (Target depth)

RIG: 8 tonne backhoe **DRILLER:** ANH Contracting **LOGGED:** GG **CASING:**
TYPE OF BORING: 250 mm diameter power auger borehole
WATER OBSERVATIONS: No free groundwater observed.

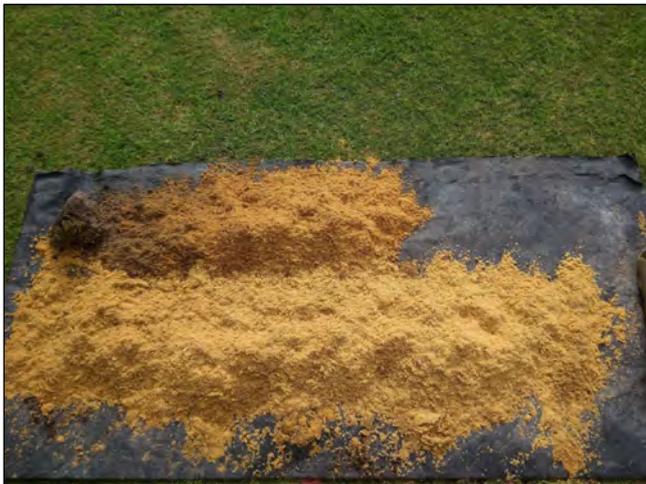
BORE No: 156
PROJECT No: 216618.01
DATE: 23/6/2023
SHEET 1 OF 1

RL	Depth (m)	Description of Strata	Graphic Log	Sampling & In Situ Testing				Water	Dynamic Penetrometer Test (blows per 150mm)					
				Type	Depth	Sample	Results & Comments		5	10	15	20		
	0.3	FILL/SAND SP: fine to medium grained, grey-brown and grey, trace silt, moist, medium dense, fill.	[Cross-hatch pattern]											
	0.3 - 2.5	SAND SP: fine to medium grained, yellow-brown, trace silt, moist, medium dense. Possibly sand derived from Tamala Limestone. - becoming pale yellow-brown from 1.2 m depth.	[Dotted pattern]											
	2.5	Bore discontinued at 2.5m (Target depth)

RIG: hand auger **DRILLER:** GG **LOGGED:** GG **CASING:**
TYPE OF BORING: 110 mm diameter hand auger borehole
WATER OBSERVATIONS: No free groundwater observed.

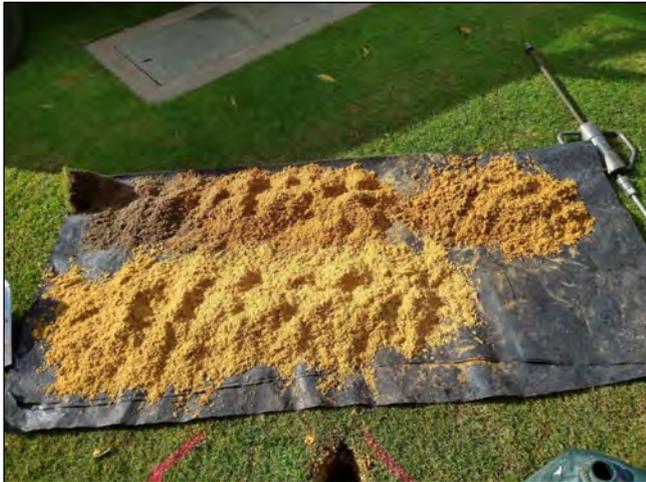
BORE No: 157
PROJECT No: 216618.01
DATE: 23/6/2023
SHEET 1 OF 1

RL	Depth (m)	Description of Strata	Graphic Log	Sampling & In Situ Testing				Water	Dynamic Penetrometer Test (blows per 150mm)				
				Type	Depth	Sample	Results & Comments		5	10	15	20	
	0.25	FILL/SAND SP: fine to medium grained, grey-brown, trace gravel and silt, moist, medium dense, fill.	XXXX										
	0.5	SAND SP: fine to medium grained, yellow-brown, trace silt, moist, medium dense. Possibly sand derived from Tamala Limestone.	E	0.5								
	1.0		D E	1.0								
	1.5		E	1.5								
	2.0	- becoming pale yellow-brown from 2.0 m depth.	E	2.0								
	2.5	Bore discontinued at 2.5m (Target depth)		E	2.5

RIG: hand auger **DRILLER:** GG **LOGGED:** GG **CASING:**
TYPE OF BORING: 110 mm diameter hand auger borehole
WATER OBSERVATIONS: No free groundwater observed.

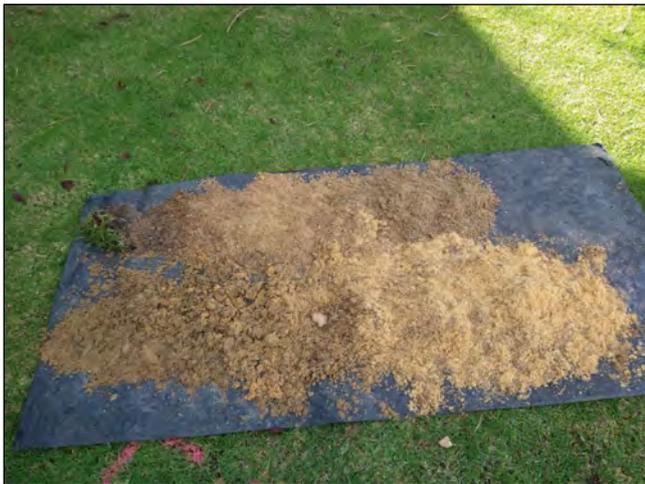
BORE No: 158
PROJECT No: 216618.01
DATE: 26/6/2023
SHEET 1 OF 1

RL	Depth (m)	Description of Strata	Graphic Log	Sampling & In Situ Testing				Water	Dynamic Penetrometer Test (blows per 150mm)				
				Type	Depth	Sample	Results & Comments		5	10	15	20	
		FILL/SAND SP: fine to medium grained, grey, trace gravel and silt, moist, medium dense, fill. - becoming brown and yellow-brown from 0.1 m depth.											
		- becoming grey-brown and brown from 0.8 m depth.											
		- becoming grey-brown and yellow-brown from 1.2 m depth.											
	2.0	SAND SP: fine to medium grained, pale yellow-brown, trace silt, moist. Possibly sand derived from Tamala Limestone.		D	1.1								
	2.5	Bore discontinued at 2.5m (Target depth)

RIG: hand auger **DRILLER:** GG **LOGGED:** GG **CASING:**
TYPE OF BORING: 110 mm diameter hand auger borehole
WATER OBSERVATIONS: No free groundwater observed.

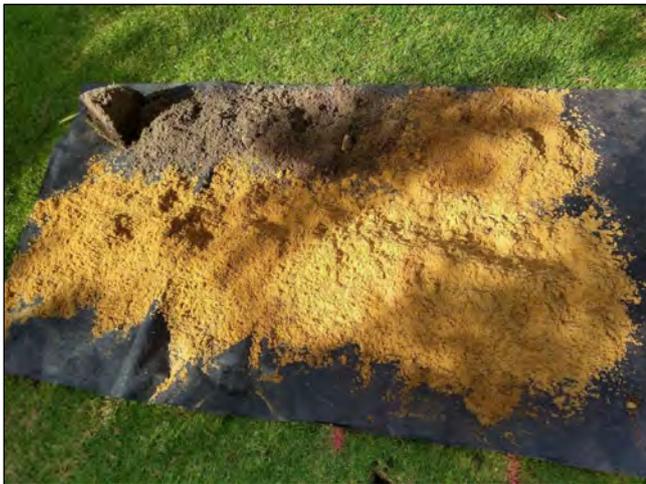
BORE No: 159
PROJECT No: 216618.01
DATE: 26/6/2023
SHEET 1 OF 1

RL	Depth (m)	Description of Strata	Graphic Log	Sampling & In Situ Testing				Water	Dynamic Penetrometer Test (blows per 150mm)
				Type	Depth	Sample	Results & Comments		
	0.7	FILL/SAND SP: fine to medium grained, dark grey, trace gravel and silt, moist, dense to very dense, fill.	[Cross-hatched pattern]	D	0.4				5 10 15 20
	1	SAND SP: fine to medium grained, yellow-brown, trace silt, moist, very dense. Possibly sand derived from Tamala Limestone.	[Dotted pattern]						
	2	- becoming pale brown from 1.9 m depth.	[Dotted pattern]						
	2.5	Bore discontinued at 2.5m (Target depth)

WATER OBSERVATIONS: No free groundwater observed.

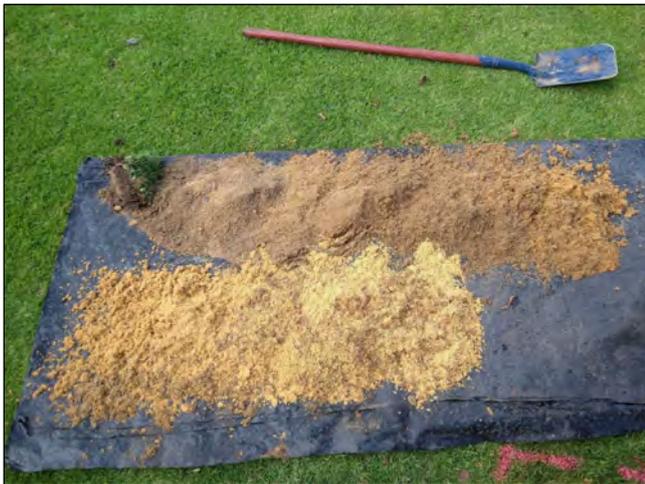
BORE No: 160
PROJECT No: 216618.01
DATE: 23/6/2023
SHEET 1 OF 1

RL	Depth (m)	Description of Strata	Graphic Log	Sampling & In Situ Testing				Water	Dynamic Penetrometer Test (blows per 150mm)				
				Type	Depth	Sample	Results & Comments		5	10	15	20	
	0.4	FILL/SAND SP: fine to medium grained, grey-brown, trace silt, trace gravel to 0.2 m depth, moist, medium dense, fill.	[Cross-hatch pattern]										
	0.4	SAND SP: fine to medium grained, brown, trace silt, moist, medium dense. Possibly sand derived from Tamala Limestone.	[Dotted pattern]	D	1.0								
		- becoming yellow-brown from 1.6 m depth.											
		- becoming pale yellow-brown from 2.0 m depth.											
	2.5	Bore discontinued at 2.5m (Target depth)

RIG: hand auger **DRILLER:** GG **LOGGED:** GG **CASING:**
TYPE OF BORING: 110 mm diameter hand auger borehole
WATER OBSERVATIONS: No free groundwater observed.

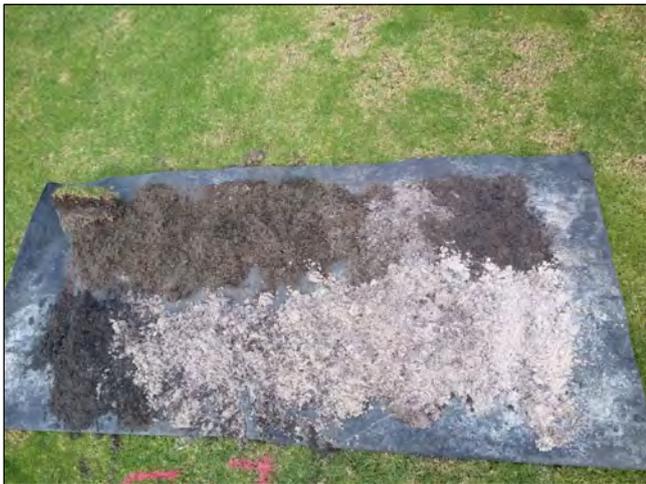
BORE No: 162
PROJECT No: 216618.01
DATE: 22/6/2023
SHEET 1 OF 1

RL	Depth (m)	Description of Strata	Graphic Log	Sampling & In Situ Testing				Water	Dynamic Penetrometer Test (blows per 150mm)					
				Type	Depth	Sample	Results & Comments		5	10	15	20		
		FILL/SAND SP: fine to medium grained, dark grey, trace gravel and silt, moist, medium dense, fill.	[Cross-hatch pattern]	E	0.5									
		- becoming pale grey and no gravel from 0.7 m depth.		D	1.0									
	1.1	SAND SP: fine to medium grained, dark grey, trace silt, moist. Bassendean Sand.	[Dotted pattern]	E	1.5									
		- becoming pale grey from 1.2 m depth.		E	2.0									
	2.5	Bore discontinued at 2.5m (Target depth)		E	2.5

WATER OBSERVATIONS: No free groundwater observed.
REMARKS: Location coordinates are in MGA94 Zone 50 J. *Surface level surveyed using a differential GPS with a reported accuracy of +/- 0.1 m. Sand Penetrometer AS1289.6.3.3
 Cone Penetrometer AS1289.6.3.2

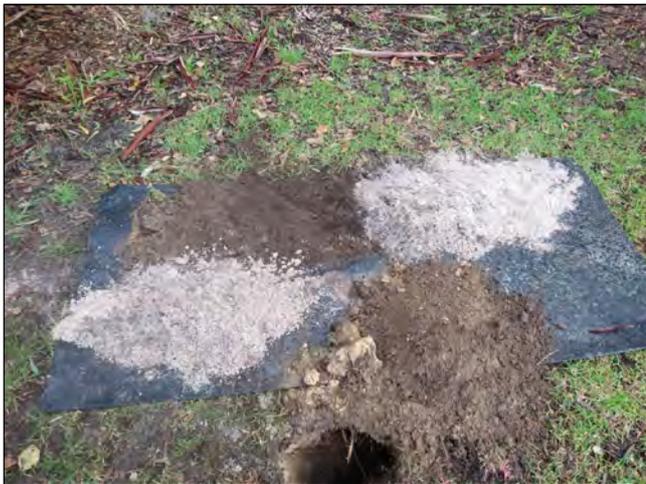
BORE No: 163
PROJECT No: 216618.01
DATE: 23/6/2023
SHEET 1 OF 1

RL	Depth (m)	Description of Strata	Graphic Log	Sampling & In Situ Testing				Water	Dynamic Penetrometer Test (blows per 150mm)			
				Type	Depth	Sample	Results & Comments		5	10	15	20
	1.2	FILL/ORGANIC SAND SP: fine to medium grained, dark grey and grey-brown, trace gravel and silt, moist, medium dense, fill. Scrap metal, pieces of glass and brick observed in fill.	[Cross-hatched pattern]	D	1.0			[Penetration curve showing ~10 blows]				
	2.0	SAND SP: fine to medium grained, pale grey, trace silt, moist. Bassendean Sand.	[Dotted pattern]									
	2.5	Bore discontinued at 2.5m (Target depth)

WATER OBSERVATIONS: No free groundwater observed.

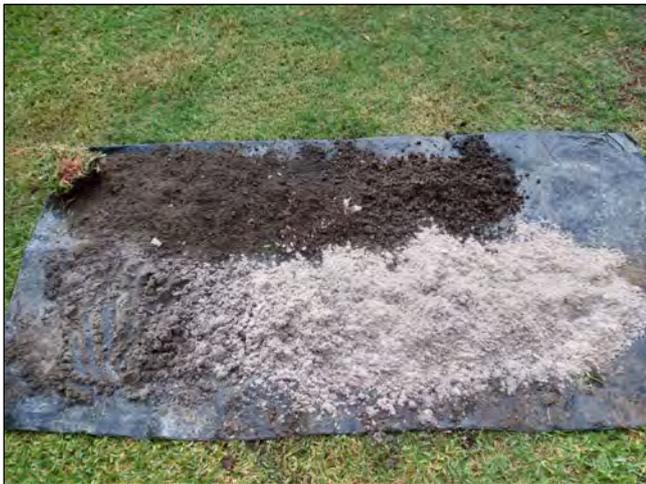
BORE No: 164
PROJECT No: 216618.01
DATE: 23/6/2023
SHEET 1 OF 1

RL	Depth (m)	Description of Strata	Graphic Log	Sampling & In Situ Testing				Water	Dynamic Penetrometer Test (blows per 150mm)
				Type	Depth	Sample	Results & Comments		
22		FILL/ORGANIC SAND SP-SM: fine to medium grained, dark grey, with gravel and silt, moist, dense to very dense, fill. Pieces of tile, glass and brick observed in fill.		D	0.5				
1	1.0	SAND SP: fine to medium grained, grey, trace silt, moist. Bassendean Sand.		E	1.0				
		- becoming pale grey from 1.4 m depth.		E	1.1				
				E	1.5				
				E	2.0				
	2.5	Bore discontinued at 2.5m (Target depth)		E	2.5

RIG: hand auger **DRILLER:** GG **LOGGED:** GG **CASING:**
TYPE OF BORING: 110 mm diameter hand auger borehole
WATER OBSERVATIONS: No free groundwater observed.

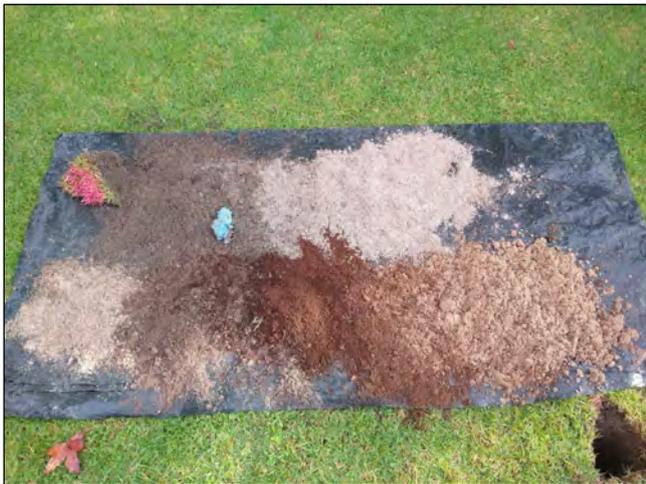
BORE No: 165
PROJECT No: 216618.01
DATE: 23/6/2023
SHEET 1 OF 1

RL	Depth (m)	Description of Strata	Graphic Log	Sampling & In Situ Testing				Water	Dynamic Penetrometer Test (blows per 150mm)				
				Type	Depth	Sample	Results & Comments		5	10	15	20	
21 20 19	0.5	FILL/SAND SP: fine to medium grained, grey, trace silt, moist, medium dense, fill. Plastic wrap observed at 0.5 m depth.	[Cross-hatch pattern]										
		SAND SP: fine to medium grained, pale grey, trace silt, moist, medium dense. Bassendean Sand.	[Dotted pattern]										
	1.3	- becoming dark grey from 1.2 m depth.											
	1.5	Cemented Silty SAND SM: fine to medium grained, dark brown, moist, weakly cemented. Coffee Rock.	[Vertical line pattern]										
		SAND SP: fine to medium grained, brown, trace silt, moist. Bassendean Sand. - becoming pale brown from 1.65 m depth.	[Dotted pattern]										
	2.1	Bore discontinued at 2.1m (Collapsing conditions)

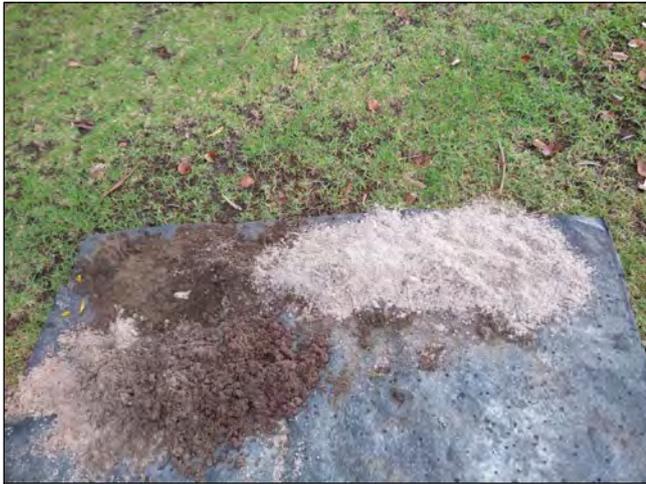
BORE No: 167
PROJECT No: 216618.01
DATE: 23/6/2023
SHEET 1 OF 1

RL	Depth (m)	Description of Strata	Graphic Log	Sampling & In Situ Testing				Water	Dynamic Penetrometer Test (blows per 150mm)
				Type	Depth	Sample	Results & Comments		
21	0.7	FILL/SAND SP: fine to medium grained, dark grey, trace gravel and silt, moist, medium dense, fill. Tile pieces observed in fill.							5 10 15 20
19	2.2	SAND SP: fine to medium grained, pale grey, trace silt, moist, medium dense to dense. Bassendean Sand. - becoming grey from 1.7 m depth.						1 2	
19	2.2	Bore discontinued at 2.2m (Collapsing conditions)

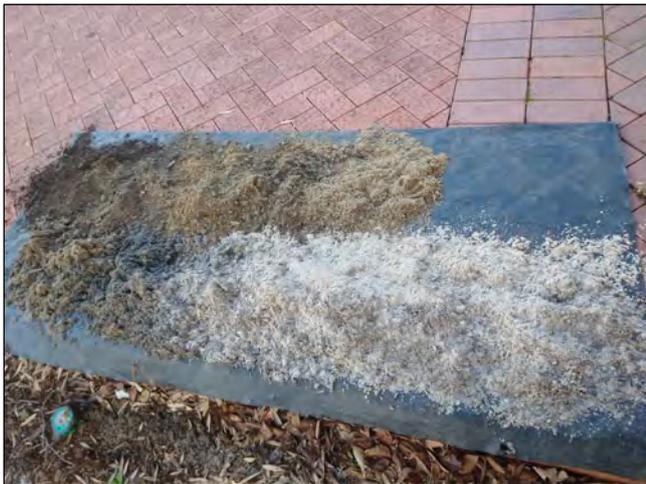
BORE No: 170
PROJECT No: 216618.01
DATE: 26/6/2023
SHEET 1 OF 1

RL	Depth (m)	Description of Strata	Graphic Log	Sampling & In Situ Testing				Water	Dynamic Penetrometer Test (blows per 150mm)				
				Type	Depth	Sample	Results & Comments		5	10	15	20	
24	0.2	FILL/SAND SP-SM: fine to medium grained, dark grey-brown, with silt, trace rootlets and gravel, moist, fill.	[Cross-hatched pattern]	D	1.0			Water					
	1	FILL/SAND SP: fine to medium grained, grey-brown, trace gravel and silt, moist, dense to very dense, fill.											
23	1	- becoming grey-brown and grey from 1.2 m depth.											
22	1.5	SAND SP: fine to medium grained, pale grey, trace silt, moist. Bassendean Sand.	[Dotted pattern]										
21	2												
20	2.5	Bore discontinued at 2.5m (Target depth)

RIG: hand auger **DRILLER:** GG **LOGGED:** GG **CASING:**
TYPE OF BORING: 110 mm diameter hand auger borehole
WATER OBSERVATIONS: No free groundwater observed.

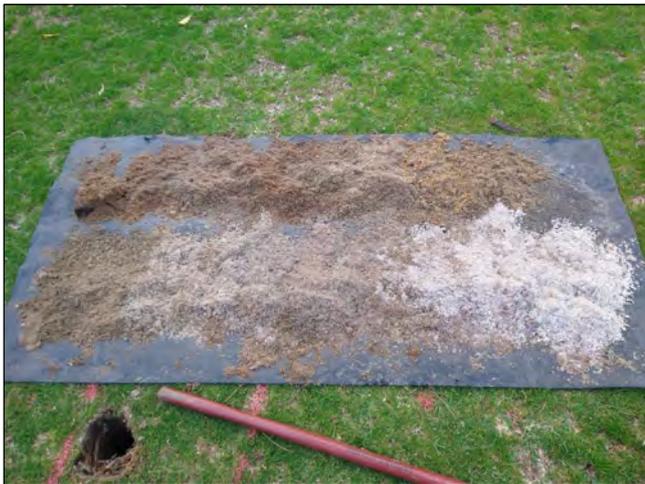
BORE No: 171
PROJECT No: 216618.01
DATE: 26/6/2023
SHEET 1 OF 1

RL	Depth (m)	Description of Strata	Graphic Log	Sampling & In Situ Testing				Water	Dynamic Penetrometer Test (blows per 150mm)					
				Type	Depth	Sample	Results & Comments		5	10	15	20		
23		FILL/SAND SP: fine to medium grained, bands of brown, yellow-brown and grey-brown, trace gravel and silt, moist, medium dense, fill.												
	1	- with gravel between 0.9 m and 1.2 m depth.												
		- becoming pale grey and grey-brown from 1.3 m depth.												
	1.9	- brick pieces observed at 1.8 m depth.												
2		SAND SP: fine to medium grained, pale grey, trace silt, moist. Bassendean Sand.												
	2.5	Bore discontinued at 2.5m (Target depth)

RIG: hand auger **DRILLER:** GG **LOGGED:** GG **CASING:**
TYPE OF BORING: 110 mm diameter hand auger borehole
WATER OBSERVATIONS: No free groundwater observed.

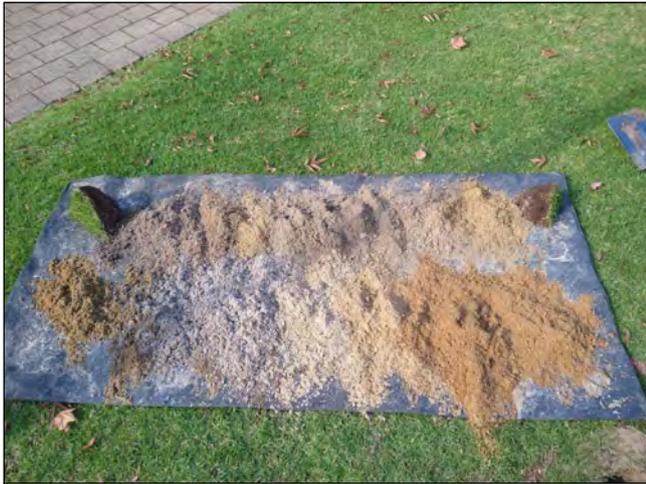
BORE No: 172
PROJECT No: 216618.01
DATE: 26/6/2023
SHEET 1 OF 1

RL	Depth (m)	Description of Strata	Graphic Log	Sampling & In Situ Testing				Water	Dynamic Penetrometer Test (blows per 150mm)
				Type	Depth	Sample	Results & Comments		
23	0.0	FILL/SAND SP: fine to medium grained, bands of grey, grey-brown, pale yellow and yellow-brown, trace gravel and silt, moist, medium dense, fill. Pieces of tile and brick observed in fill.		D	1.0				<div style="display: flex; justify-content: space-around; width: 100%;"> 5101520 </div>
22	1.3	SAND SP: fine to medium grained, pale grey, trace silt, moist. Bassendean Sand. - becoming pale brown from 1.8 m depth. - becoming brown from 2.0 m depth.							
21	2.5	Bore discontinued at 2.5m (Target depth)

RIG: hand auger **DRILLER:** GG **LOGGED:** GG **CASING:**
TYPE OF BORING: 110 mm diameter hand auger borehole
WATER OBSERVATIONS: No free groundwater observed.

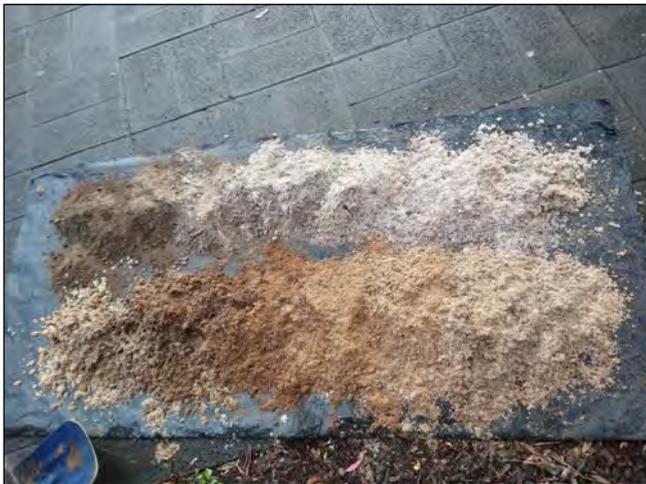
BORE No: 174
PROJECT No: 216618.01
DATE: 23/6/2023
SHEET 1 OF 1

RL	Depth (m)	Description of Strata	Graphic Log	Sampling & In Situ Testing				Water	Dynamic Penetrometer Test (blows per 150mm)
				Type	Depth	Sample	Results & Comments		
21 20 19	0.5	FILL/SAND SP: fine to medium grained, grey and grey-brown, trace gravel and silt, moist, medium dense, fill.	[Cross-hatch pattern]	E	0.5				
	1.0	SAND SP: fine to medium grained, pale grey, trace silt, moist, medium dense. Bassendean Sand.	[Dotted pattern]	D E	1.0				
	1.6	- becoming grey-brown from 1.5 m depth.	[Dotted pattern]	E	1.5				
	2.0	SAND SP: fine to medium grained, brown, trace silt, trace pockets of weakly cemented SAND SP-SM, moist. Sand derived from Tamala Limestone.	[Dotted pattern]	E	2.0				
	2.5	- becoming pale brown from 2.0 m depth. - becoming pale yellow-brown from 2.2 m depth.	[Dotted pattern]	E	2.5				
	2.5	Bore discontinued at 2.5m (Target depth)

RIG: hand auger **DRILLER:** GG **LOGGED:** GG **CASING:**
TYPE OF BORING: 110 mm diameter hand auger borehole
WATER OBSERVATIONS: No free groundwater observed.

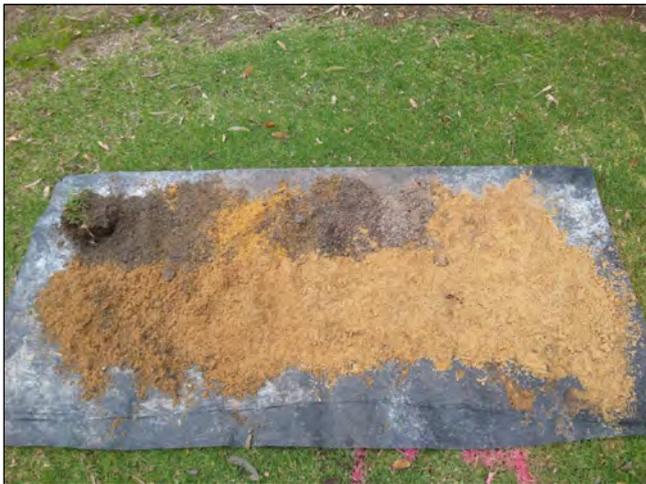
BORE No: 175
PROJECT No: 216618.01
DATE: 22/6/2023
SHEET 1 OF 1

RL	Depth (m)	Description of Strata	Graphic Log	Sampling & In Situ Testing				Water	Dynamic Penetrometer Test (blows per 150mm)				
				Type	Depth	Sample	Results & Comments		5	10	15	20	
23 22 21	0.1	FILL/TOPSOIL: SAND SP: fine to medium grained, grey, trace silt and rootlets, moist, fill. FILL/SAND SP: fine to medium grained, grey-brown, trace gravel and silt, moist, medium dense to dense, fill.	[Cross-hatched pattern]	E	0.5								
	0.7	SAND SP: fine to medium grained, grey, trace silt, moist, dense. Possibly fill.	[Dotted pattern]	E	1.0								
	1.0	SAND SP: fine to medium grained, yellow-brown, trace silt, moist. Possibly sand derived from Tamala Limestone.	[Dotted pattern]	D	1.1								
				E	1.5								
				E	2.0								
		2.5	Bore discontinued at 2.5m (Target depth)		E	2.5

RIG: hand auger **DRILLER:** GG **LOGGED:** GG **CASING:**
TYPE OF BORING: 110 mm diameter hand auger borehole
WATER OBSERVATIONS: No free groundwater observed.

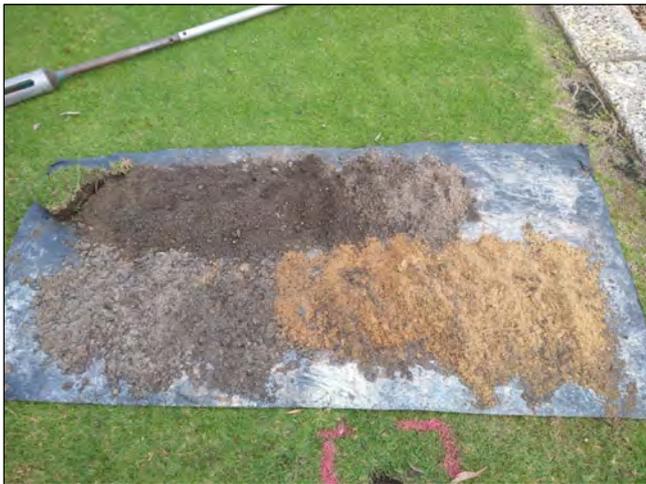
BORE No: 176
PROJECT No: 216618.01
DATE: 22/6/2023
SHEET 1 OF 1

RL	Depth (m)	Description of Strata	Graphic Log	Sampling & In Situ Testing				Water	Dynamic Penetrometer Test (blows per 150mm)				
				Type	Depth	Sample	Results & Comments		5	10	15	20	
23	0.1	FILL/TOPSOIL: SAND SP-SM: fine to medium grained, dark grey-brown, with silt, moist, fill.	[Cross-hatched pattern]	D	0.3								
		FILL/SAND SP: fine to medium grained, dark grey, trace gravel, silt and tree roots, moist, medium dense, fill.											
22	0.8	SAND SP: fine to medium grained, grey, trace silt, moist, dense. Bassendean Sand.	[Dotted pattern]	D	1.0								
1		- becoming brown from 1.6 m depth.											
2		- becoming pale brown from 2.0 m depth.											
21	2.5	Bore discontinued at 2.5m (Target depth)

RIG: hand auger **DRILLER:** GG **LOGGED:** GG **CASING:**
TYPE OF BORING: 110 mm diameter hand auger borehole
WATER OBSERVATIONS: No free groundwater observed.

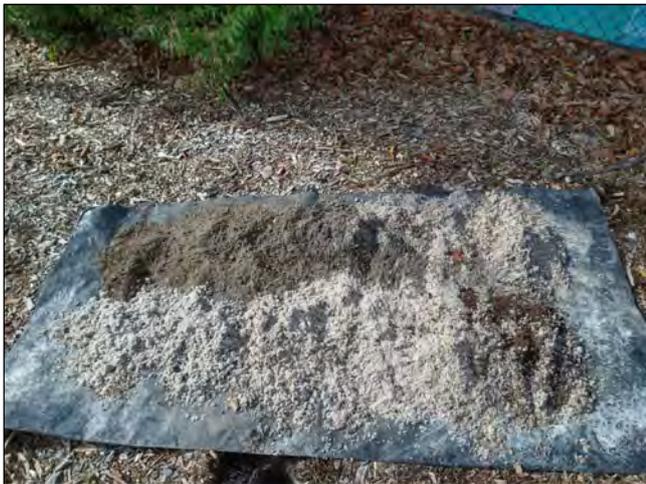
BORE No: 177
PROJECT No: 216618.01
DATE: 22/6/2023
SHEET 1 OF 1

RL	Depth (m)	Description of Strata	Graphic Log	Sampling & In Situ Testing				Water	Dynamic Penetrometer Test (blows per 150mm)
				Type	Depth	Sample	Results & Comments		
	0.6	FILL/SAND SP: fine to medium grained, dark grey, trace gravel and silt, moist, medium dense, fill.	[Cross-hatched pattern]						
	1.0	SAND SP: fine to medium grained, grey, trace silt, moist, medium dense to dense. Bassendean Sand. - becoming pale grey from 0.8 m depth.	[Dotted pattern]	D	1.0				[Penetration curve graph]
	1.9 2.0	Cemented Silty SAND SM: fine to medium grained, dark brown, moist, weakly cemented. Coffee rock. Bore discontinued at 2.0m (Hard digging, refusal on coffee rock)	[Horizontal lines pattern]

RIG: hand auger **DRILLER:** GG **LOGGED:** GG **CASING:**
TYPE OF BORING: 110 mm diameter hand auger borehole
WATER OBSERVATIONS: No free groundwater observed.

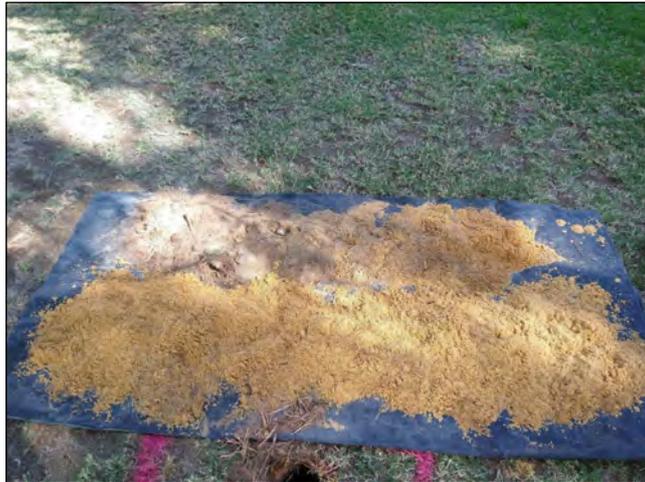
BORE No: 30
PROJECT No: 216618.00
DATE: 27/9/2022
SHEET 1 OF 1

RL	Depth (m)	Description of Strata	Graphic Log	Sampling & In Situ Testing				Water	Dynamic Penetrometer Test (blows per 150mm)				
				Type	Depth	Sample	Results & Comments		5	10	15	20	
	0.45	FILL/SAND SP-SM: fine to medium grained, grey-brown, with silt, trace gravel, moist, dense, fill.											
	1	SAND SP: fine to medium grained, yellow-brown, trace silt, moist, dense. Sand derived from Tamala Limestone.											
	2.5	Bore discontinued at 2.5m (Target depth)

TYPE OF BORING: 110 mm diameter hand auger borehole

WATER OBSERVATIONS: No free groundwater observed.

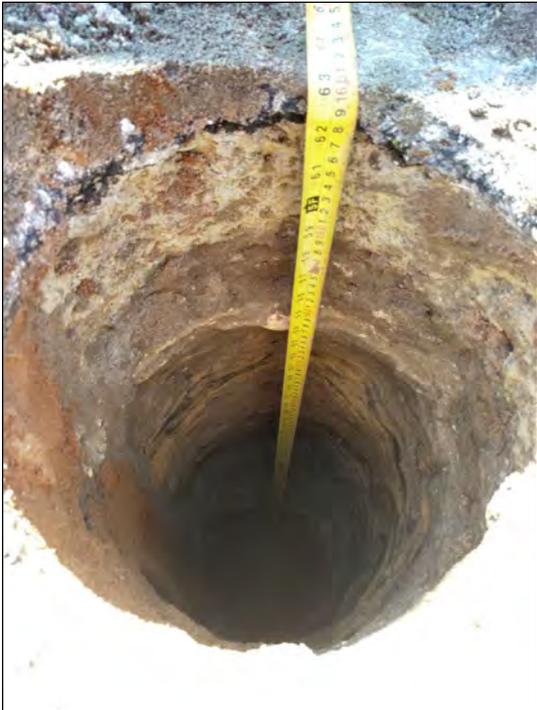
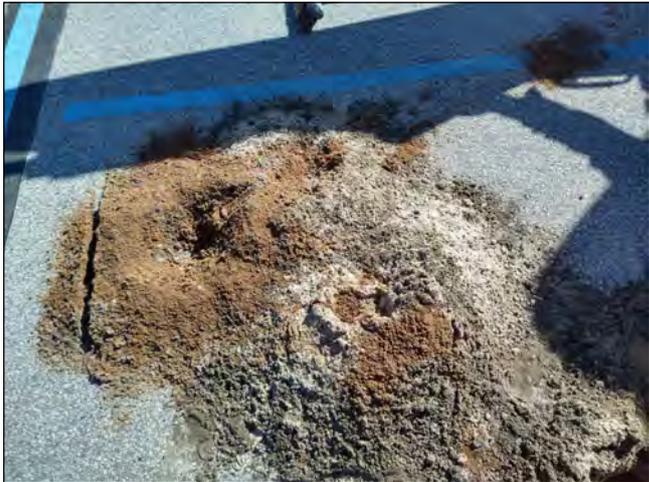
0.03	ASPHALT: black, 7 mm nominal aggregate.	▬											
	0.13	FILL/Sandy GRAVEL GP-GM: fine to coarse sized, pale grey, fine to medium grained, with silt, moist, fill.	▨

0.26	FILL/Gravelly SAND SP-SM: fine to medium grained, grey-brown, fine to coarse sized, with silt, moist, fill.	▩											
	0.7	FILL/SAND SP: fine to medium grained, bands of grey-brown, dark grey-brown and yellow-brown, trace silt and gravel, moist, dense to very dense, fill.	▧

1.0	SAND SP: fine to medium grained, grey, trace silt, moist, dense. Bassendean Sand.	▦	D	1.0									
	1.5	- becoming pale grey from 1.5 m depth.

2.0	- becoming pale brown from 2.0 m depth.												
	2.2	- becoming brown, weakly cemented from 2.2 m depth.												
	2.5	Bore discontinued at 2.5m (Target depth)

RIG: 8 tonne backhoe **DRILLER:** ANH Contracting **LOGGED:** GG **CASING:** None
TYPE OF BORING: 250 mm diameter power auger borehole
WATER OBSERVATIONS: No free groundwater observed.
REMARKS: Location coordinates are in MGA94 Zone 50 J. *Surface level measured using a differential GPS with a reported accuracy of 0.1 m. Sand Penetrometer AS1289.6.3.3
 Cone Penetrometer AS1289.6.3.2
