ECU Mount Lawley Redevelopment

Precinct Structure Plan Water Management Report

DevelopmentWA

By Urbaqua

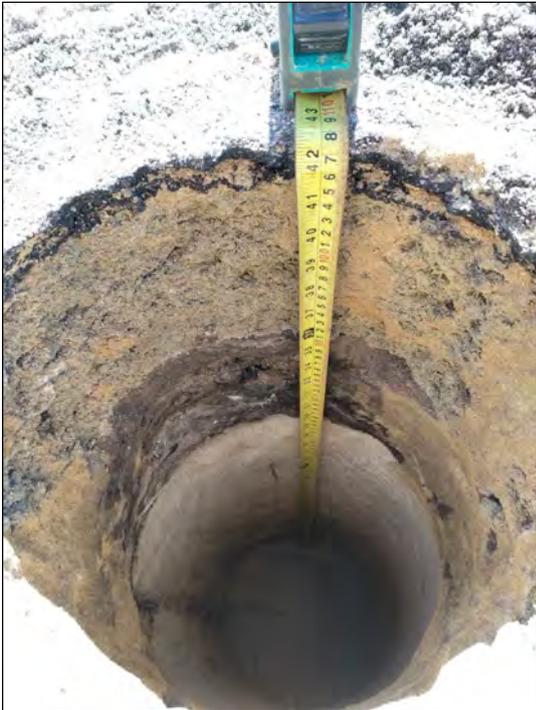
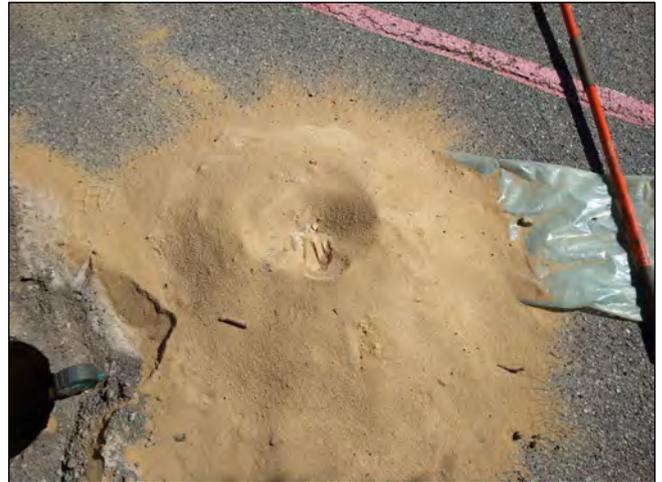
BORE No: 37
PROJECT No: 216618.00
DATE: 27/9/2022
SHEET 1 OF 1

RL	Depth (m)	Description of Strata	Graphic Log	Sampling & In Situ Testing				Water	Dynamic Penetrometer Test (blows per 150mm)					
				Type	Depth	Sample	Results & Comments		5	10	15	20		
	0.03	ASPHALT: black, 7 mm nominal aggregate.	▨											
	0.2	FILL/Sandy GRAVEL GP-GM: fine to coarse sized, grey-brown and pale grey, fine to medium grained, with silt, moist, fill.	▩											
	0.34	FILL/SAND SP: fine to medium grained, dark grey-brown and grey-brown, trace silt and gravel, moist, dense, fill.	▧											
	0.8	SAND SP: fine to medium grained, pale grey, trace silt, moist, dense. Possibly fill.	▦											
22	1	SAND SP: fine to medium grained, pale yellow-brown, trace silt, moist, medium dense. Sand derived from Tamala Limestone.	▤	B	0.9									
21	2													
20	2.5	Bore discontinued at 2.5m (Target depth)

TYPE OF BORING: 250 mm diameter power auger borehole

WATER OBSERVATIONS: No free groundwater observed.
